## Guidelines for the Application of Crossing Solutions at Roundabouts and Channelized Turn Lanes for Pedestrians with Vision Disabilities

Bastian Schroeder, Lee Rodegerdts, Pete Jenior, Edward Myers, Christopher Cunningham, Katy Salamati, Sarah Searcy, Sarah O'Brien, Janet Barlow, and Billie Louise (Beezy) Bentzen; National Cooperative Highway Research Program; Transportation Research Board; National Academies of Sciences, Engineering, and Medicine

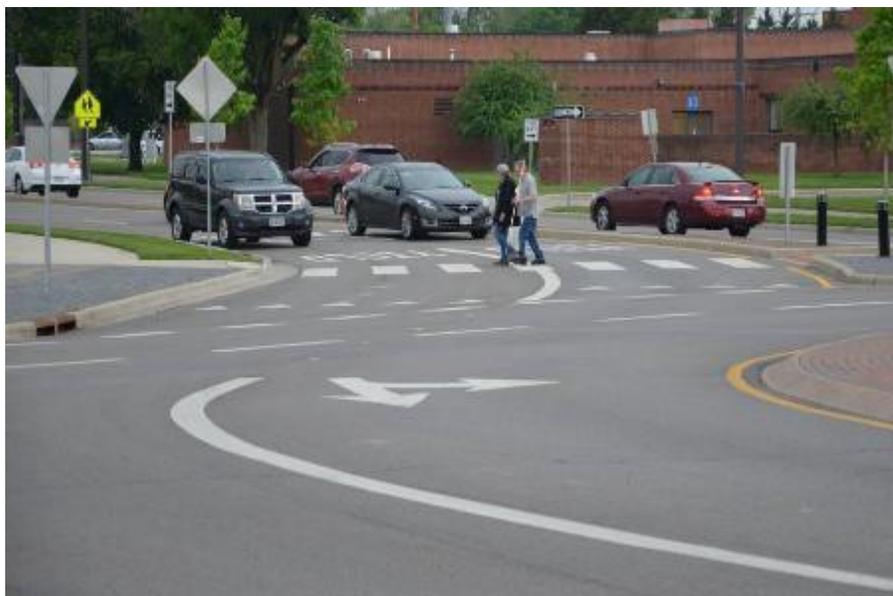
**Figure 2-1: Blind pedestrian crossing at multi-lane roundabout**

*This figure shows two pedestrians crossing at a multilane roundabout, one with a white cane extended. Vehicles are yielding in each lane.*

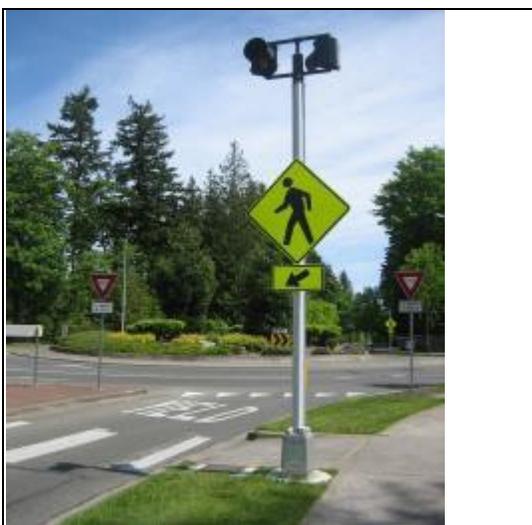
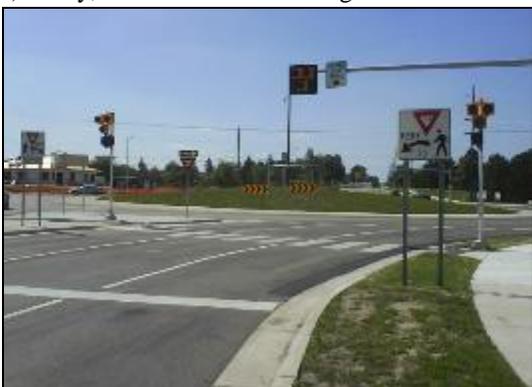
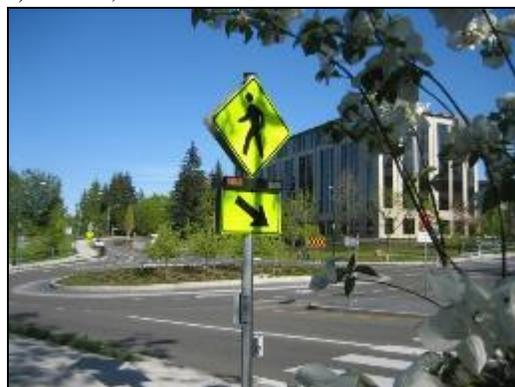
#### Exhibit 1: Images of Sample Treatments

a) Lacey, WA Overhead Flashing Beacon

c) Oakland County, MI PHB three-lane RBT

d) RRFB in Olympia, WA

*This exhibit shows pictures of four existing treatments including: (a) an overhead flashing beacon at a single-lane roundabout approach in Lacey, WA, (b) a raised pedestrian crosswalk at a channelized turn lane in Tucson, AZ, (c) a Pedestrian Hybrid Beacon at a three-lane roundabout approach in Oakland County, MO, and (d) a rectangular rapid-flashing beacon at a two-lane roundabout in Olympia, WA.*

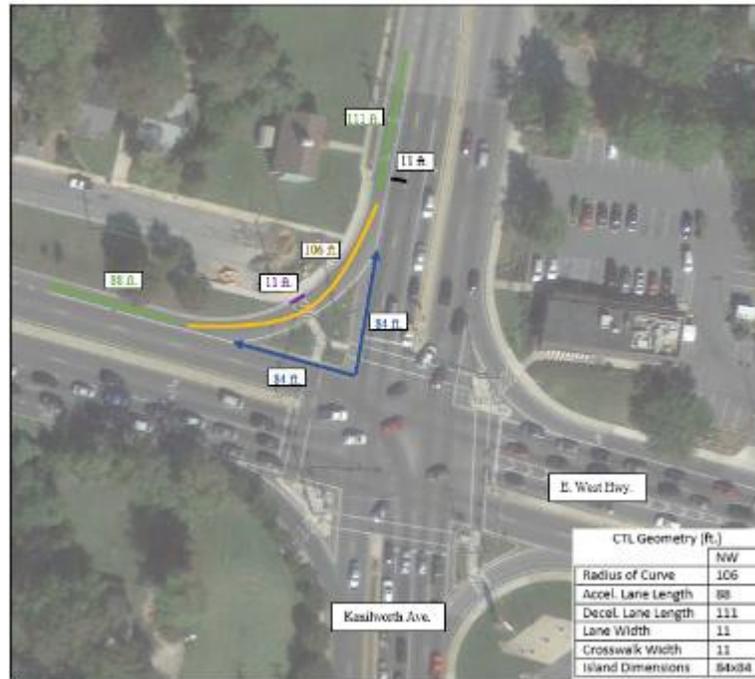
Figure 3-8: CTL at Kenilworth Avenue and East West Highway, Greenbelt, MD

1. Kenilworth Avenue at East West Highway – Northwest quadrant of intersection, deceleration lane, no acceleration lane, no other treatments installed
2. Kildaire Farm Road at Tryon Road – Southwest quadrant of intersection, deceleration lane, no acceleration lane, no other treatments installed

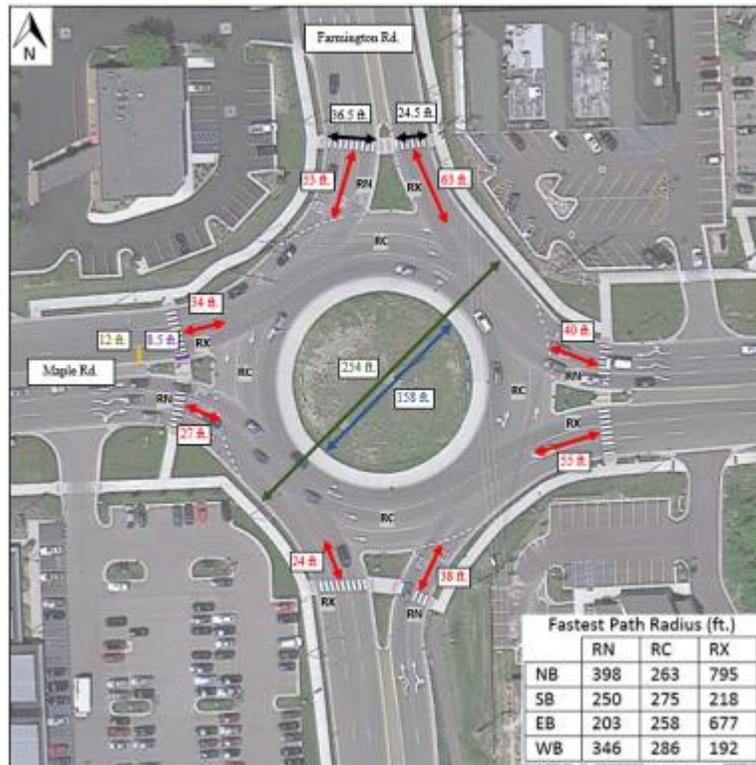
Figure 3-11: Roundabout at Maple Road at Farmington Road, Oakland County, MI

In August 2014, the team completed a study at the multi-lane roundabout at Maple Road and Farmington Road in Oakland County, MI. The roundabout was previously evaluated in a separate research project in (a) a “before” condition without treatment and in (b) an “after” condition with Rectangular Rapid-Flashing Beacons (RRFBs) installed. For this study, the roundabout was also outfitted with raised crosswalks at four test legs: 3-lane entry from east, 3-lane exit to east, 2-lane entry from south, and 2-lane exit to north.

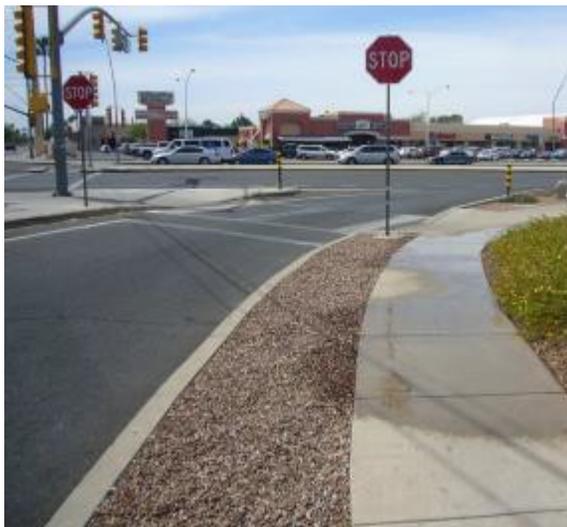
Figure 4-1: Wilmont Road at Speedway Boulevard, NW Quadrant, Tucson, AZ

1. Wilmont Road at Speedway Boulevard – Northwest quadrant of intersection, urban location, deceleration lane, no acceleration lane, stop sign at downstream merge point
  - a. Intervention Rate: 2.2%
  - b. Average Delay: 6.3 seconds
  - c. Yielding Rate: 88.6%
  - d. Average Speed (200'): G – 33 mph; R – 28 mph
  - e. Average Speed (CW): n/a (stop sign)

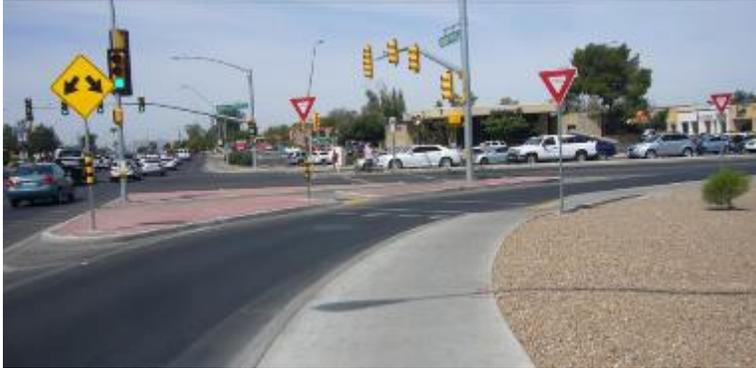
Figure 4-2: Sabino Canyon Road at Tanque Verde Road, NE Quadrant, Tucson, AZ

2. Sabino Canyon Road at Tanque Verde Road – Northeast quadrant of intersection, urban location, deceleration and acceleration lane, no additional treatments
  - a. Intervention Rate: 0.0%
  - b. Average Delay: 4.2 seconds
  - c. Yielding Rate: 46.6%
  - d. Average Speed (200'): G – 30 mph; R – 28 mph
  - e. Average Speed (CW): G – 22 mph; R – 19 mph

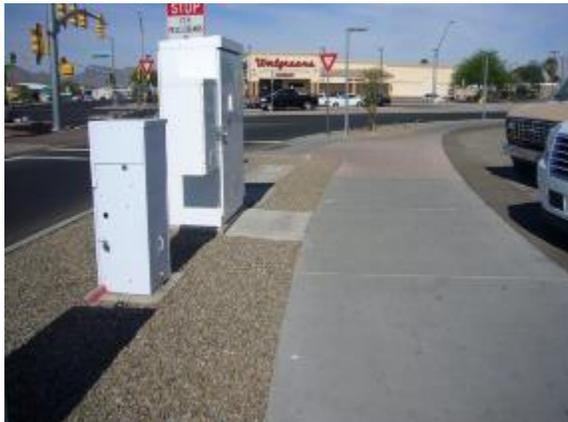
Figure 4-3: Grant Road at Oracle Road, NE Quadrant, Tucson, AZ

3. Grant Road at Oracle Road – Northeast quadrant of intersection, urban location, deceleration lane, no acceleration lane, raised crosswalk
  - a. Intervention Rate: 0.0%
  - b. Average Delay: 3.0 seconds
  - c. Yielding Rate: 67.9%
  - d. Average Speed (200'): G – 31 mph; R – 30 mph
  - e. Average Speed (CW): G – 21 mph; R – 19 mph

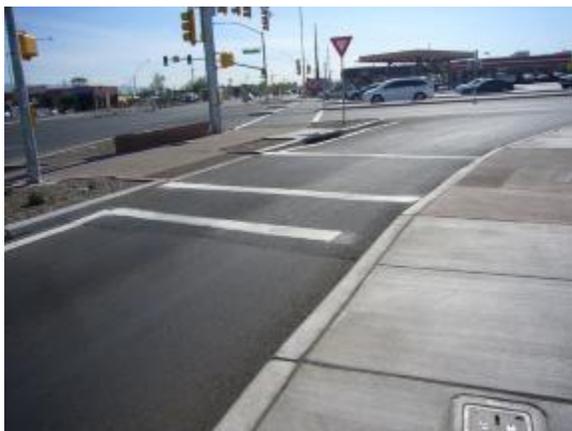
Figure 4-4: Grant Road at Oracle Road, SW Quadrant, Tucson, AZ

4. Grant Road at Oracle Road – Southwest quadrant of intersection, urban location, deceleration lane, no acceleration lane, raised crosswalk
  - a. Intervention Rate: 6.7%
  - b. Average Delay: 3.7 seconds
  - c. Yielding Rate: 49.5%
  - d. Average Speed (200'): G – 32 mph; R – 29 mph

- e. Average Speed (CW): G – 20 mph; R – 17 mph

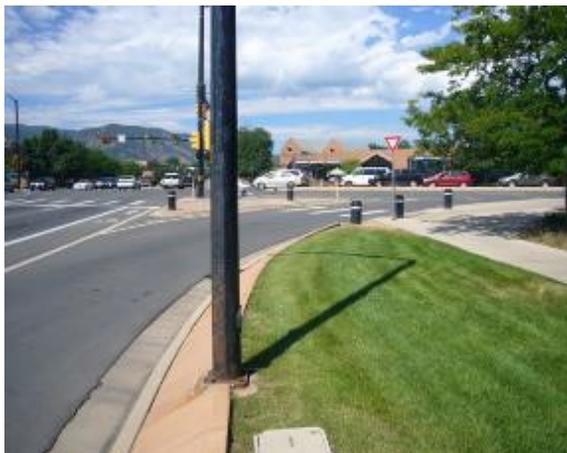
Figure 4-5: 28th Street at Pearl Street, NE Quadrant, Boulder, CO

1. 28<sup>th</sup> Street at Pearl Street – Northeast quadrant of intersection, urban location, deceleration lane, no acceleration lane, no additional treatments
  - a. Intervention Rate: 8.5%
  - b. Average Delay: 12.2 seconds
  - c. Yielding Rate: 66.0%
  - d. Average Speed (200'): G – 25 mph; R – 21 mph
  - e. Average Speed (CW): G – 14 mph; R – 13 mph

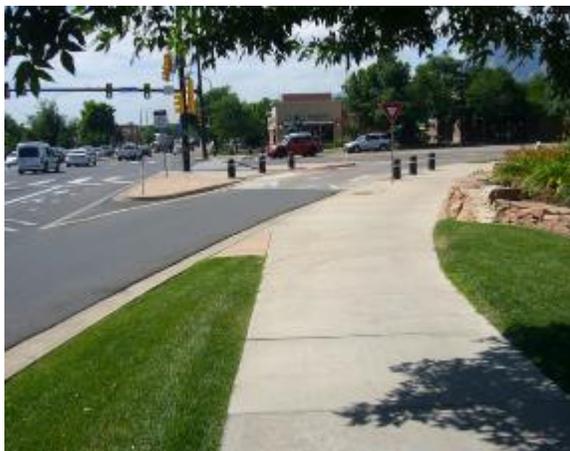
**Figure 4-6: 28th Street at Pearl Street, NW Quadrant, Boulder, CO**

2. 28<sup>th</sup> Street at Pearl Street – Northwest quadrant of intersection, urban location, deceleration lane, no acceleration lane, raised crosswalk
  - a. Intervention Rate: 1.7%
  - b. Average Delay: 15.7 seconds
  - c. Yielding Rate: 57.8%
  - d. Average Speed (200'): G – 26 mph; R – 20 mph
  - e. Average Speed (CW): G – 15 mph; R – 13 mph

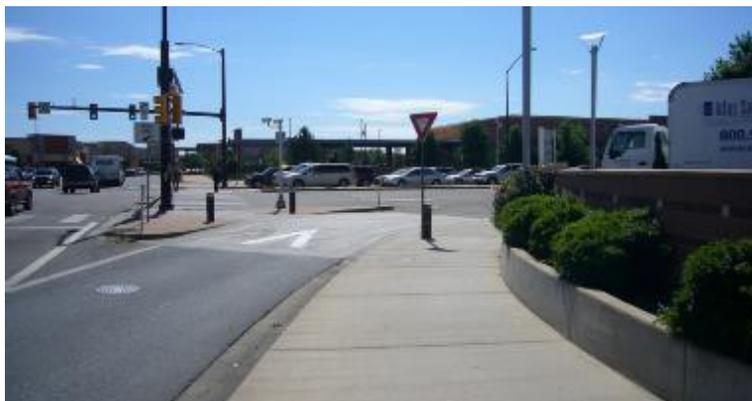
**Figure 4-7: 28th Street at Canyon Boulevard, SW Quadrant, Boulder, CO**

3. 28<sup>th</sup> Street at Canyon Boulevard – Southwest quadrant of intersection, urban location, deceleration lane, no acceleration lane, raised crosswalk
  - a. Intervention Rate: 6.7%
  - b. Average Delay: 23.9 seconds
  - c. Yielding Rate: 40.3%
  - d. Average Speed (200'): G – 29 mph; R – 27 mph
  - e. Average Speed (CW): G – 15 mph; R – 14 mph

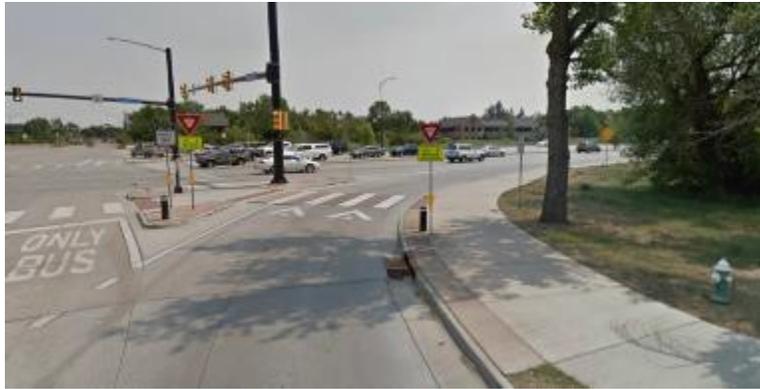
**Figure 4-8: Foothills Parkway at Arapahoe Avenue, SW Quadrant, Boulder, CO**

4. Foothills Parkway at Arapahoe Avenue – Southwest quadrant of intersection, suburban location, deceleration lane, acceleration lane, raised crosswalk
  - a. Intervention Rate: 0.0%
  - b. Average Delay: 14.6 seconds
  - c. Yielding Rate: 32.4%
  - d. Average Speed (200'): G – 33 mph; R – 35 mph
  - e. Average Speed (CW): G – 21 mph; R – 22 mph

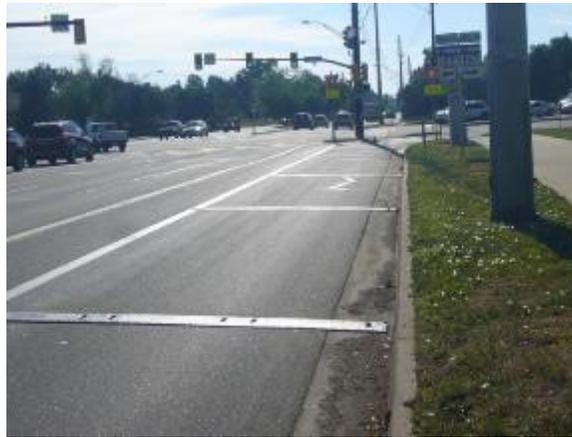
**Figure 4-9: Foothills Parkway at Baseline Drive, SW Quadrant, Boulder, CO**

5. Foothills Parkway at Baseline Drive – Southwest quadrant of intersection, suburban location, deceleration lane, acceleration lane, sound strip treatment
  - a. Intervention Rate: 0.0%
  - b. Average Delay: 9.8 seconds
  - c. Yielding Rate: 30.5%
  - d. Average Speed (200'): G – 28 mph; R – 29 mph
  - e. Average Speed (CW): G – 20 mph; R – 18 mph

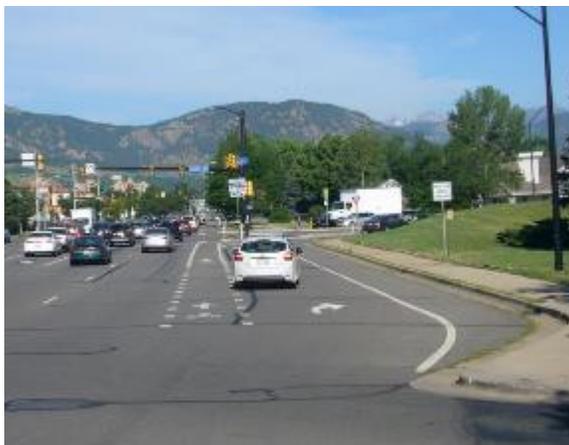
**Figure 4-10: Foothills Parkway at Baseline Drive, NE Quadrant, Boulder, CO**

6. Foothills Parkway at Baseline Drive – Northeast quadrant of intersection, suburban location, deceleration lane, acceleration lane, raised crosswalk
  - a. Intervention Rate: 0.0%
  - b. Average Delay: 13.0 seconds
  - c. Yielding Rate: 36.1%
  - d. Average Speed (200'): G – 33 mph; R – 31 mph
  - e. Average Speed (CW): G – 25 mph; R – 22 mph

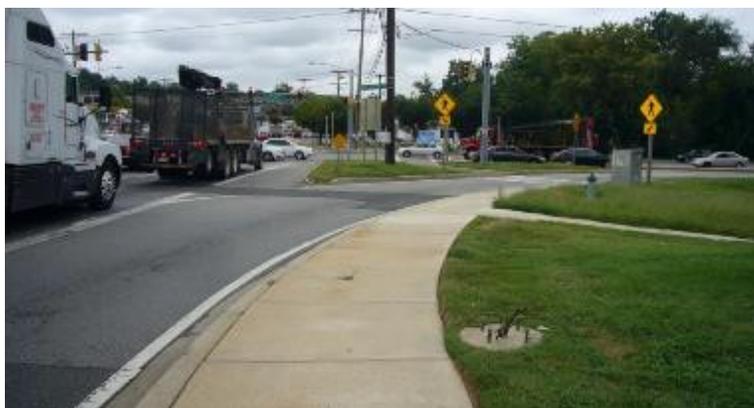
**Figure 4-11: Kenilworth Avenue at East West Highway, NW Quadrant, Greenbelt, MD**

1. Kenilworth Avenue at East West Highway - Northwest quadrant of the intersection, deceleration lane, no acceleration lane, no other treatments installed
  - a. Intervention Rate: 10.4%
  - b. Average Delay: 20.1 seconds
  - c. Yielding Rate: 23.2%
  - d. Average Speed (200'): G – 28 mph; R – 29 mph
  - e. Average Speed (CW): G – 17 mph; R – 15 mph

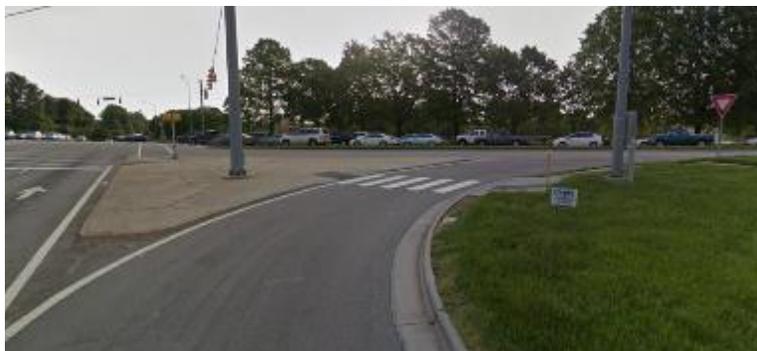
Figure 4-12: Kildaire Farm Road at Tryon Road, SW Quadrant, Cary, NC

2. Kildaire Farm Road at Tryon Road – Southwest quadrant of the intersection, deceleration lane, no acceleration lane, no other treatments installed
  - a. Intervention Rate: 3.3%
  - b. Average Delay: 16.0 seconds
  - c. Yielding Rate: 46.8%
  - d. Average Speed (200'): G – 38 mph; R – 35 mph
  - e. Average Speed (CW): G – 15 mph; R – 13 mph

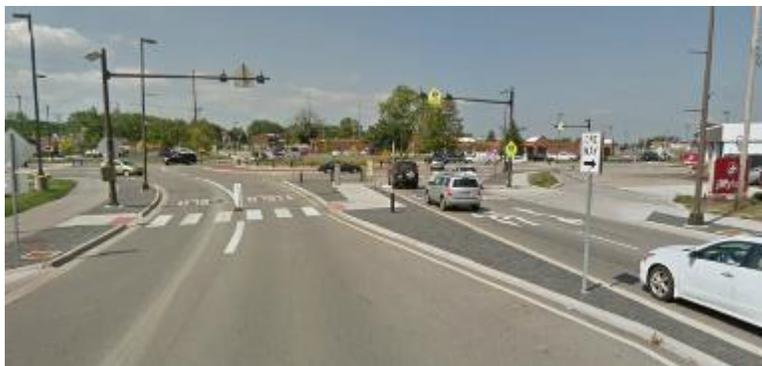
Figure 4-13: Main Street at Cemetery Road, East Approach, Hilliard, OH

1. Main Street at Cemetery Road – East and west approaches, two-lane entries and exits, west approach features a “standard” crosswalk location, east approach features an offset or “zig-zag” configuration, both approaches have in-road yield to pedestrian signs
  - a. Intervention Rate:
    - East Entry: 1.7%
    - East Exit: 6.7%
    - West Entry: 1.9%
    - West Exit: 14.0%
  - b. Average Delay:
    - East Entry: 21.7 seconds
    - East Exit: 17.4 seconds
    - West Entry: 14.8 seconds
    - West Exit: 17.9 seconds
  - c. Yielding Rate:
    - East Entry: 58.9%
    - East Exit: 23.4%
    - West Entry: 63.6%
    - West Exit: 21.3%
  - d. Average Speed (CW):
    - East Entry: 17 mph
    - East Exit: 26 mph
    - West Entry: 16 mph
    - West Exit: 21 mph

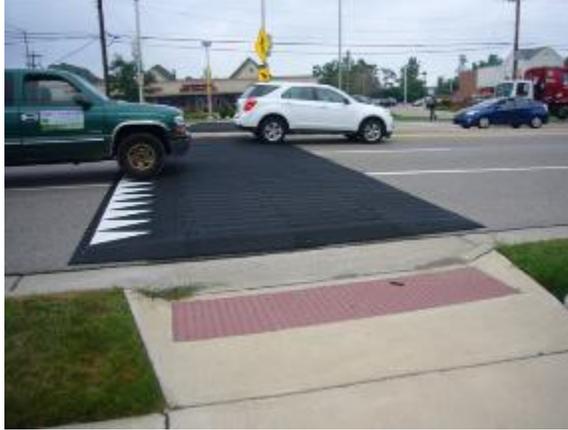
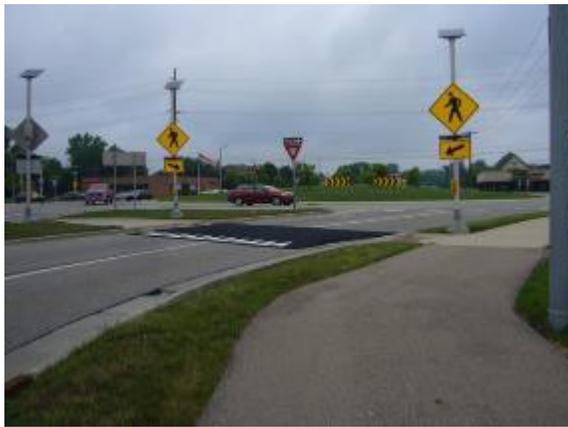
1. Maple Road at Farmington Road – East and south approaches, RRFB on all approaches, raised crosswalk on tested approaches only, three-lane east leg, two-lane north and south legs
  - a. Intervention Rate:
    - East Entry: 0.0%
    - East Exit: 0.0%
    - South Entry: 0.0%
    - South Exit: 6.0%
  - b. Average Delay:
    - East Entry: 9.4 seconds
    - East Exit: 10.9 seconds
    - South Entry: 9.3 seconds
    - South Exit: 8.2 seconds
  - c. Yielding Rate:
    - East Entry: 90.8%
    - East Exit: 54.1%
    - South Entry: 65.2%
    - South Exit: 65.4%
  - d. Average Speed (CW):
    - East Entry: 13 mph
    - East Exit: 15 mph
    - South Entry: 13 mph
    - South Exit: 15 mph

Figure 4-14: Maple Road at Farmington Road, East Approach Exit, Oakland County, MI

Figure 4-15: Maple Road at Farmington Road, South Approach Entry, Oakland County, MI

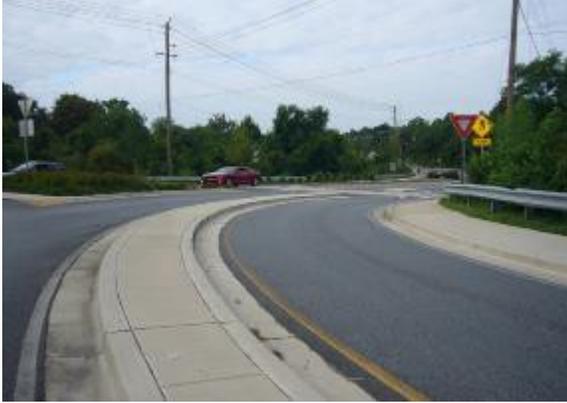
**Figure 4-16: Greenbelt Metro Drive at Cherrywood Lane, West Entry and Exit Approaches, Greenbelt, MD**

1. Greenbelt Metro Drive at Cherrywood Lane – West entry and west exit approaches, raised crosswalks, one-lane entry, two-lane exit
  - a. Intervention Rate:
    - West Entry: 2.1%
    - West Exit: 4.0%
  - b. Average Delay:
    - West Entry: 24.0 seconds
    - West Exit: 26.2 seconds
  - c. Yielding Rate:
    - West Entry: 41.9%
    - West Exit: 13.7%
  - d. Average Speed (CW):
    - West Entry: 17 mph
    - West Exit: 17 mph

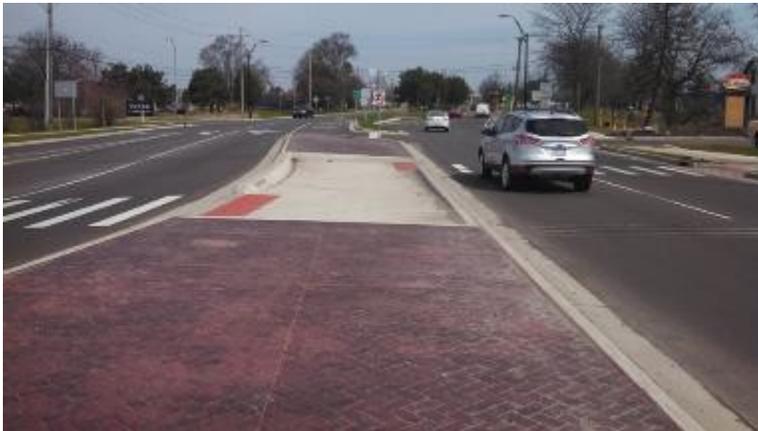
**Figure 4-17: Ellsworth Road at State Road, West Entry and Exit Approaches, Ann Arbor, MI**

1. Ellsworth Road at State Road – West entry and west exit approaches, “zig-zag” crosswalk, rumble strips
  - a. Intervention Rate:
    - West Entry: 0.0%
    - West Exit: 3.1%
  - b. Average Delay:
    - West Entry: 7.9 seconds
    - West Exit: 9.9 seconds
  - c. Yielding Rate:
    - West Entry: 78.3%
    - West Exit: 8.0%
  - d. Average Speed (CW):
    - West Entry: 18 mph
    - West Exit: 27 mph

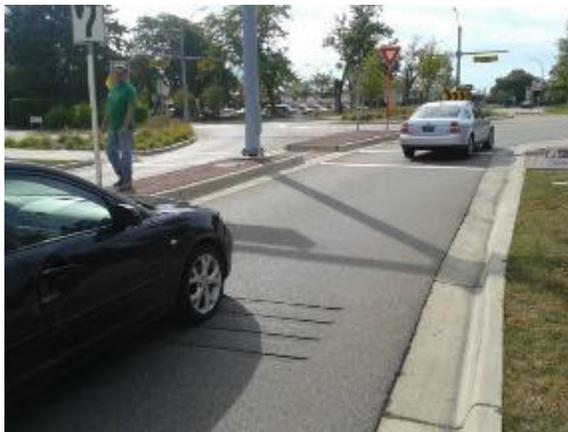
Figure 4-18: Nixon Road at Huron Parkway, South Exit and Entry Approaches, Ann Arbor, MI

2. Nixon Road at Huron Parkway – South entry and south exit approaches, single-lane roundabout, rumble strips
  - a. Intervention Rate:
    - West Entry: 0.0%

- West Exit: 0.0%
- b. Average Delay:
  - West Entry: 5.8 seconds
  - West Exit: 8.4 seconds
- c. Yielding Rate:
  - West Entry: 79.4%
  - West Exit: 45.5%
- d. Average Speed (CW):
  - West Entry: 15 mph
  - West Exit: 16 mph

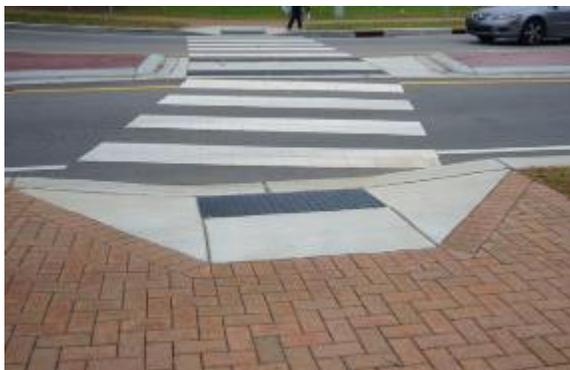
Figure 4-19: Old Apex Road at West Chatham Street, West Entry and Exit Approaches, Cary, NC

1. Old Apex Road at West Chatham Street – West entry and west exit approaches, three-legged, single-lane roundabout
  - a. Intervention Rate:
    - West Entry: 1.7%
    - West Exit: 3.3%
  - b. Average Delay:
    - West Entry: 11.4 seconds
    - West Exit: 11.7 seconds
  - c. Yielding Rate:
    - West Entry: 61.4%
    - West Exit: 32.2%
  - d. Average Speed (CW):
    - West Entry: 18 mph
    - West Exit: 21 mph

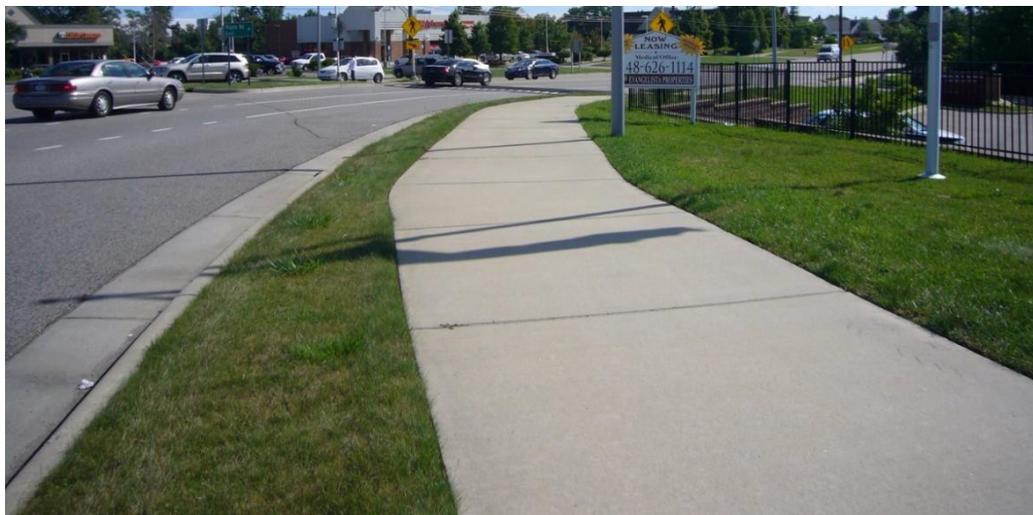
When there was a landscape strip between the sidewalk and curb, blind pedestrians usually did not walk on it, and instead stayed on the sidewalk while looking to the side with their cane for the crosswalk. Participants reported that they were more comfortable when looking for the crosswalk when they were separated by landscaping from traffic moving in the roadway. Not all participants used the strategy of following, or trailing the landscape strip on their side closest to the roadway with their cane when looking for the opening to the crosswalk at first. Most participants adopted that strategy (if there was a landscape strip) after they were told that they had passed the crosswalk.

**Figure 4-20: Grass between sidewalk and curb along edge of circulatory roadway between the crosswalks**

*This figure shows a photo of a roundabout with an approximately 4-foot-wide grass strip between the sidewalk and the roadway that follows the curvature of the road between the crosswalks at a roundabout.*

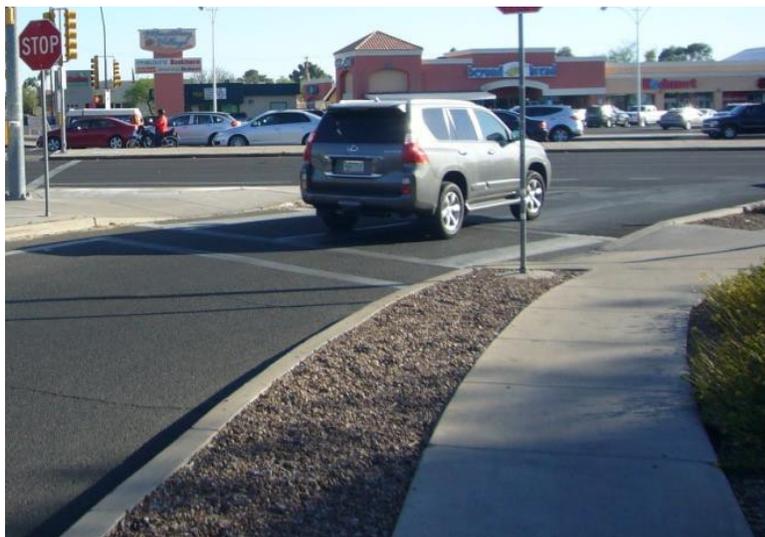
If there was grass or a gravel type surface that felt different under foot than pavement, blind participants usually did not continue walking on it, but looked with their cane of foot for a sidewalk-type surface on which to travel. Less disorientation and confusion was noted on islands with landscaped or graveled areas.

**Figure 4-21: Gravel landscape strip provides detectable edge of sidewalk for person who is blind and separation between the sidewalk and CTL travel lane**

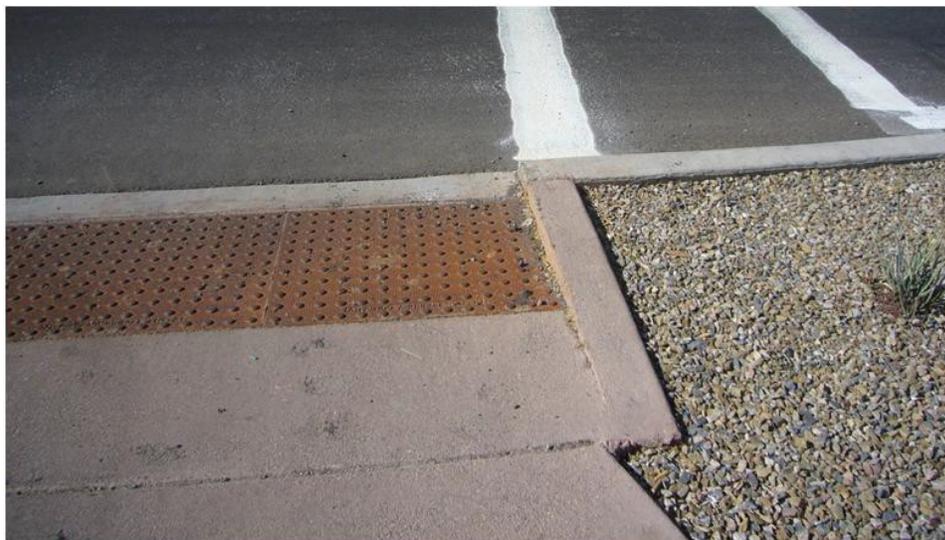
**Figure 4-22: Gravel or grass outside the crosswalk and walkway area**

*Photo of a curb ramp leading to a crosswalk, with detectable warning surface on the ramp, returned curb on the ramp and gravel landscaping outside the sidewalk area.*

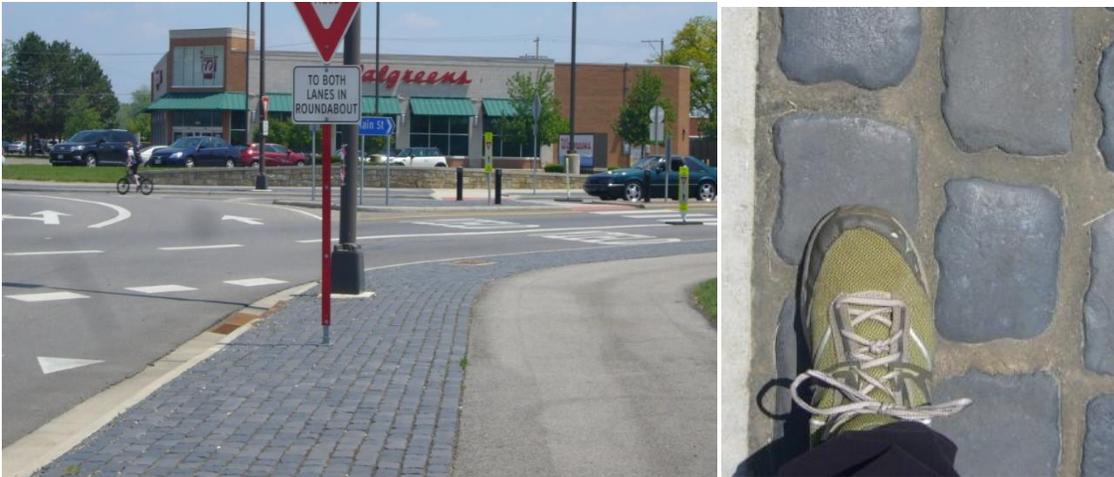
**Figure 4-23: Pavers, with fairly rough texture (cobblestone)**

*This figure shows a photo of a roundabout approach with surface material that was not recognized as a non-walking surface by blind participants. The cobblestone surface was installed at this roundabout between the concrete paved sidewalk and the curb, but it did not provide guidance (that might have been intended). Inset on right shows size of cobblestones in comparison to a person's foot; each cobblestone is approximately the width of the foot, with an inch or more of grout between stones.*

For pedestrians who were blind, paved or hardscape surfaces, even with those with had a relatively rough texture, were not observed to provide a reliable cue that the area was not the sidewalk area. At one roundabout location, cobblestone pavers were used for separation between the roadway and sidewalk, as shown in the photo below, but blind pedestrians walked on that surface, sometimes lining up to cross the roundabout at the assumed “corner” leading across the circulatory roadway, or alongside the circulatory roadway, but not at the crosswalk.

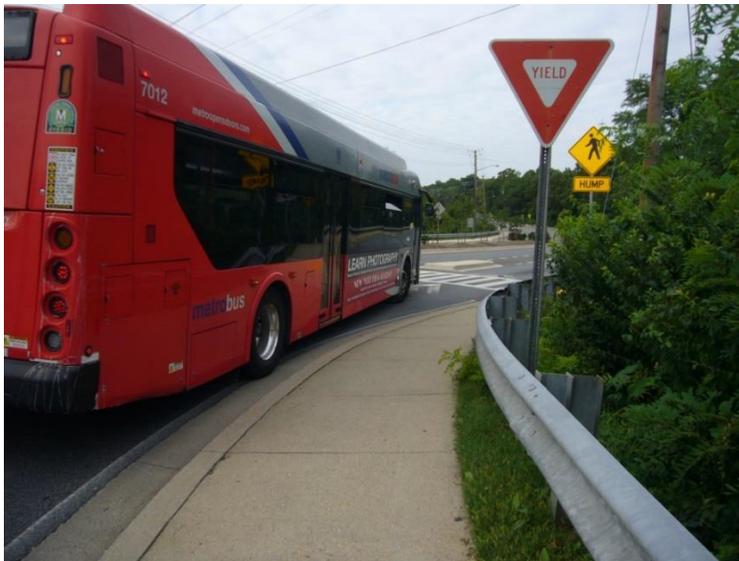
**Figure 4-24: Sidewalk at back of curb with no landscape separation**

*Photo of a 5-foot-wide sidewalk that is right behind the curb, with a guard rail on the back side of the sidewalk. Crosswalk is visible ahead and a bus is in the lane close to the sidewalk, leaning toward the sidewalk. Blind pedestrians have to follow the curb line with their cane to find the detectable warning surface and curb ramp in order to locate the crosswalk. Does not provide separation required by proposed PROWAG*

Sidewalks at back of curb required blind pedestrians to follow the curb line with their cane, walking dangerously (and uncomfortably) close to traffic along the curving sidewalk, searching for the slope of a curb ramp, detectable warnings or other indication of the crosswalk.

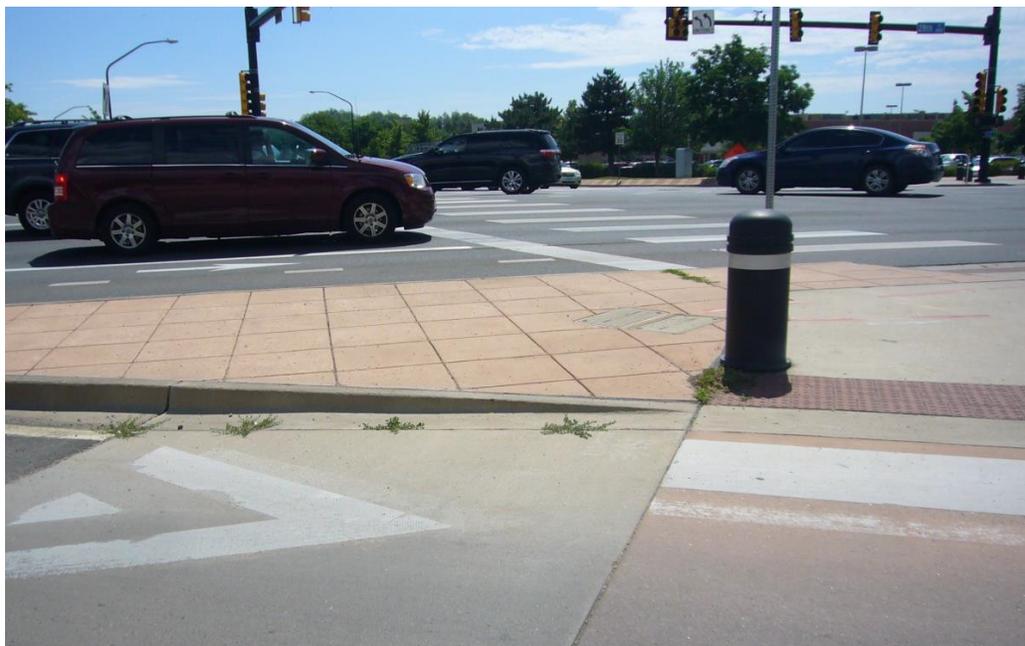
**Figure 4-25: Paved colored surfaces do not provide adequate cues**

*Photo shows a portion of an island where reddish color was added to the island pavement outside the white concrete pedestrian pathway between the crosswalks. Blind pedestrians did not walk within the concrete pathway through island and did not consistently locate the proper crossing location for the crossing from the island.*

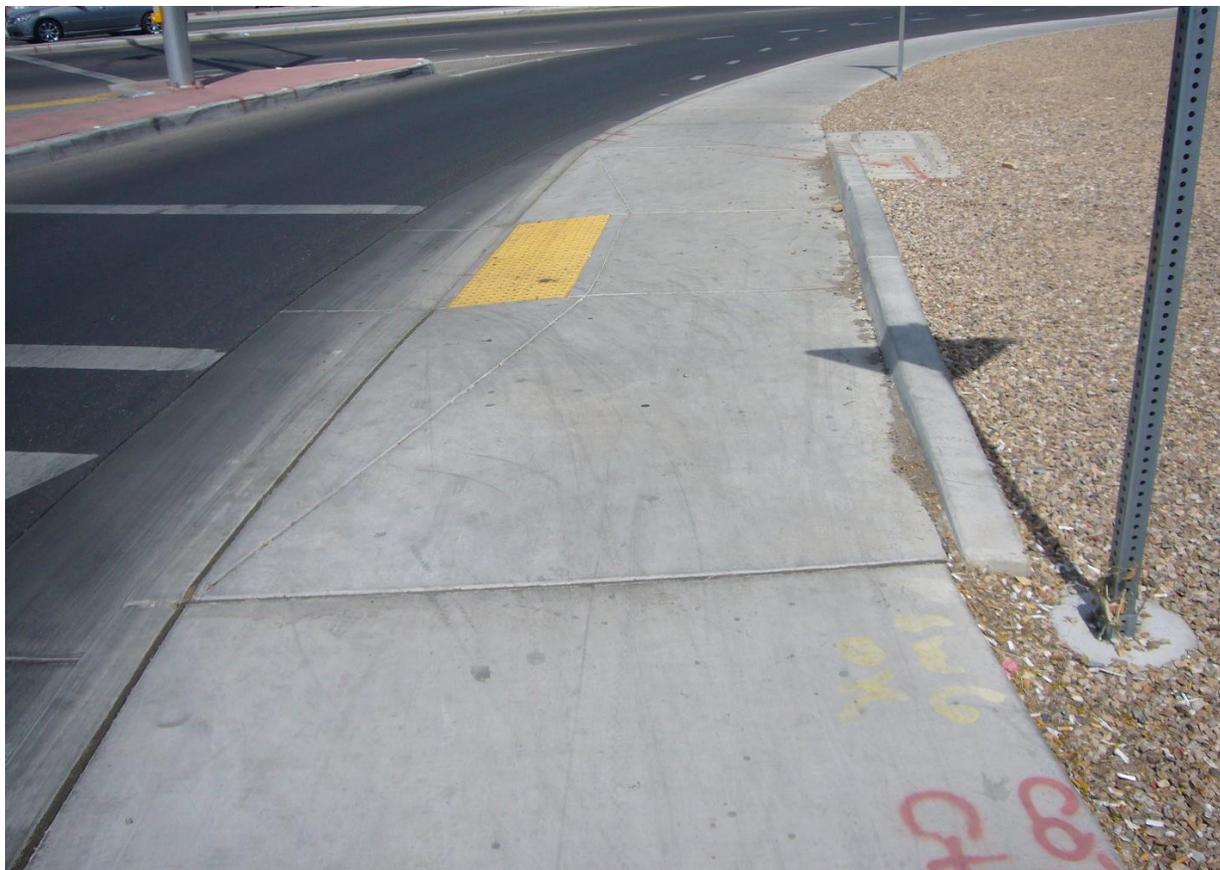
At locations with parallel curb ramps, it appeared that participants were unfamiliar with this type of ramp design. Parallel curb ramps are most often used where there is limited right-of-way and the sidewalk is at back of curb. The entire sidewalk slopes down to a level landing, or turning space, where the crosswalk is located. Some blind participants stopped on the slope, parallel to the crossing, thinking that they had reached an edge of the street when they reached the level landing. This slope and the need to turn 90 degrees to cross were confusing to them. Some blind participants mistook the curb at the back of the ramp for the edge of the street and attempted to cross from behind or on top of the curb. Alignment cues are limited and the landing is often level with the street. Parallel curb ramps are described and shown in Figure 4-26.

**Figure 4-26: Parallel ramp, showing curb at back of ramp**

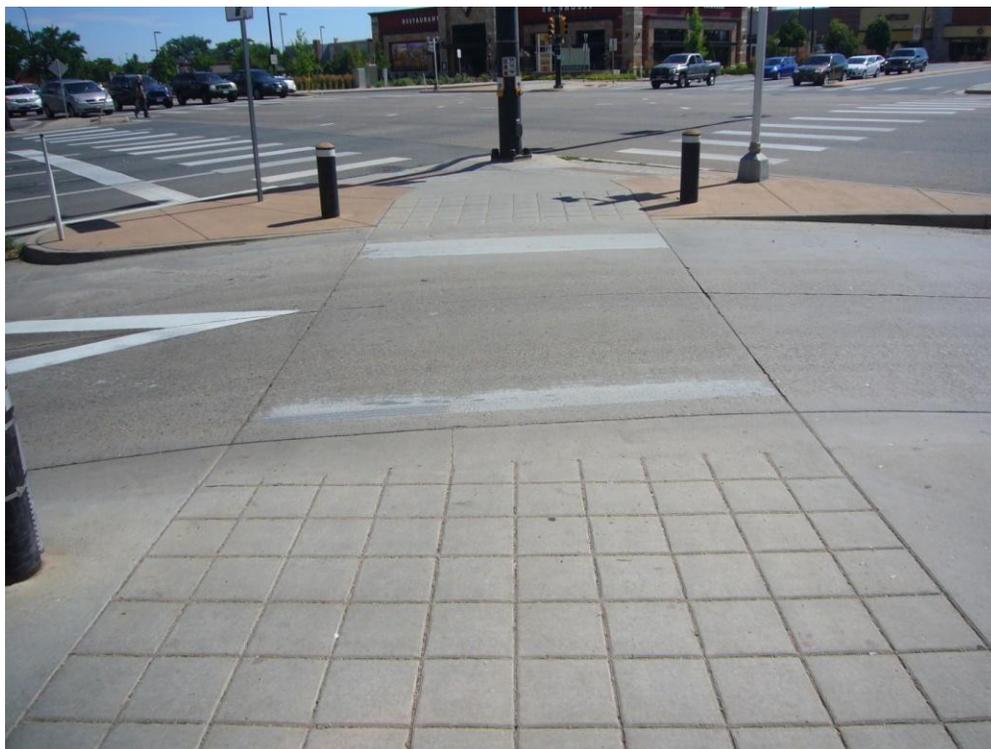
Note that there is a considerable body of research regarding the detectability of underfoot surfaces by persons who are blind, either using their foot or the long cane for detection. Surfaces used in some locations, such as the scored concrete shown in Figure 4-27, are not among the surfaces that have been shown in research to be reliably detectable.

**Figure 4-27: CTL with raised crosswalk and no detectable warning surfaces. Scored concrete is not detectable.**

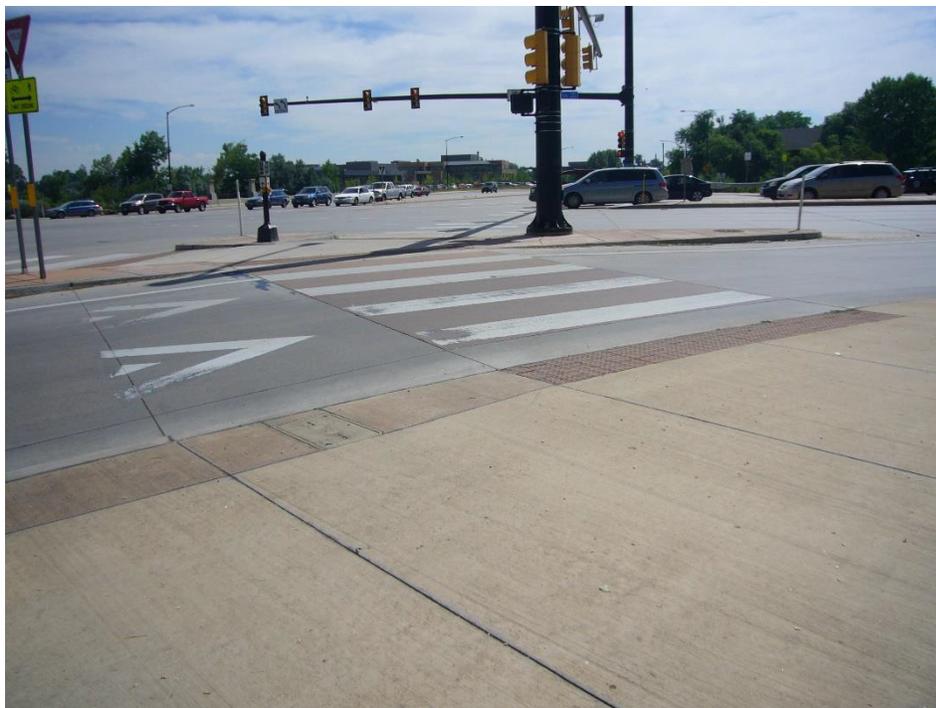
At locations with raised crosswalks where changes in elevation between street and curb ramp are not present, the detectable warning surface is the only clue to the location of the edge of the street. If detectable warnings were not installed, participants were likely to walk into the vehicular lanes (Figure 4-27). However, even where detectable warnings were installed, participants walked into the street if they approached from an angle that allowed them to continue without stepping off the curb or actually crossing the detectable warning surface (Figure 4-28).

**Figure 4-28: View of raised crosswalk where some participants did not find detectable warnings**

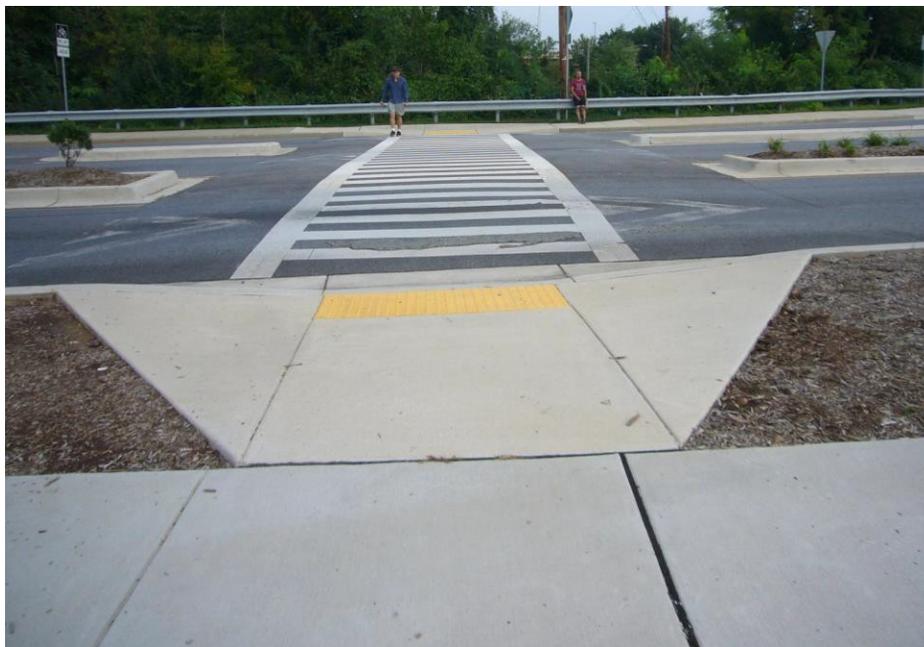
Detecting the street is also important at both edges of both triangular islands at CTLs and splitter islands at roundabouts. Islands with cut-through walkways and no detectable warnings at each edge of the island were undetected by blind participants at both roundabouts and CTLs during the wayfinding studies. Where the island was not detected, participants usually failed to stop before entering other lanes of the roadway. If the island is intended as a refuge, and if pedestrians are expected to stop and consider the traffic on the other portion of the roadway before continuing, detectable warning surfaces must be installed for the entire width of the cut-through area and should extend at least 24" in the direction of travel at the edge of the island on each side of the island. At locations where the islands are not close to the crosswalk edges, as shown in Figure 4-29, blind pedestrians did not recognize that there was a potential refuge area, while sighted pedestrians made two-stage crossings, pausing at the islands to wait for gaps in traffic.

**Figure 4-29: Roundabout without detectable surfaces or refuge in splitter islands.**

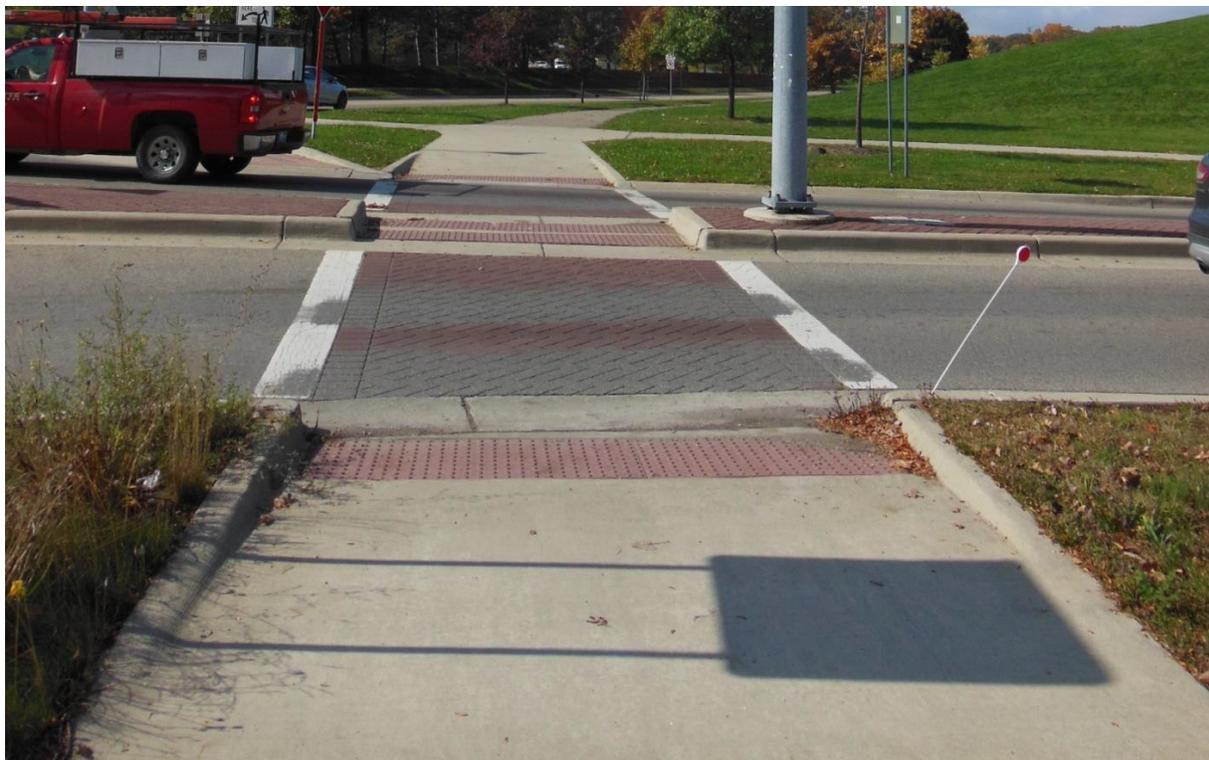
In most cases, the placement of the crosswalk can make a difference in the alignment of these features. For example, the base of curb ramps must be perpendicular to the gutter to avoid tipping by wheelchair users, so the location and angle of the ramp can be affected by the location on the curve of the roundabout or CTL roadway. Aligning all these features may require moving the crosswalk to a different point.

**Figure 4-30: Approach direction, landscaping, returned curbs, detectable warning surface and crosswalk are all aligned, providing potential alignment cues for blind pedestrians**

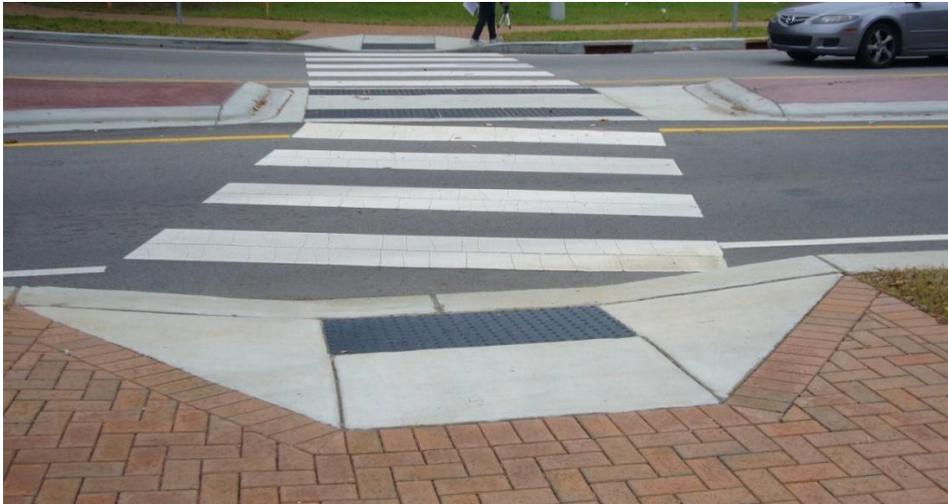
When the various features mentioned above (the landscaping or edge of the sidewalk, the curb ramp slope, detectable warning surface, and edge of the street/gutter) were not aligned with the crosswalk direction, participants appeared more likely to be misaligned. In the examples shown in Figure 4-31 and Figure 4-32, the crosswalk angled slightly to the right, while the other cues were aligned toward the left, which appeared to cause confusion. This geometric situation is seen fairly commonly when a crosswalk is close to the roundabout's circulatory roadway, since the curb ramp must intersect the gutter at right angles to be accessible to wheelchair users and avoid a tipping hazard. This was also noted at several CTL crosswalks.

**Figure 4-31: Landscaping, curb ramp slope, detectable warning surface and gutter are not aligned with direction of travel on the crosswalk. This appeared to lead to alignment errors by blind pedestrians**

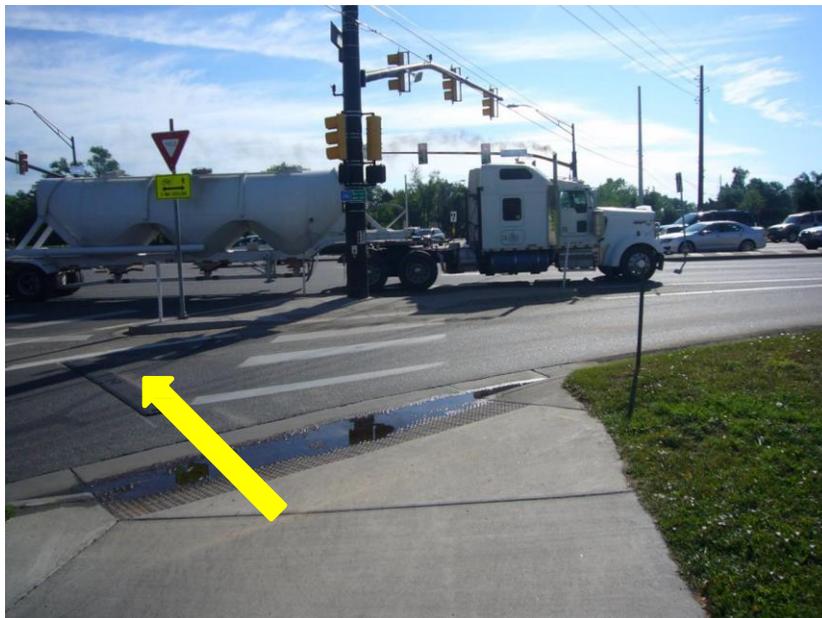
At one CTL location, where participants were observed to be aligning themselves with the slope of the ramp and the line of the gutter, participants routinely missed the small island as they crossed. Instead, they inadvertently entered the main intersection outside of any marked crosswalks. This situation is shown in Figure 4-33.

**Figure 4-33:** At this location, some blind participants appeared to align themselves with the slope of the curb ramp and the line of the gutter, which led them to completely miss contacting the island.

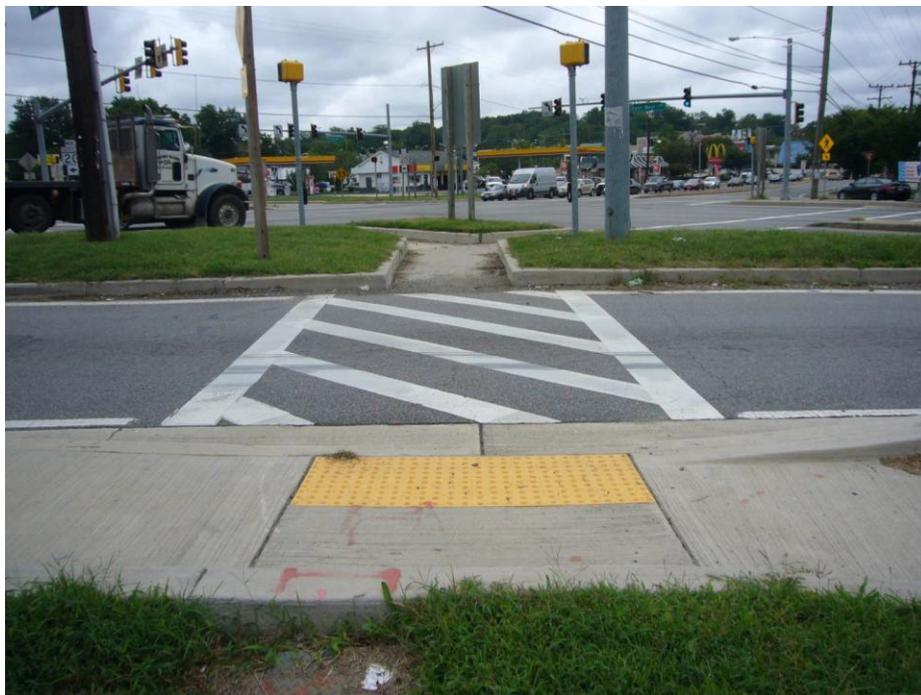
**Figure 4-34:** Cut-through is narrower than the crosswalk

*Photo of crosswalk at CTL. Crosswalk is approximately 10-feet-wide and cut-through area of the grassy island at the end of the crosswalk is approximately 5 feet.*

Another feature of several locations was a cut-through area on the island that was narrower than the crosswalk, curb ramp, and landscaped area at the approach end of crosswalk. This situation can be problematic for large groups of sighted pedestrians, who must channelize themselves upon reaching the island. The issue for blind participants was largely one of confusion about their location as they contacted the island, but this was sometimes mitigated by island characteristics. For example, at the location shown in Figure 4-34 where there was a narrow cut-through area, with grass on other parts of the island, participants searched for the cut-through area and found it. At similar locations where there was a narrow cut-through area and a paved island, blind participants commonly stepped up onto the island and were confused and disoriented when they contacted the cut-through area, thinking that it was the street.
