## Guidelines for the Application of Crossing Solutions at Roundabouts and Channelized Turn Lanes for Pedestrians with Vision Disabilities

Bastian Schroeder, Lee Rodegerdts, Pete Jenior, Edward Myers, Christopher Cunningham, Katy Salamati, Sarah Searcy, Sarah O'Brien, Janet Barlow, and Billie Louise (Beezy) Bentzen; National Cooperative Highway Research Program; Transportation Research Board; National Academies of Sciences, Engineering, and Medicine

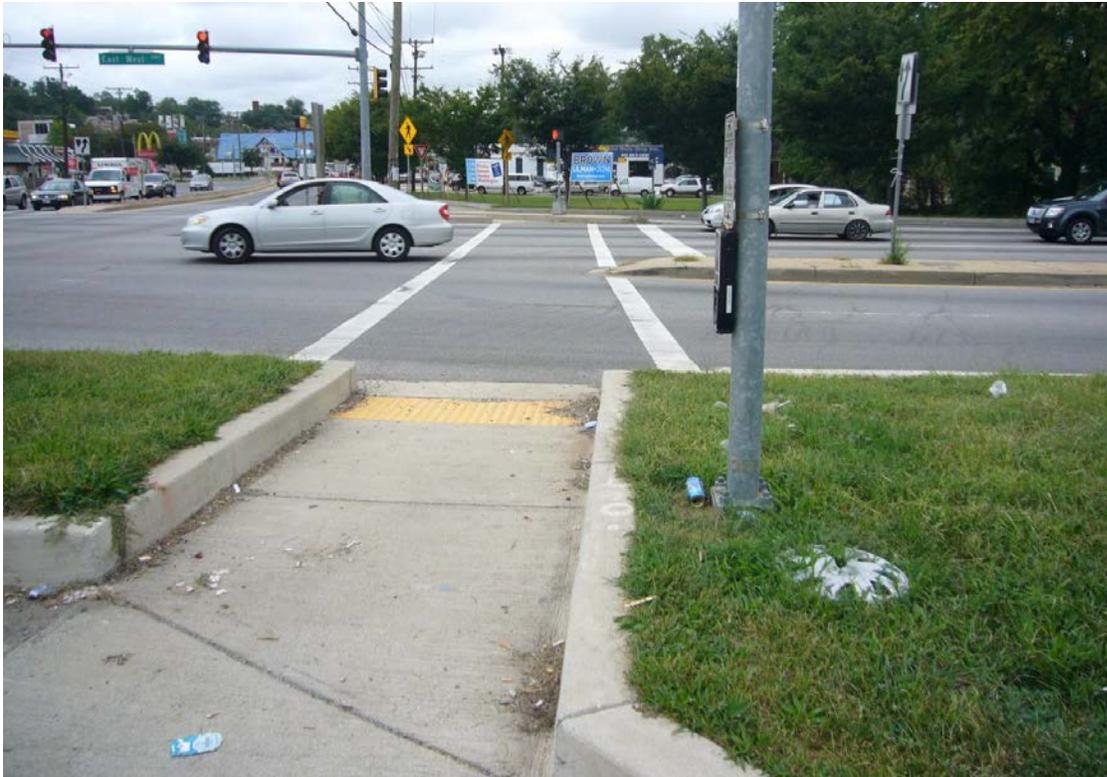
Blind participants also had a problem with using the correct pushbutton for their crossing. Most of the pushbuttons at locations where data was collected were not audible/accessible. Participants commonly pushed the wrong pushbutton on the island.

**Figure 4-35: The APS pedestrian pushbutton on this island was not found by blind participants.**

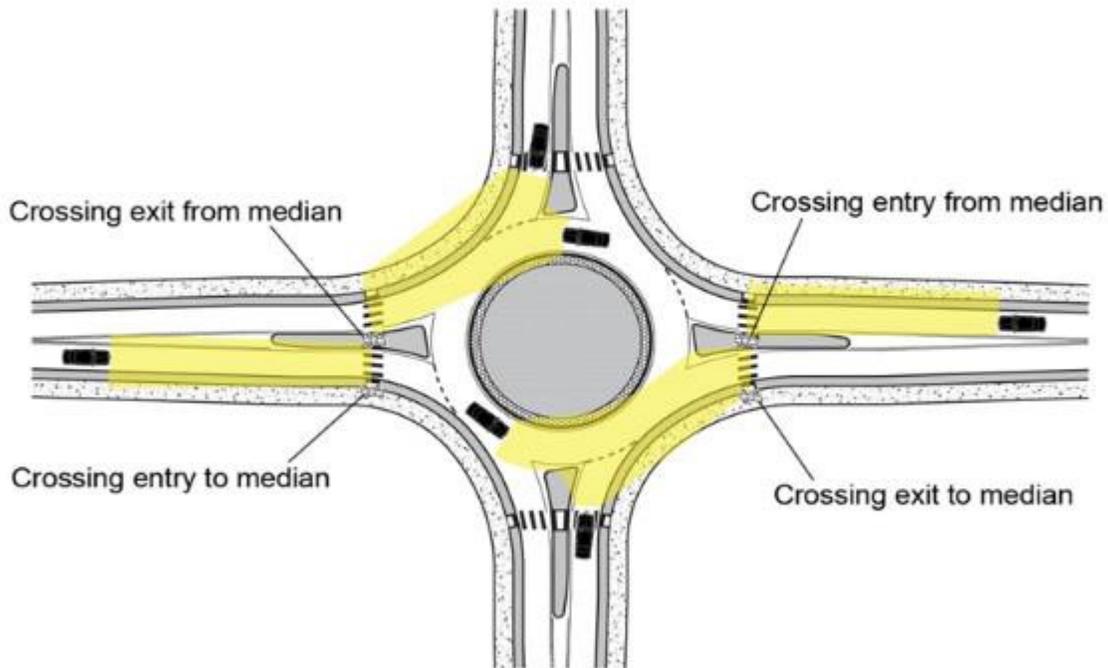
After plotting the distance from the pedestrian location, the sight triangle is determined as shown in Figure 5-4. Any sight obstruction should be eliminated from the sight triangles for better pedestrian visibility and enabling pedestrians who are blind to hear approaching vehicles more clearly.

**Figure 5-4: Pedestrian Sight Triangles for each Crossing Location (Sidewalk and crosswalks will be added to this figure)**

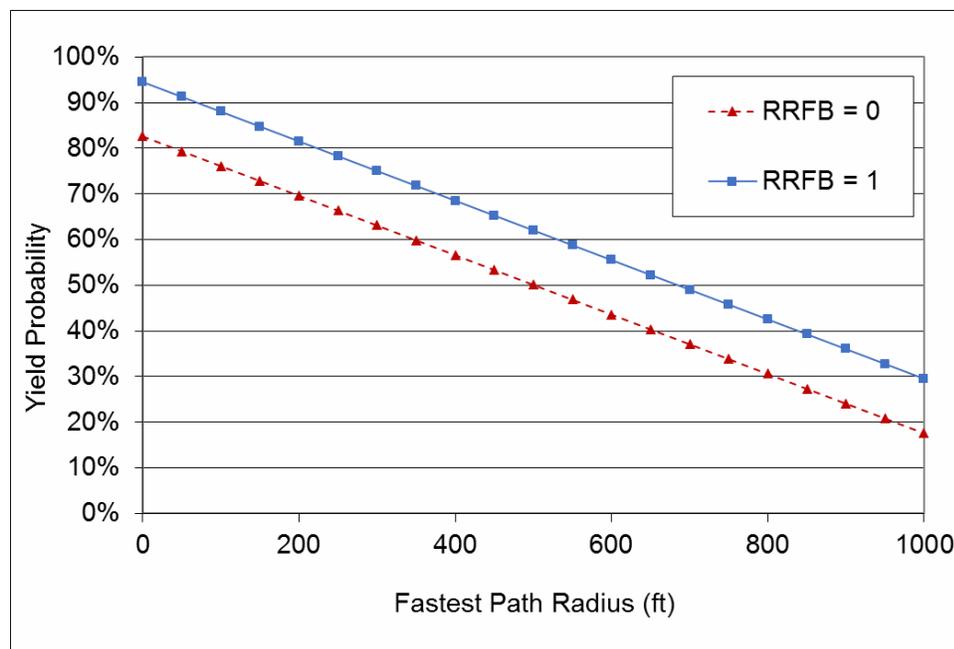
Figure 5-9: Graphical Representation of Yield Probability Model

It is noted that the difference between roundabout entry and exit does not show up as a variable in the model, even though previous research found those to have significantly different yielding rates. In the current yield model the RDS variable accounts for these differences, with exit legs oftentimes having faster radii (and thus less yielding) than entry legs. This effect of fastest path radius is graphically illustrated in Figure 5-9.

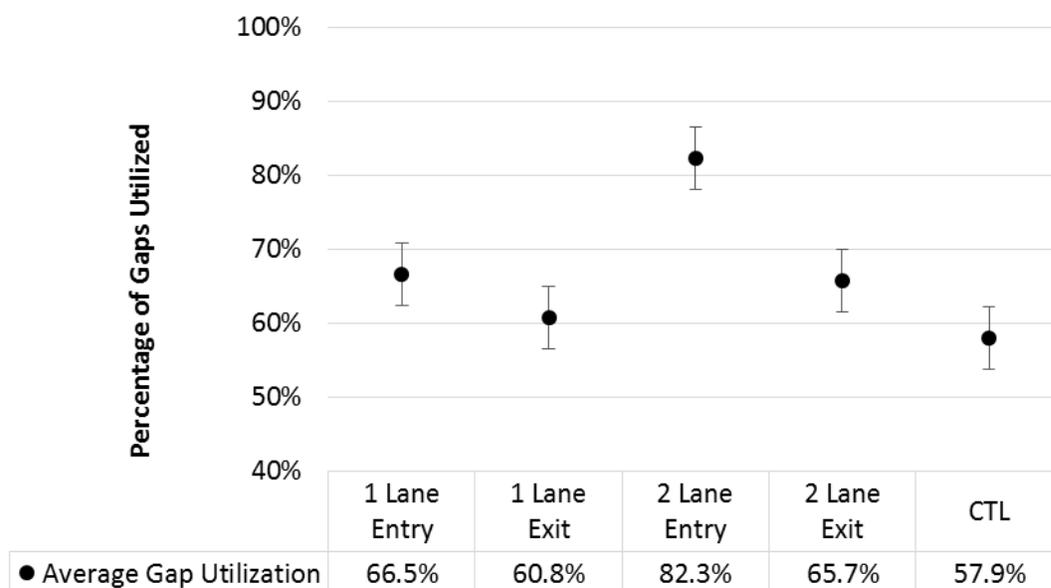
Figure 5-10: Graphical Presentation of Average Gap Utilization Rates

There is presently insufficient data in the literature to derive more sophisticated gap utilization models, but analysts are encouraged to use local data or estimates should those be available. The observed averages and standard error of gap utilization are shown graphically in Figure 5-10.

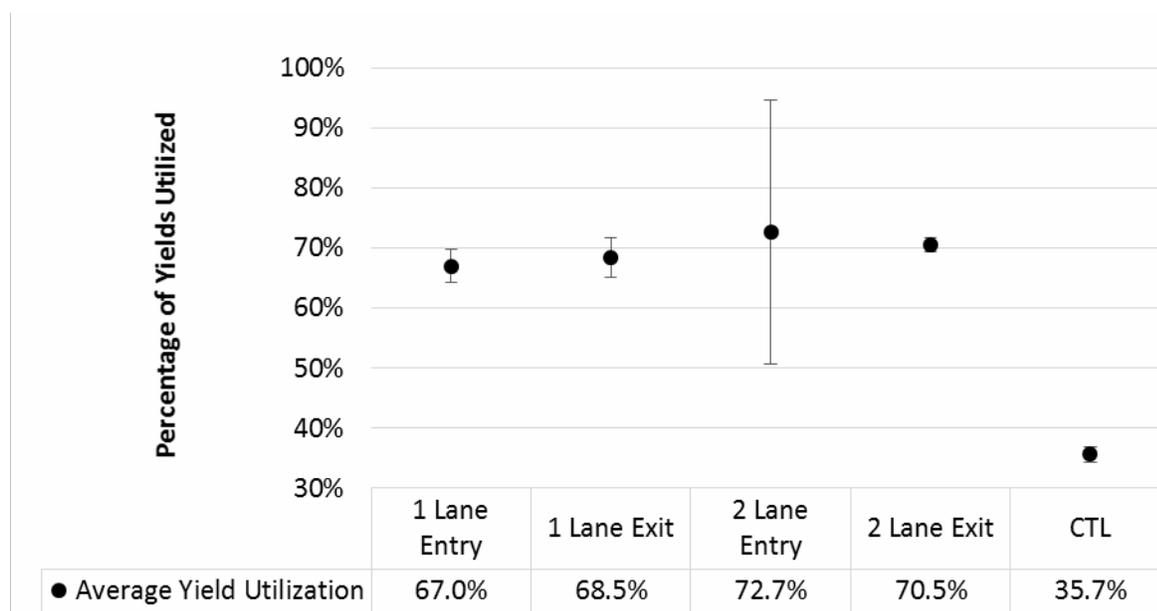
Figure 5-11: Graphical Presentation of Average Yield Utilization Rates

The table shows average yield utilization rates for all roundabout sites in the range of 60-80%. For CTLs, the yield utilization was found to be much lower on average at around 35%, which is likely explained by increased background noise at many CTL locations. There is presently insufficient data in the literature to derive more sophisticated yield utilization models, but analysts are encouraged to use local data or estimates should those be available. The observed averages and standard error of yield utilization are shown graphically in Figure 5-11.

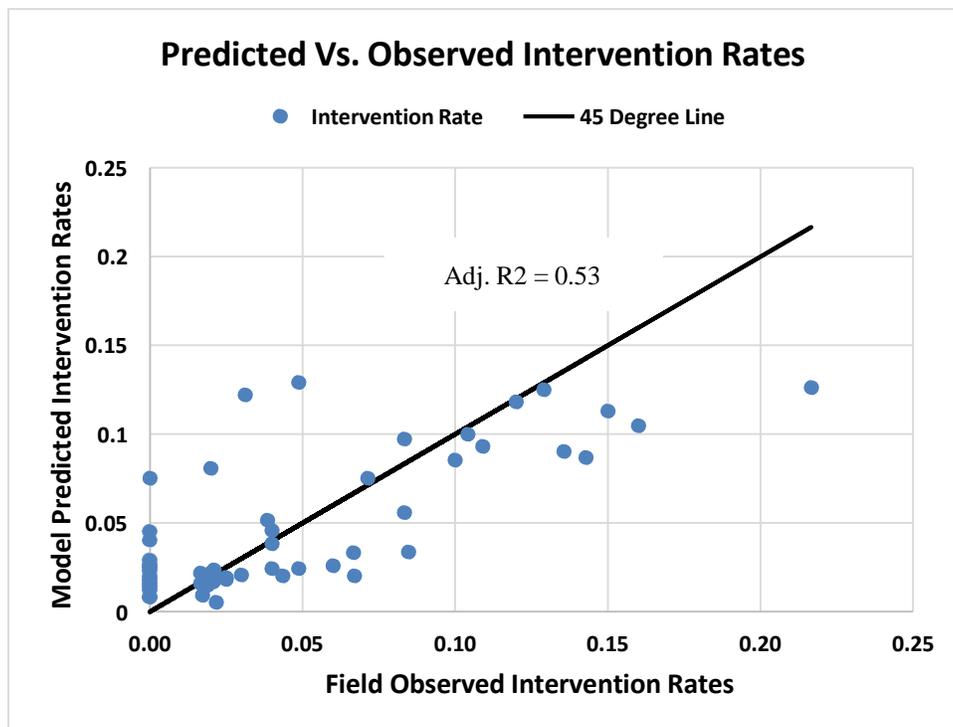
Figure 5-15 plots the predicted intervention rates against the field observed intervention rates. A 45-degree line is drawn for reference to visually compare observed and predicted interventions.

**Figure 5-15: Plot of Predicted Intervention Rates vs. Observed Intervention Rates**

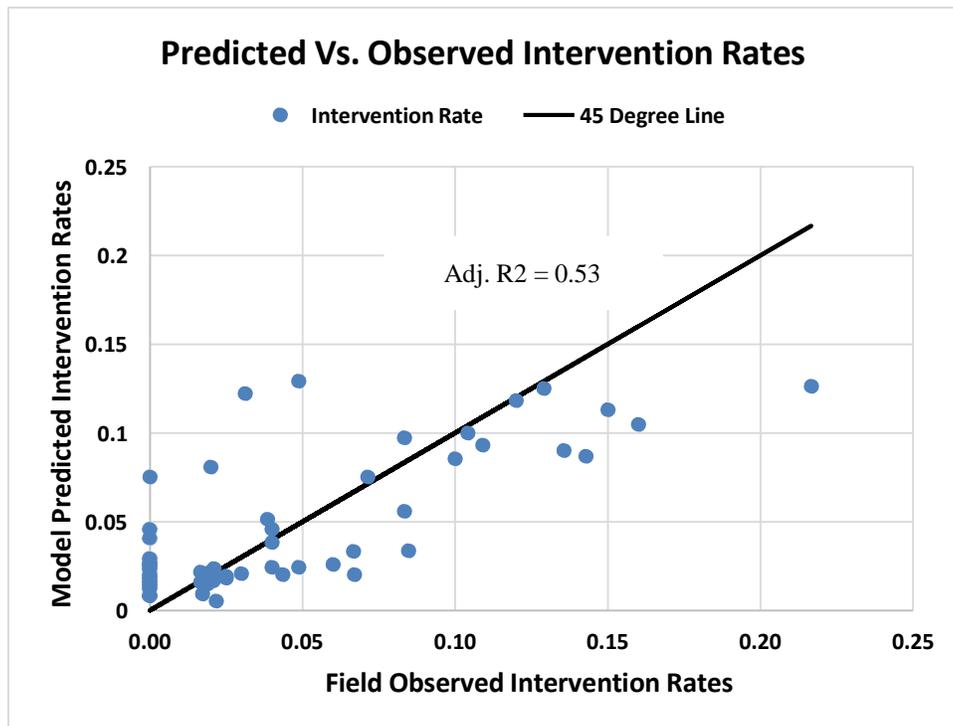
Multivariable linear regression models were generated to predict the rate that blind pedestrians may make bad crossing decisions that result in intervention events and intervention and risky events. Two separate models were generated to predict the intervention rates (associated with dangerous crossing decisions) and total of intervention and risky crossing decisions. Both of these models include noise level at the crosswalk (0 or low levels of noise and 1 for high levels of noise), average speed of the vehicle at the crosswalk (continuous variable for values greater than 10 mph) and sight distance (0 if pedestrian sight distance is provided and 1 if it is not provided). Figure 9-1 plots the predicted intervention rates vs. the field observed intervention rates. Figure 9-2 shows the predicted intervention-Risky rates vs. the field observed intervention-risky rates.

Figure 9-1 Plot of Predicted Intervention Rates vs. Observed Intervention Rates

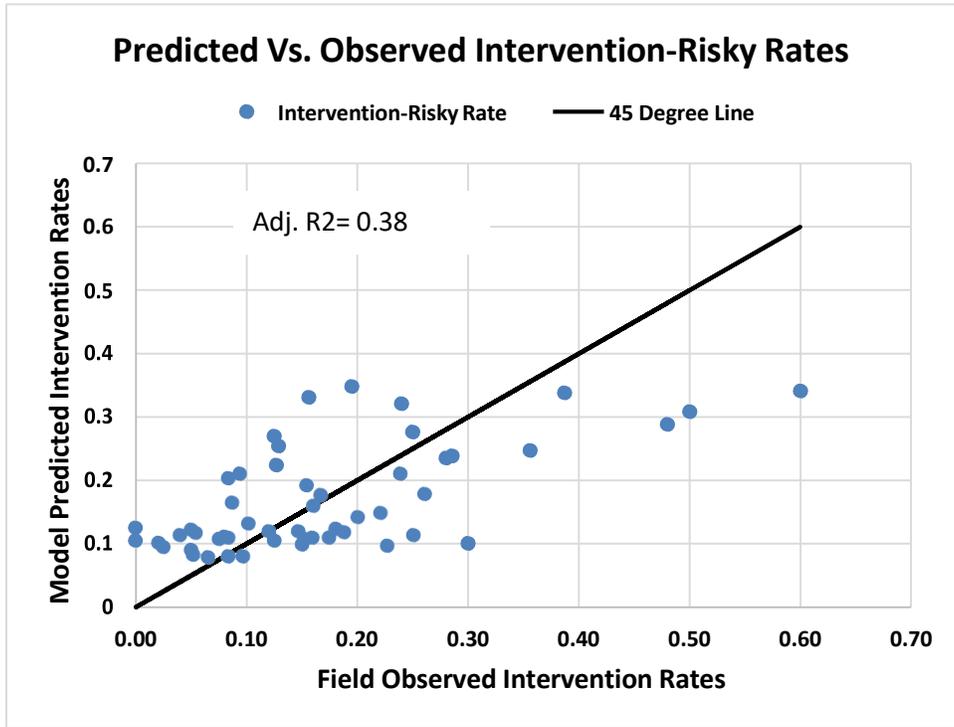
Figure 9-2 Plot of Predicted Intervention-Risky Rates vs. Observed Intervention-Risky Rates

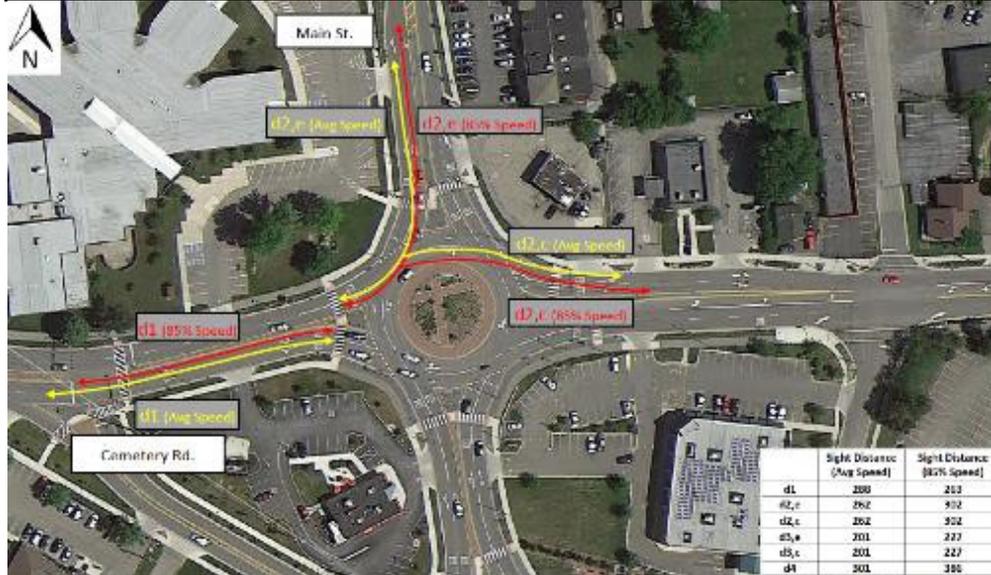
Figure 11-3: West Approach at Cemetery Road at Main Street, Hilliard, OH

In this step, necessary sight distance was measured using the existing geometric measurement and 85 percentile and average speed collected from the filed study. The team assumed 3.5 feet per second walking speed and 2 second lost time. Figure 11-3 shows the calculated sight distance,  $d$ , for each crossing location at the entry and exit for the Cemetery Road and Main Street roundabout in Hilliard, OH.

After applying this method to all the roundabouts and CTLs locations, the team observed longer sight distances than they expected. The team decided to use a different approach for further analysis.

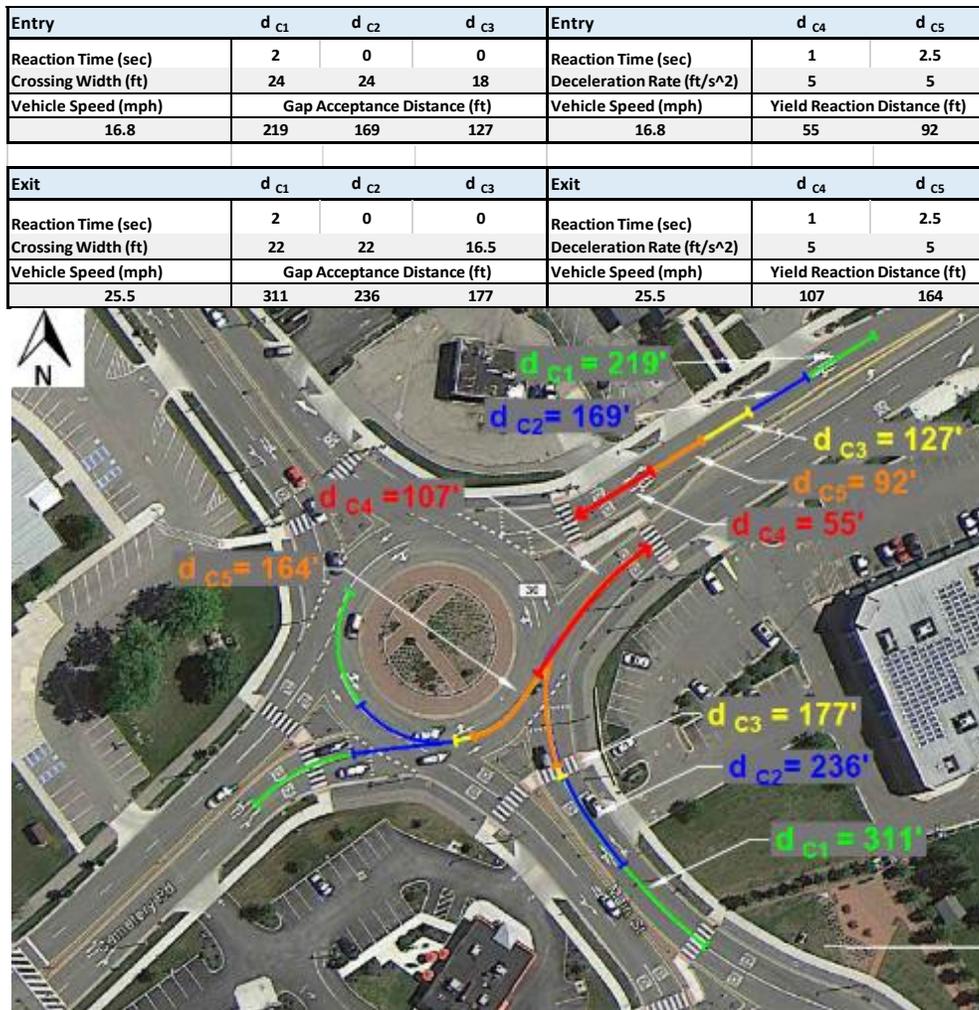
The average collected field speed and the existing geometric measurement were used in this step. Figure 11-4 shows the calculated sight distance, d, for each approach, entry and exit, at the Cemetery Road and Main Street roundabout in Hilliard, OH.

**Figure 11-4: West and East Approach at Cemetery Road at Main Street, Hilliard, OH**

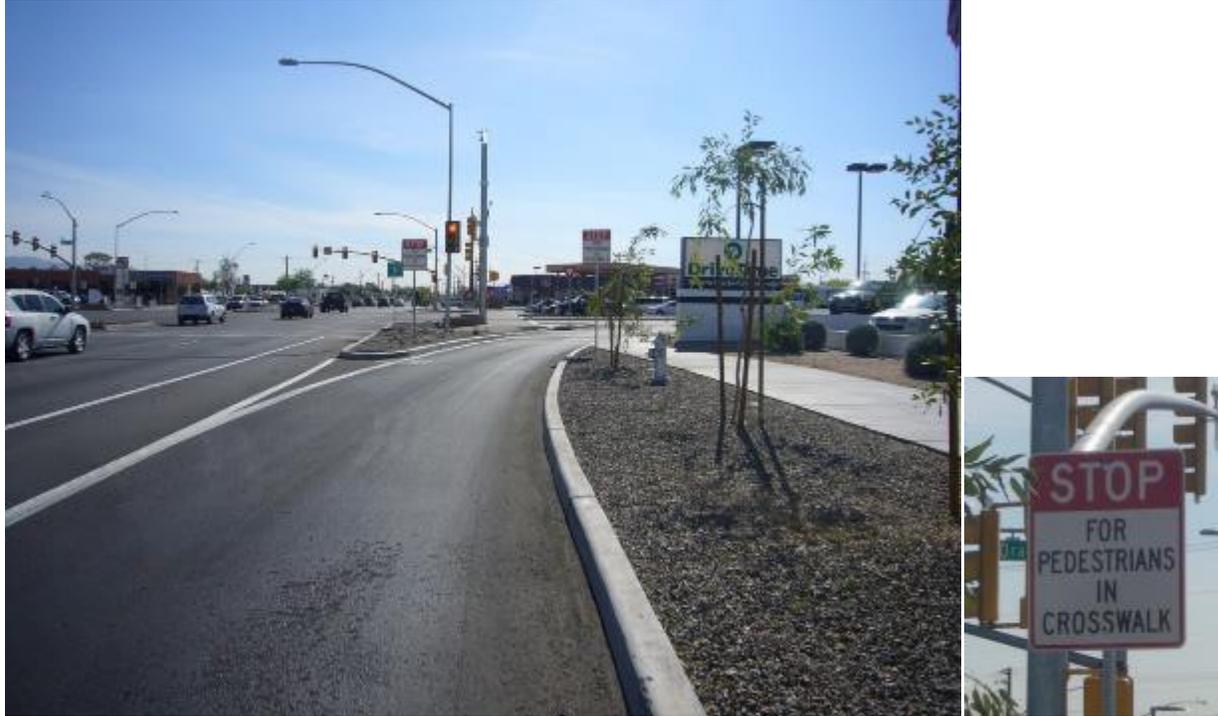
Figure 12-1: Drivers' view

- a) Stop for pedestrians in crosswalk sign (not MUTCD standard, designed and used in Tucson) before crosswalk on both sides of CTL, sign enlarged at right.
- b) No sign or marking indicating raised crosswalk (markings at this intersection are not complete).
- c) Yield sign just past crosswalk, before yield point for Oracle Road.
- d) Business sign restricts driver's view of pedestrian approaching crosswalk from south (right) around corner.
- e) Island design and CTL design is relatively small, with relatively small turn radius.
- f) Lane width is relatively narrow.

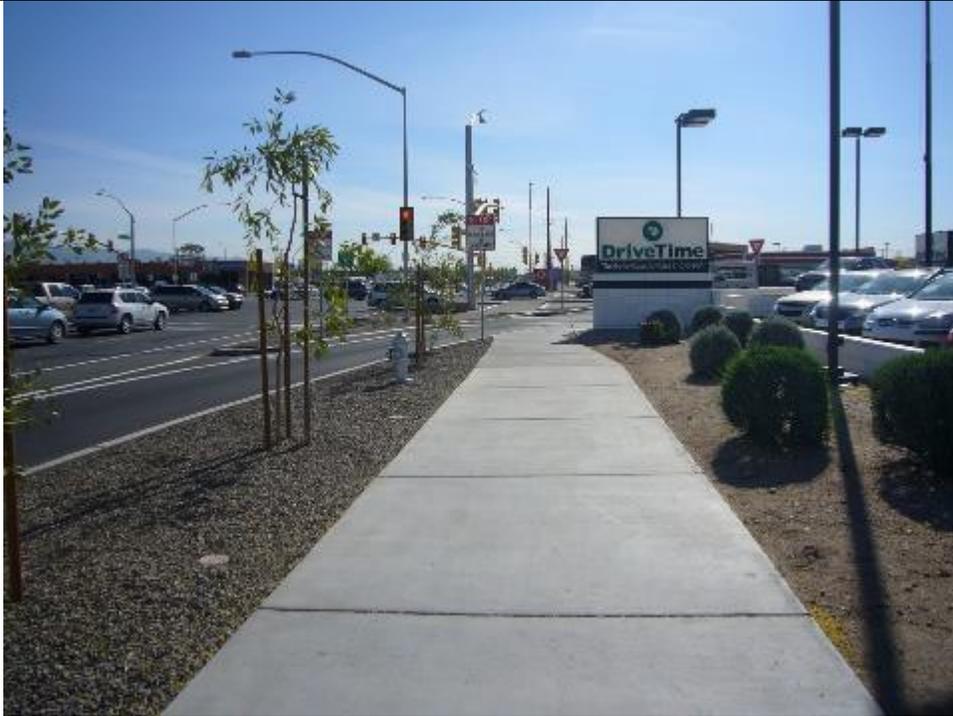
**Figure 12-2: Pedestrian's view**

Sidewalk landscaping ends before crosswalk area, when sidewalk is basically aligned with Grant Road traffic. Person who is blind who doesn't realize it's a CTL may cross from that point when contacting curb rather than continuing around corner to the crosswalk.

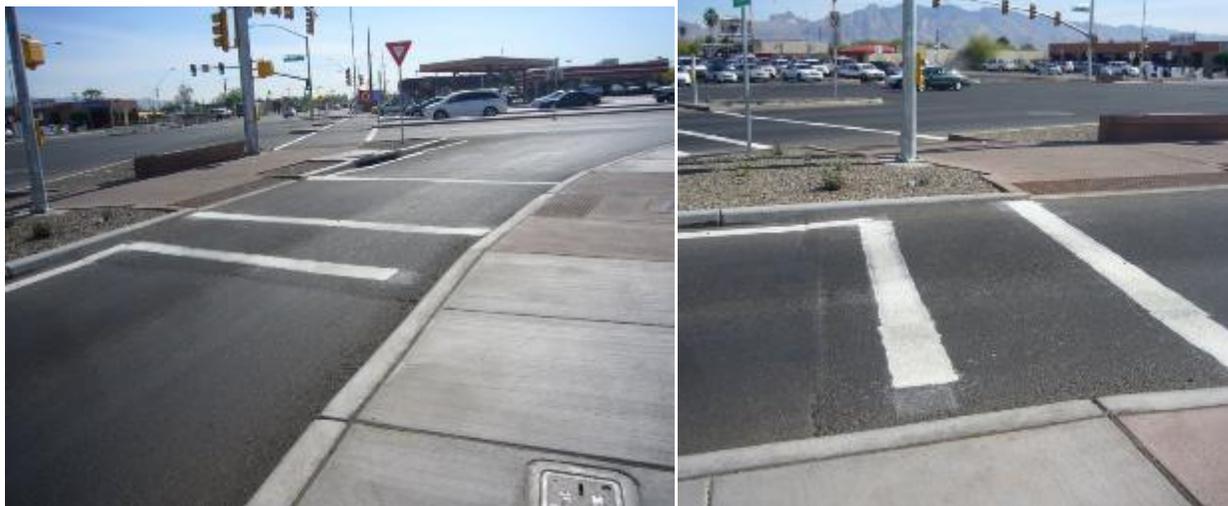
**Figure 12-3: Raised crosswalk**

a) Views of raised crosswalk construction and slope for vehicles, seems to be 3/72 transition slope or 1:24, basically very gentle for drivers.

b) Note stop line upstream of crosswalk.

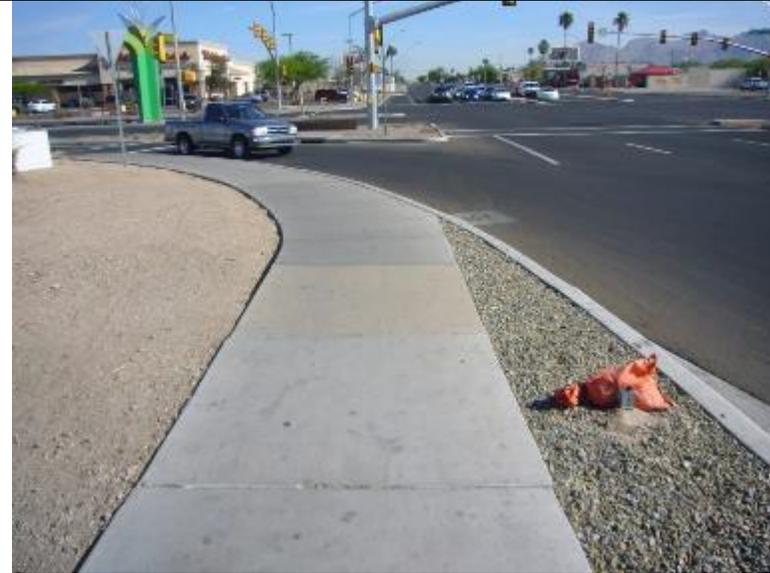
**Figure 12-4: Approach from south on sidewalk along Oracle (downstream street)**

- a) Landscaping that is on both sides of sidewalk when approaching is discontinued on the street side before the crosswalk. A person who is blind and unfamiliar with fact there is CTL at this location is likely to cross straight ahead when contacting curb rather than continuing around corner to the crosswalk. Driver will be looking left at that point.
- b) Landscaping on left of sidewalk continues around corner to sign.

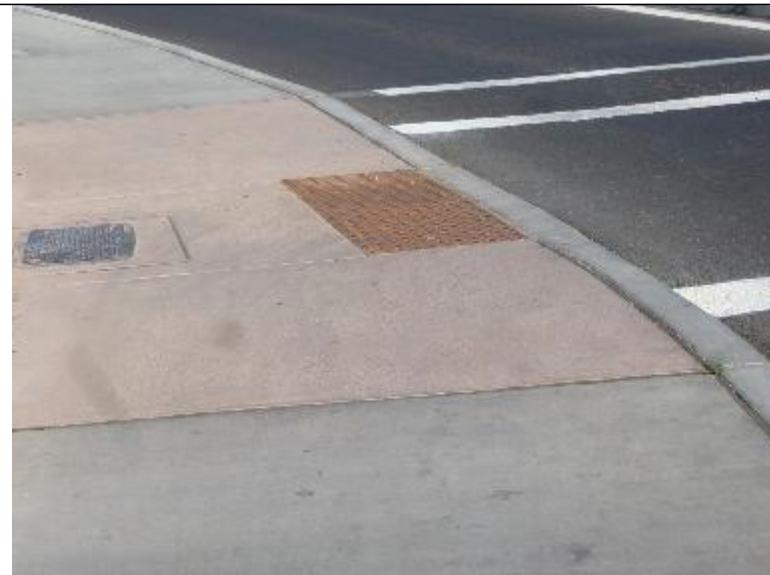
**Figure 12-5: Curb ramp**

Parallel ramp with cast iron detectable warning surface (truncated domes). At a parallel ramp, the whole sidewalk slopes down to a level landing. At this location, pedestrians need to turn at the bottom of the ramp to align for the crosswalk. Because of the raised crosswalk, the slope is less steep than at some locations, very subtle. Most participants seemed to use the slope as a cue, then the DW, curb line and traffic moving by them as an alignment cue. Parallel ramps typically have a raised curb area at the back of the ramp, which might be used for alignment in some cases.

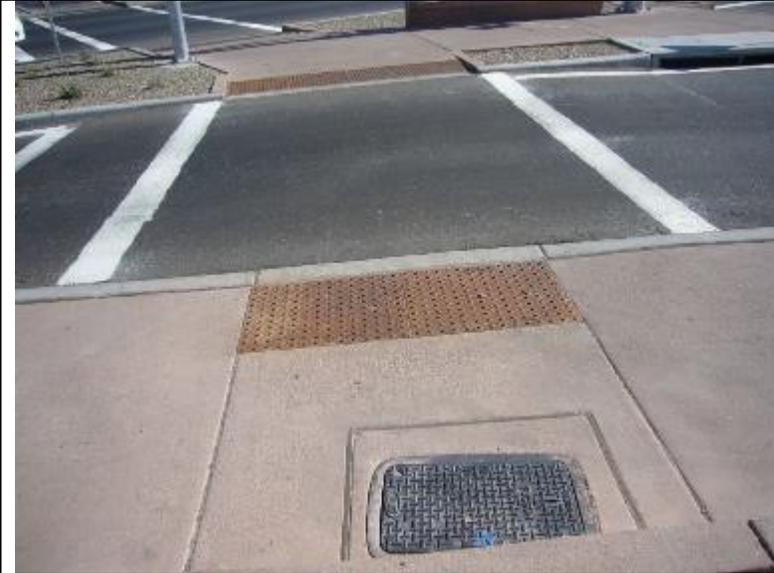
**Figure 12-6: Crosswalk view from the back of the ramp**

**Detectable warning surface is wider at island than at curb, very low curb on each side of DW on curb side within crosswalk.**

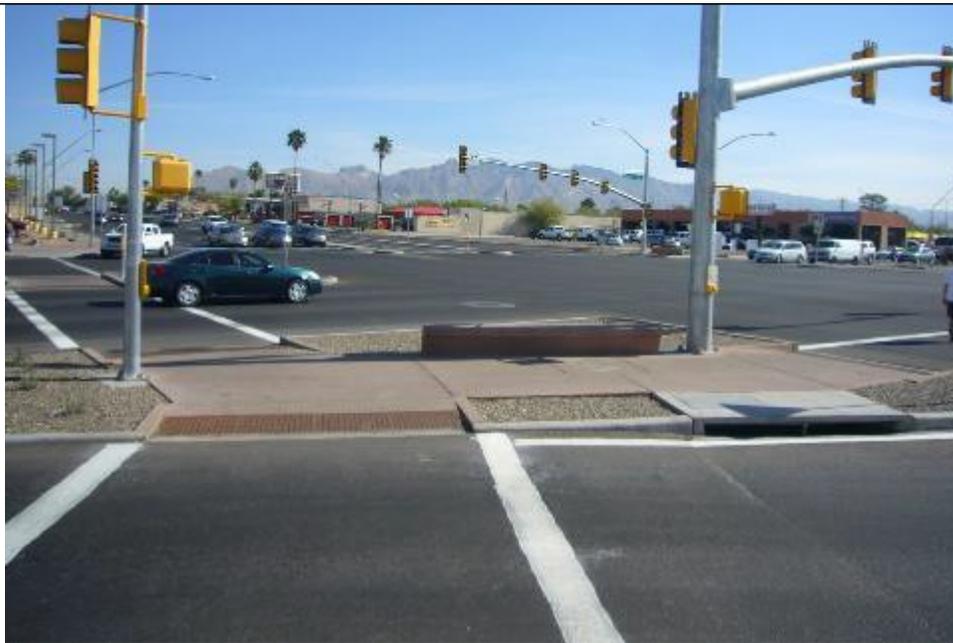
**Figure 12-7: Pedestrian path on island**

**Pedestrian path is paved, with gravel landscaping of the rest of the island. Benches on the island are used by pedestrians on a regular basis.**

**Very similar to island on SW corner (see descriptions at Figure 12-7, Figure 12-8 & Figure 12-9).**

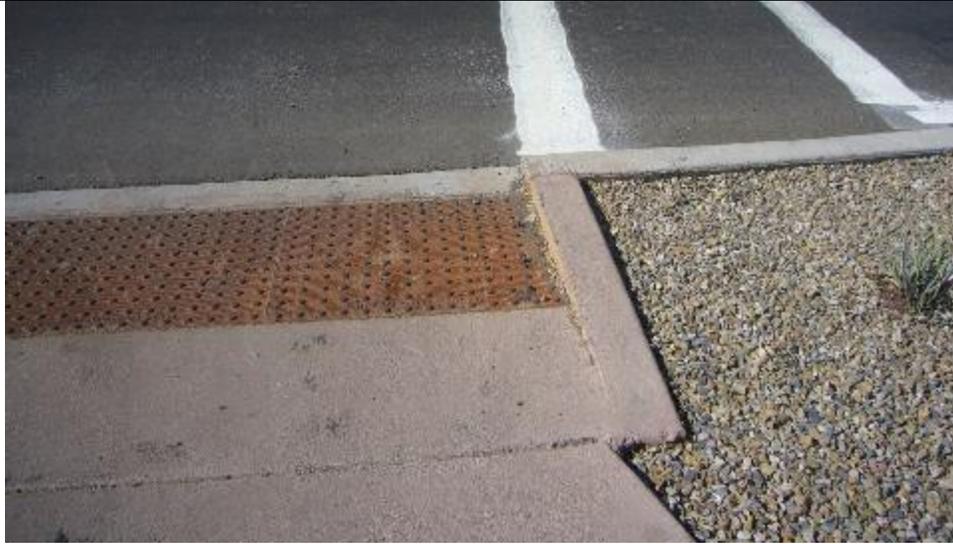
**Figure 12-8: Returned curb on edge of ramp**

**Returned curb on edge of ramp at crosswalk may provide an alignment cue for pedestrians who are blind if aligned with crosswalk direction. Obviously not helpful for that if not aligned with direction of crosswalk.**

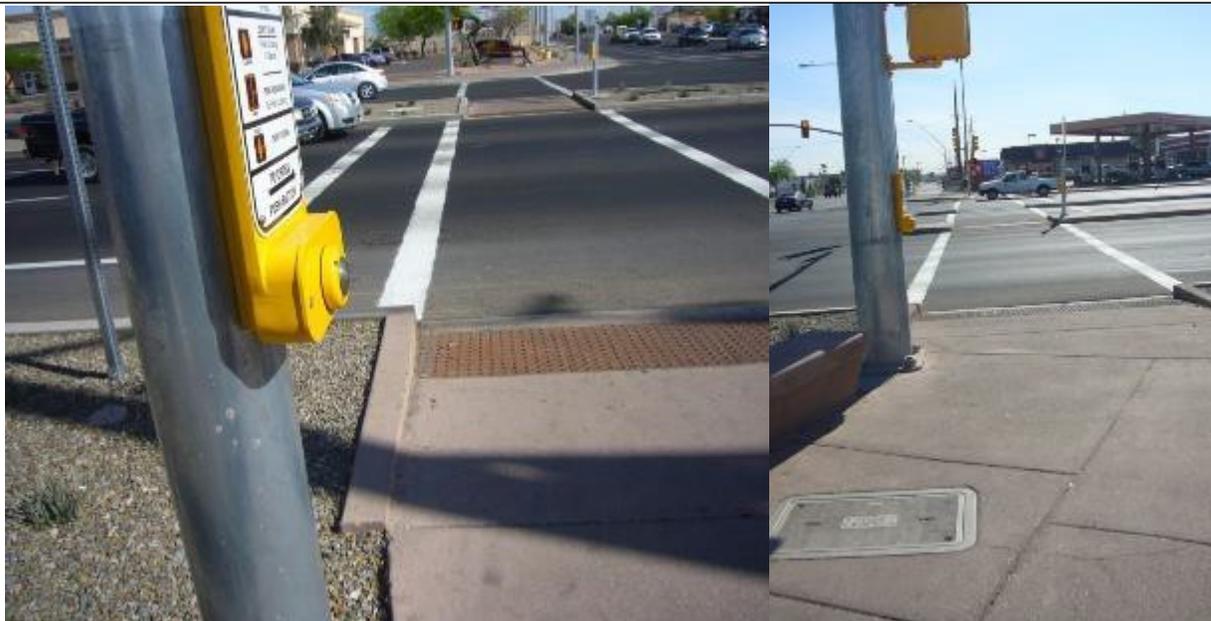
**Figure 12-9: Pushbutton alignment**

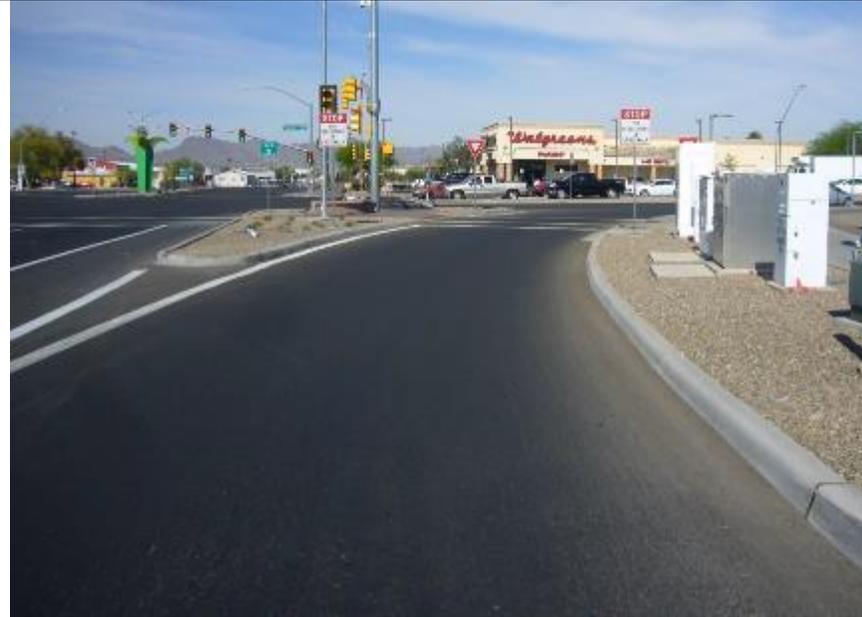
**Figure 12-10: Driver view of approach**

- a) Controller boxes in landscape strip may block driver's view of approaching pedestrian.
- b) Same signs as on SW corner (stop for pedestrians in crosswalk before crosswalk, yield sign just past raised crosswalk).
- c) Raised crosswalk with no sign or markings of raised crosswalk.
- d) Wide lane, longer crossing for pedestrian than the CTL on the SW corner.

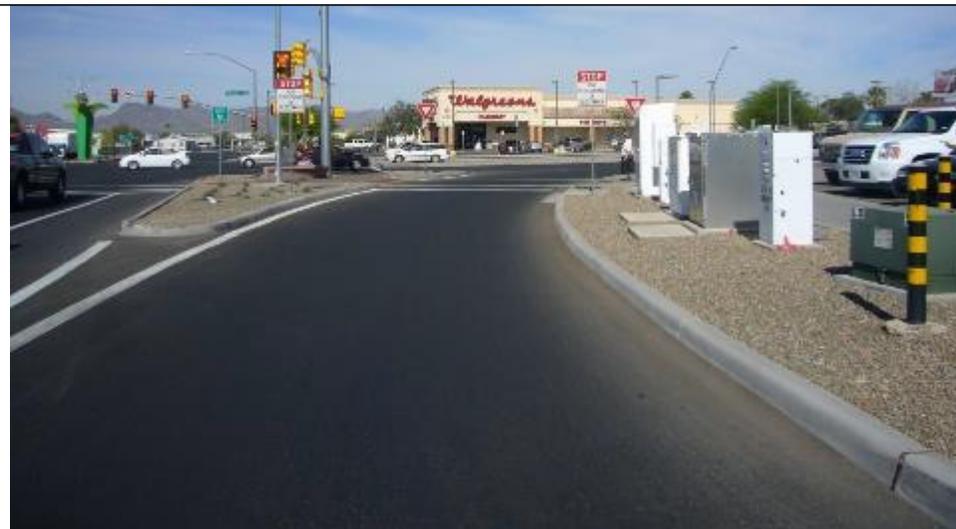
**Figure 12-11: Driver view of pedestrian at crosswalk**

Pedestrian standing at crosswalk was visible to approaching drivers, and sighted pedestrians could see drivers once they were at the crosswalk.

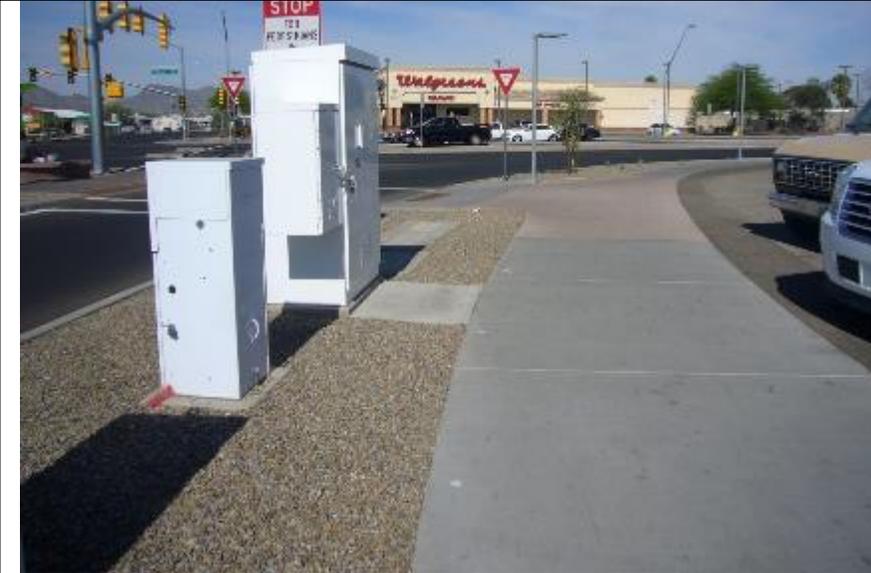
**Figure 12-12: Pedestrian view of approach to crossing, along Grant**

**a) Landscaping along street side except at crosswalk can provide some guidance to crosswalk and provides separation from street, easier and more comfortable to trail with a cane than trailing the curb line.**

**b) Level sidewalk going around corner may make it more likely that a person who is blind will miss detecting the crosswalk and intersection altogether, if aware that it's a CTL and not looking for the ramp by trailing the edge of the sidewalk (may be particularly an issue for dog guide users).**

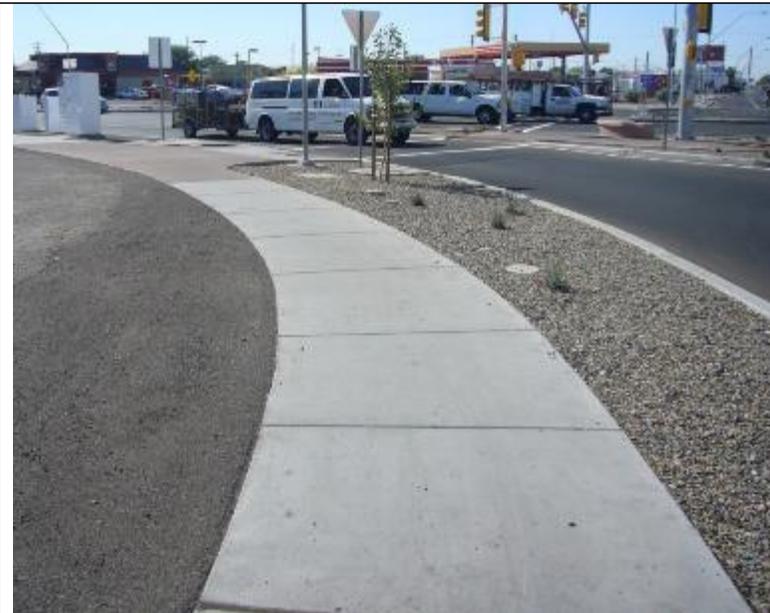
**Figure 12-13: Pedestrian approach along Oracle (from downstream end)**

**a) Landscaping keeps blind pedestrians from crossing at the wrong location.**

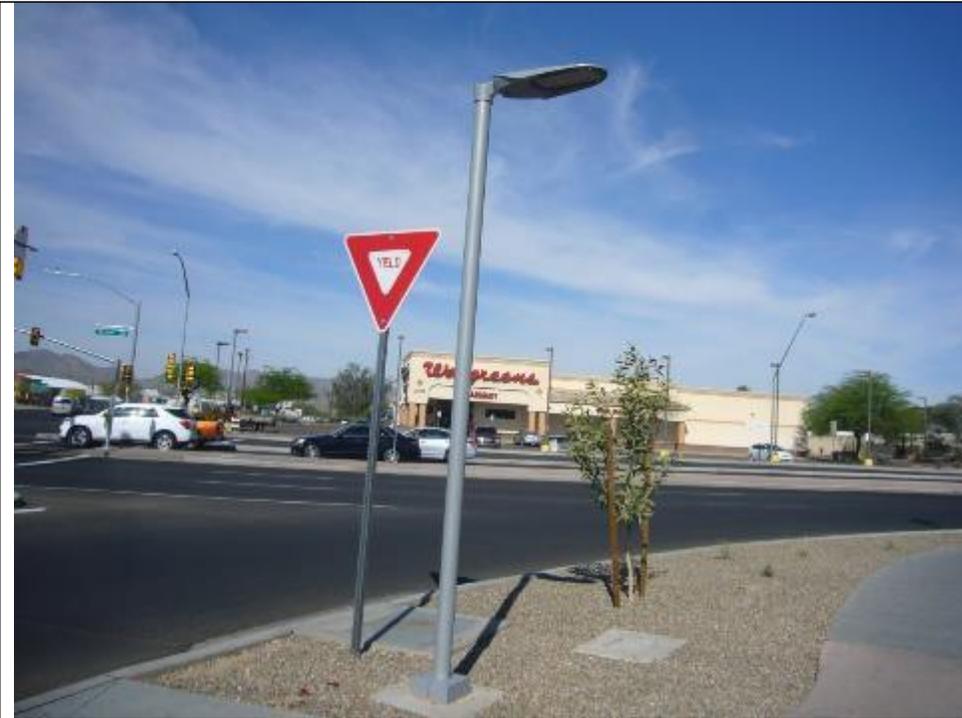
Figure 12-14: Lighting on the sidewalk

a) Lighting was provided over sidewalk, but no extra lighting at the crosswalk [we didn't look at it at night].

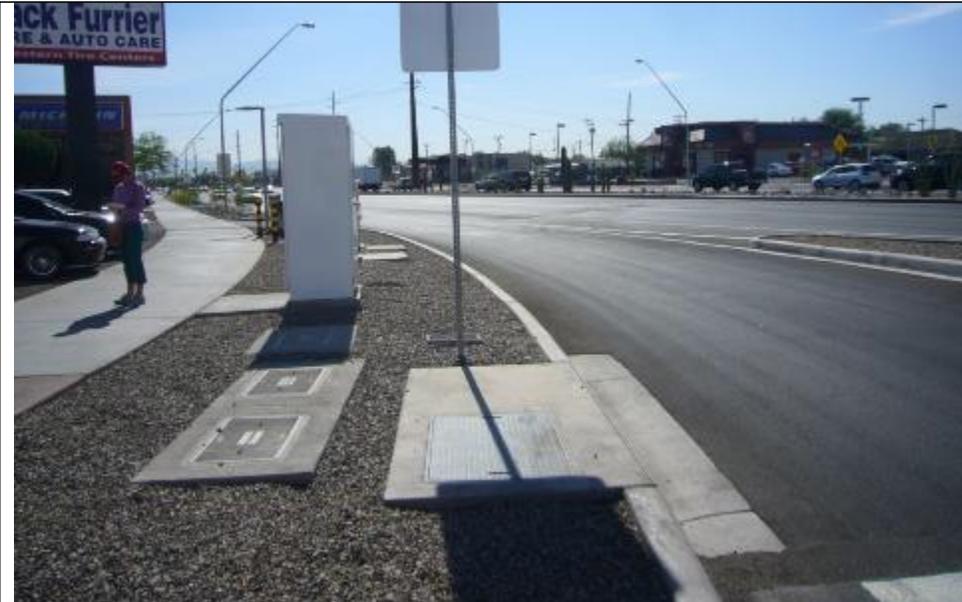
Figure 12-15: Pedestrian's view of approaching vehicles in CTL

Controller and other boxes on the side made some possibly confusing sound reflections of approaching and waiting vehicles (noted by O&M specialist), although no blind pedestrians commented on it, nor were there any decisions that were noticeably affected by that.

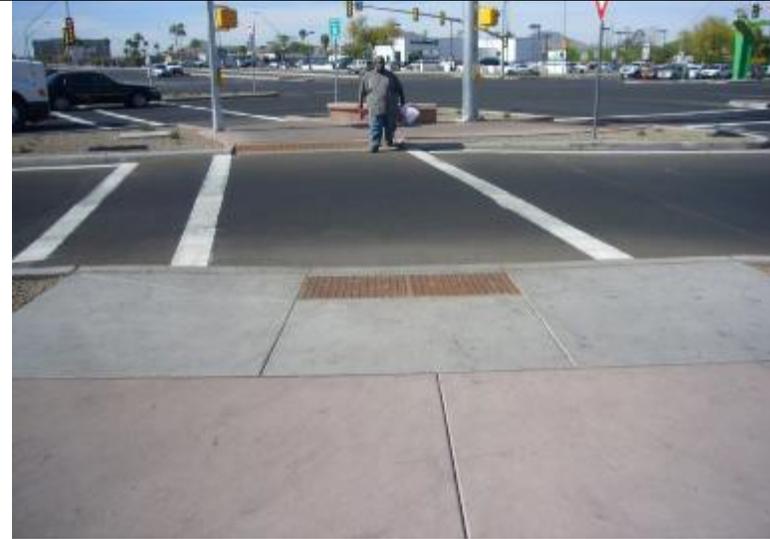
**Figure 12-16: Wide perpendicular ramp from curb to island**

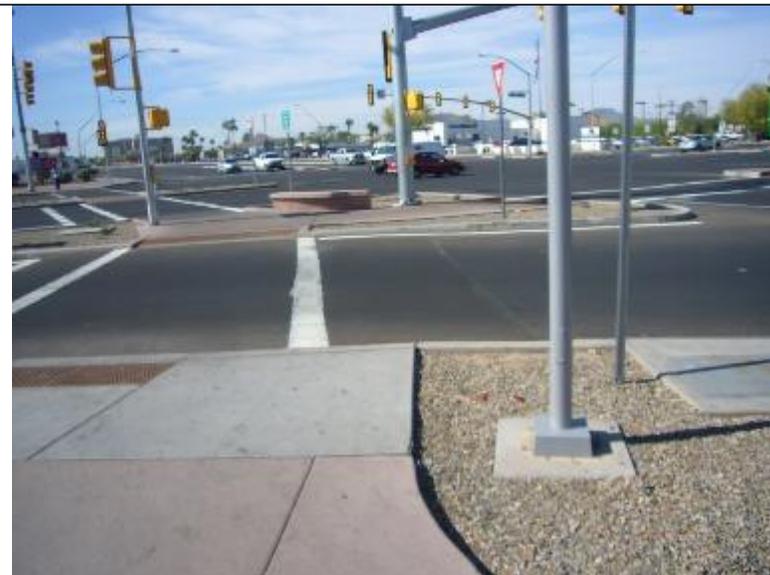
**Figure 12-17: Edge of landscaping not aligned with edge of crosswalk or with crosswalk direction**

**A blind pedestrian who lines up with it will end up outside the crosswalk.**

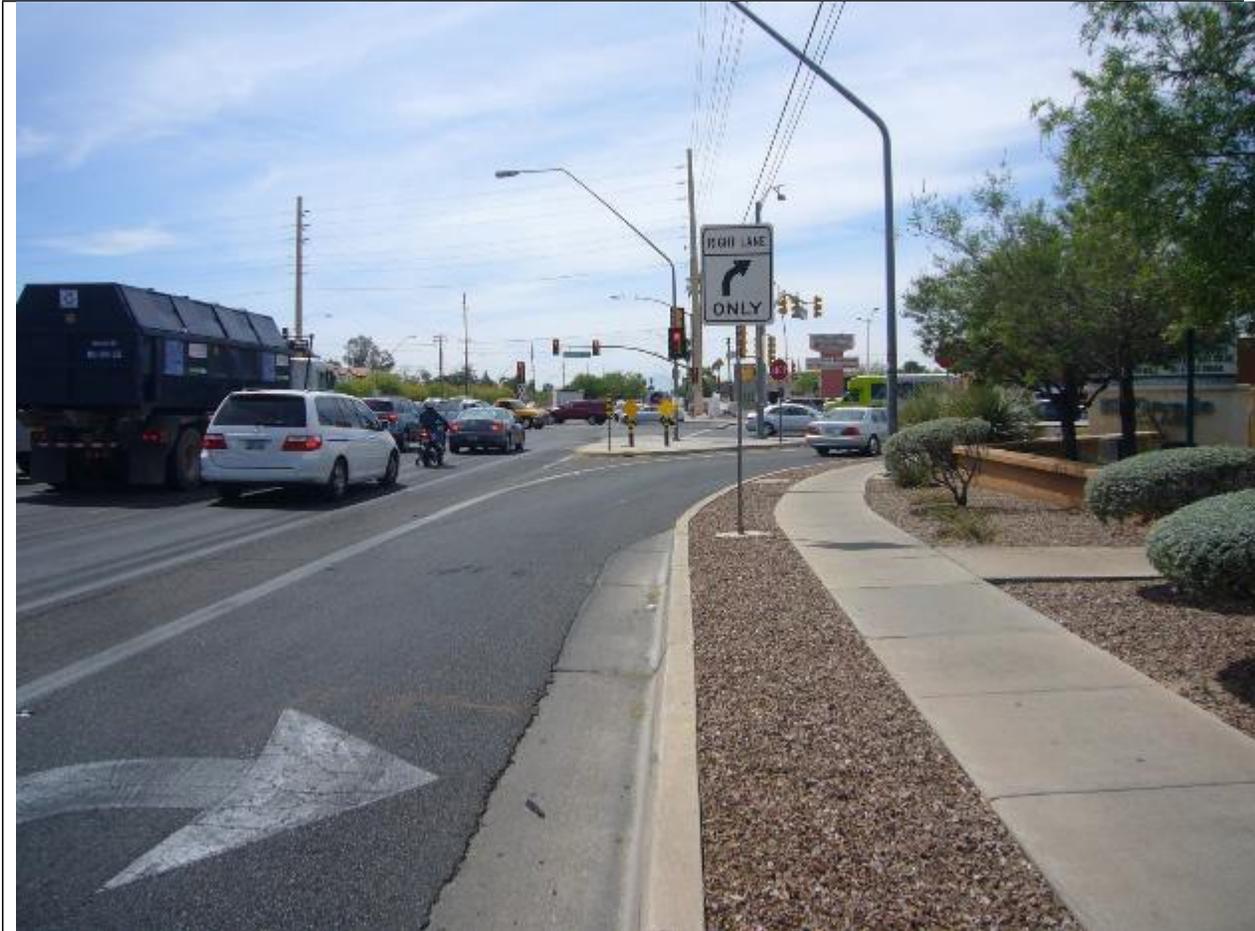
Figure 12-19: Approach to channelized turn lane driver and pedestrian view

- a) Deceleration lane
- b) Stop sign on both sides of crosswalk (on curb and on island); stop sign on island visible to approaching driver.
- c) Reflectors on poles on end of island, crash/visibility problem there?
- d) Narrow sidewalk.
- e) Landscaping between street and sidewalk.
- f) Landscaping on back side of sidewalk and low wall.
- g) No pedestrian crossing sign, although crosswalk is marked; crosswalk not visible to drivers until they start to turn.

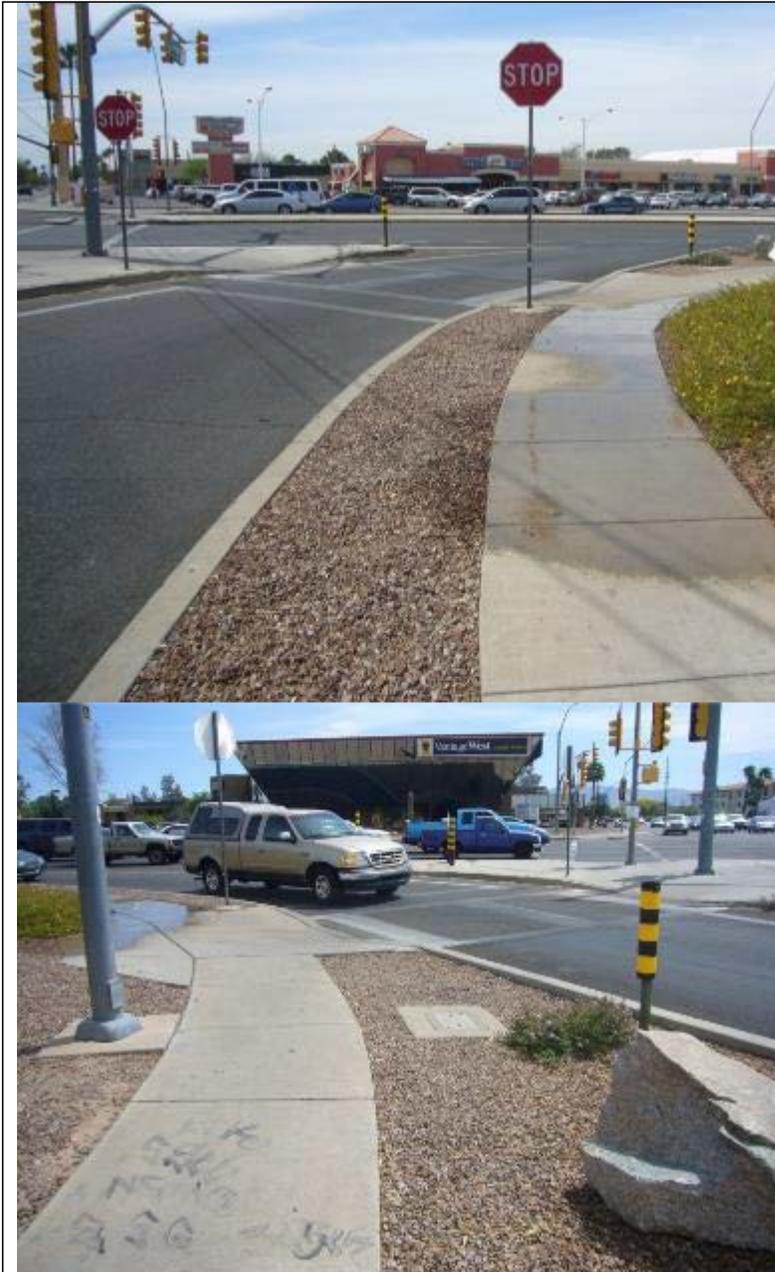
**Figure 12-20: Crossing view from upstream (on left) and downstream (on right)**

- a) Location of both stop signs visible.**
- b) Crosswalk marked, with stop line upstream of crosswalk.**
- c) Landscaping on both sides of sidewalk.**
- d) Perpendicular curb ramp slopes toward crosswalk, with landing behind ramp and main sidewalk path.**

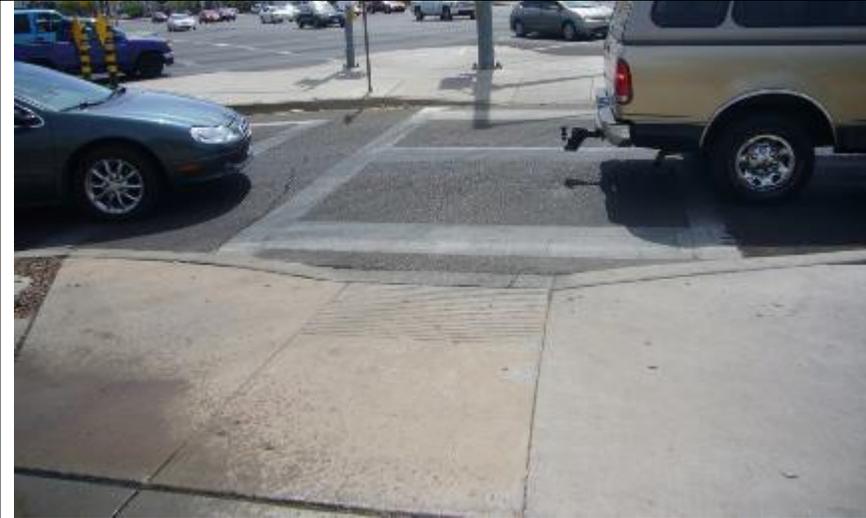
**Figure 12-21: View of crosswalk**

- a) Paved area at ramp, including the ramp flare, is wider than the crosswalk. Some blind pedestrians stated that they tried to cross from the curb, not from the ramp, and moved onto the flare to begin their crossings.
- b) No detectable warnings (truncated domes) installed at base of ramp.

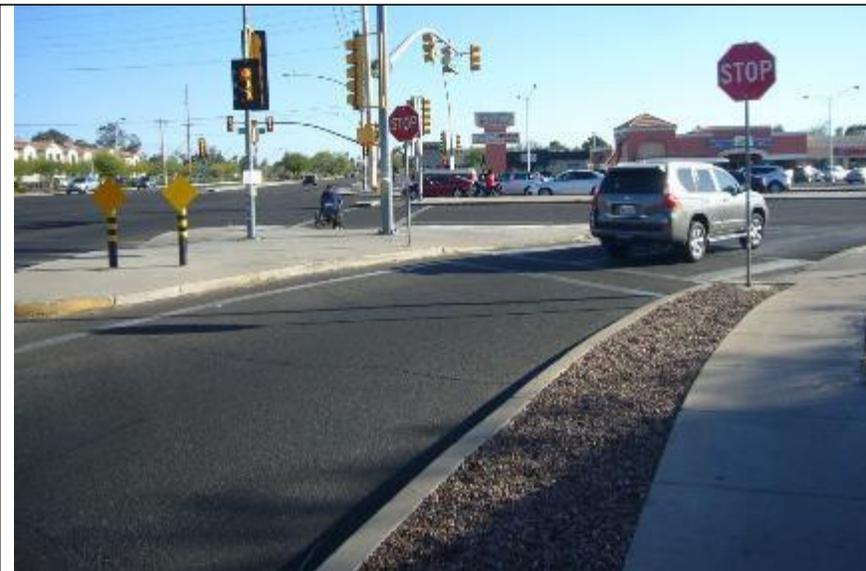
**Figure 12-22: View of island**

- a) Island is all paved with curb ramps to crosswalks; orientation problems for blind pedestrians; some trailed curb with their cane to find ramp and crossing point then got turned around when looking for pushbuttons.
- b) Pushbuttons on poles near center of island.
- c) Additional poles and reflective signs on island.
- d) Audible signal for main crossings of Speedway and Wilmot.
