## Guidelines for the Application of Crossing Solutions at Roundabouts and Channelized Turn Lanes for Pedestrians with Vision Disabilities

Bastian Schroeder, Lee Rodegerdts, Pete Jenior, Edward Myers, Christopher Cunningham, Katy Salamati, Sarah Searcy, Sarah O'Brien, Janet Barlow, and Billie Louise (Beezy) Bentzen; National Cooperative Highway Research Program; Transportation Research Board; National Academies of Sciences, Engineering, and Medicine

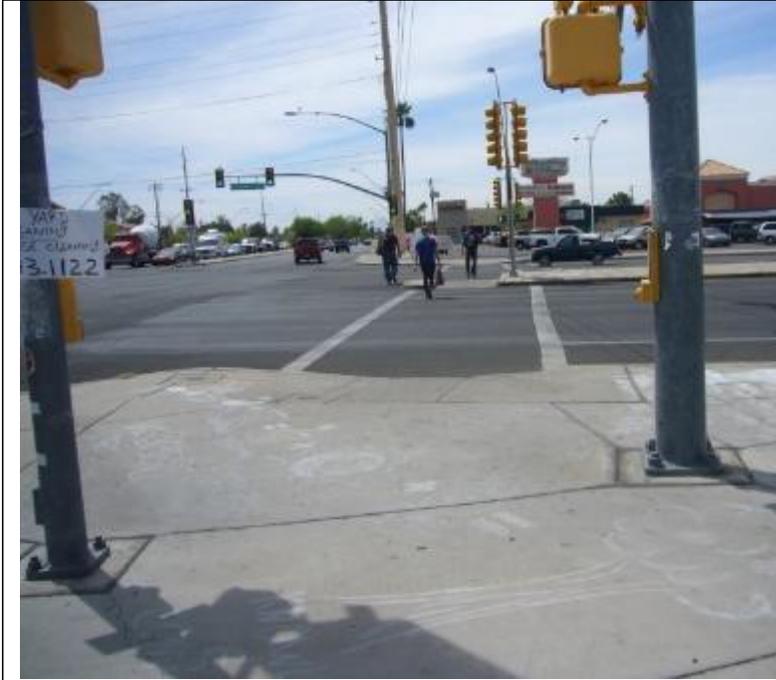
**Figure 12-23: Pushbuttons on island**

- a) Pushbuttons are in line with each crosswalk but located more than 10 back from the edge of the street.
- b) No pushbutton locator tone so blind participants had to search around for them.
- c) No tactile arrow on pushbutton; some blind participants pushed the wrong button for their crossing.
- d) Audible signal mounted on top of pedestrian signal pole above the pushbuttons.

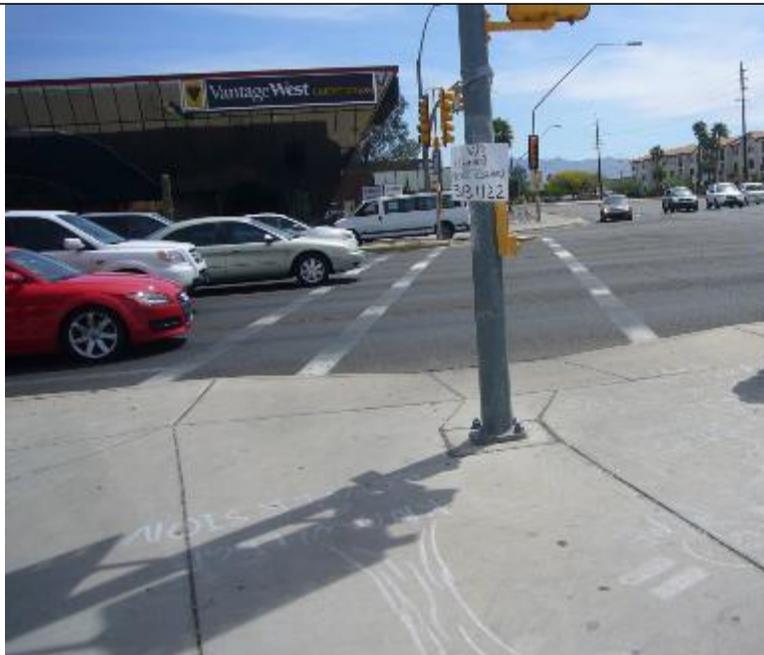
**Figure 12-24: View of crossing across Wilmot**

- a) Wide crossing.
- b) Curb ramp without detectable warnings angled to left of crosswalk.
- c) Pushbutton close to crosswalk, but no pushbutton locator tone.

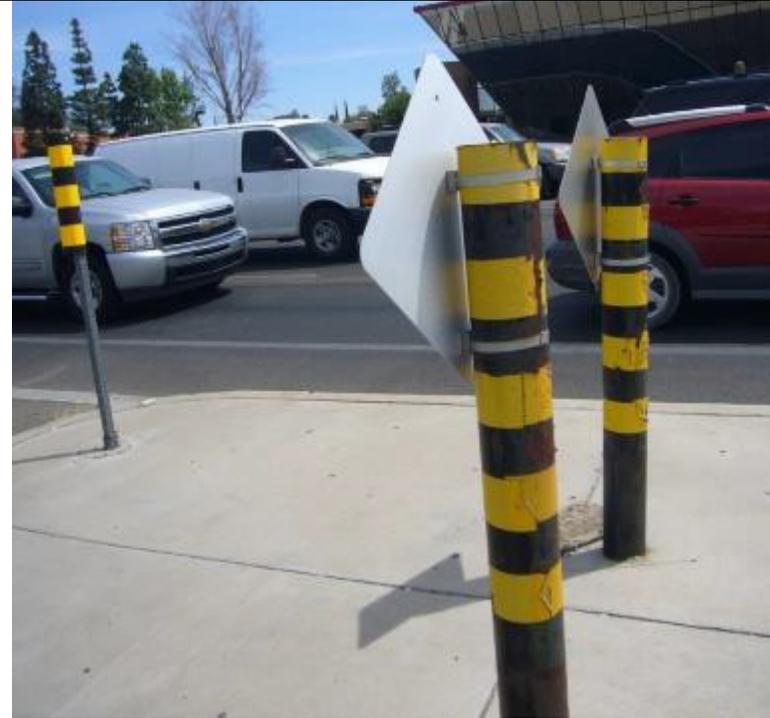
**Figure 12-25: Reflectors on island**

**Signs on the island have sharp protruding edges, hazardous for pedestrians who are blind.**

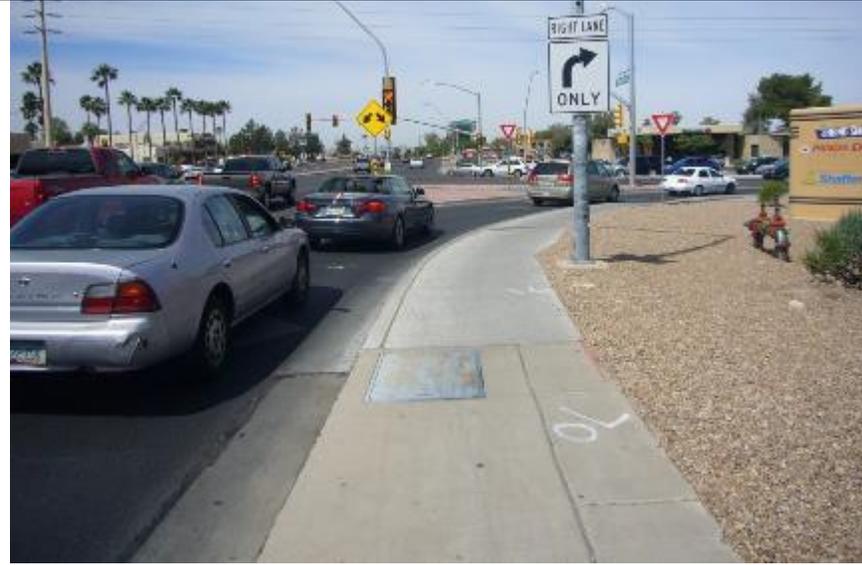
Figure 12-26: Approach view of CTL, sidewalk and crosswalk

- a) Right turn only sign (deceleration lane).
- b) Yield sign on each end of crosswalk).
- c) Lane designation sign on island.
- d) Fairly wide lane and large radius on CTL.
- e) Sidewalk is wide (6 feet) and at back of curb with no landscape separation between street and sidewalk.
- f) There is landscaping with gravel on side away from street.

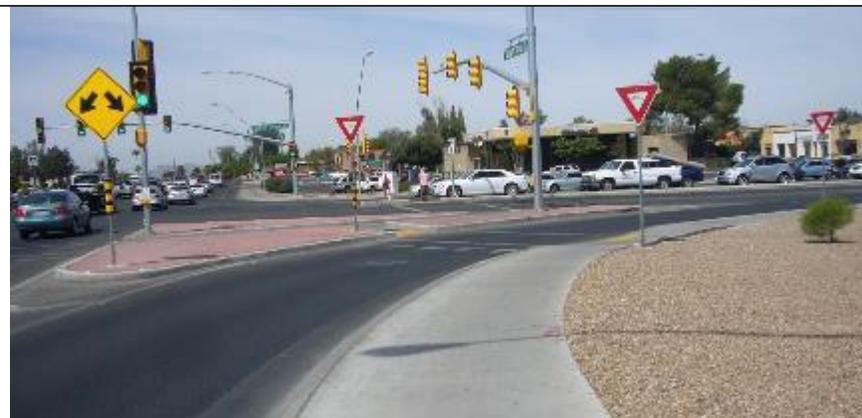
Figure 12-27: Yield signs at CTL

- a) Yield signs at crosswalk with shark's teeth marking about 4 feet in advance.
- b) Yield sign a merge point with Sabino Canyon Road.

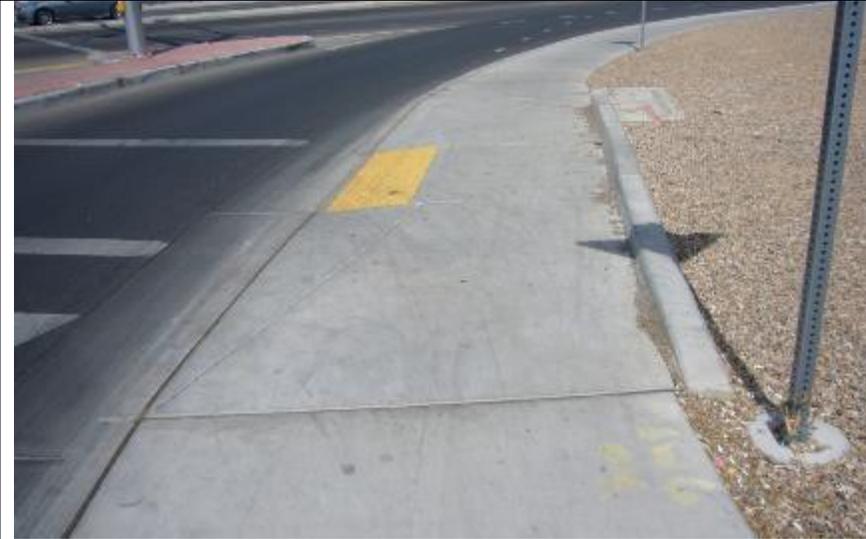
**Figure 12-28: Combo curb ramp**

- a) Curb ramp is combo parallel type, sidewalk slopes down approximately 3 inches, and a section of ramp is perpendicular to the street.
- b) Detectable warnings are installed on the perpendicular section.
- c) Raised curb at back of sidewalk is typical of a parallel ramp.

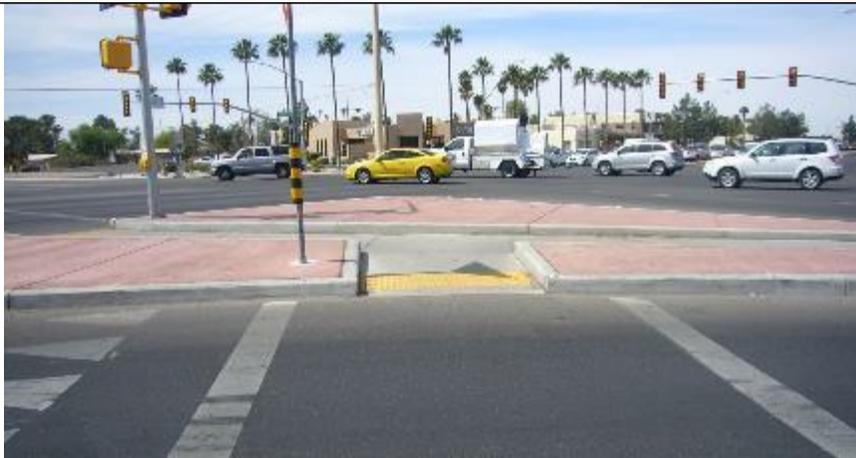
**Figure 12-29: Paths on island**

- a) Cut-through pedestrian paths well-defined.
- b) Crosswalk, and ramp on curb side, is wider than cut-through area. [One of our pedestrians ended up outside the cut-through when crossing and stepped up onto the paved surface. She thought the cut-through was the curb of the street when she came to it.]
- c) Detectable warning surface at edge of street at CTL, and each crossing.
- d) Island paved outside of cut-through areas.
- e) Pushbuttons on raised section beside street and edge of cut-through path.

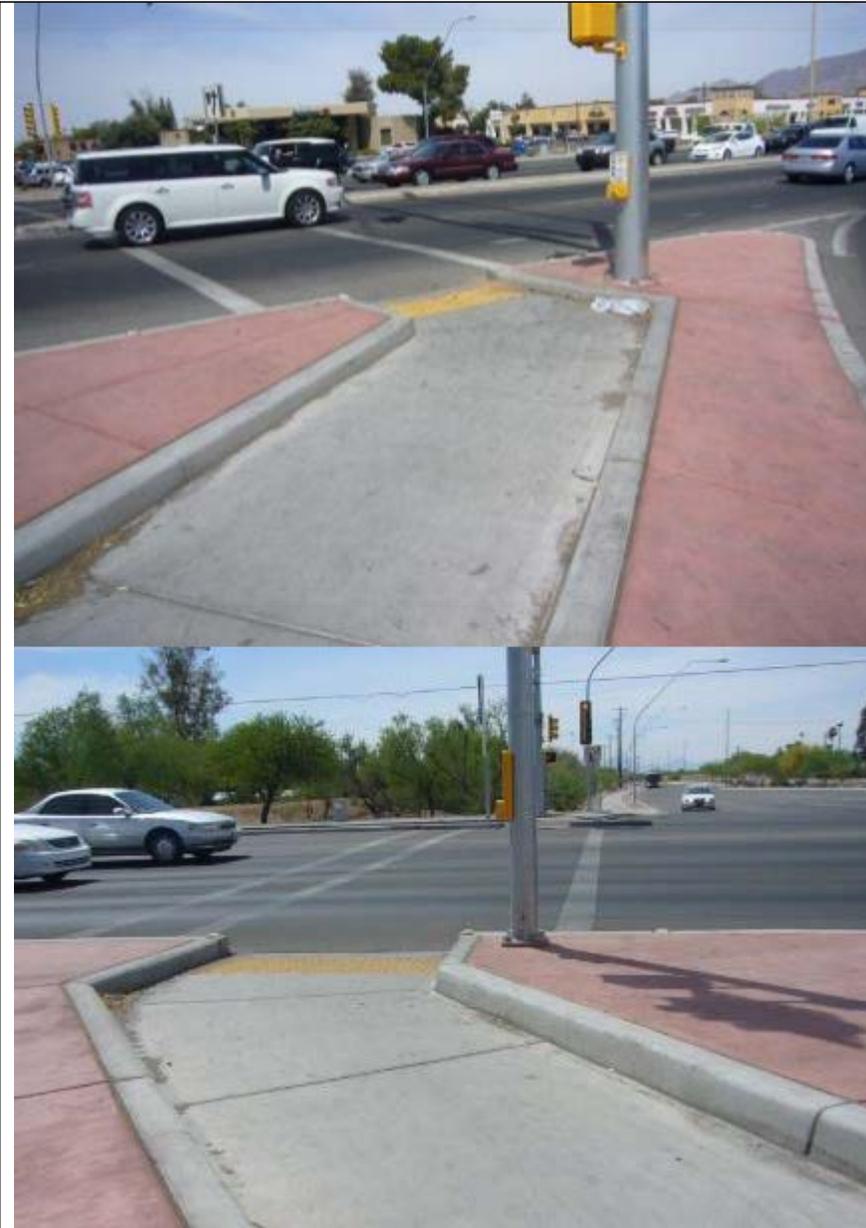
**Figure 12-30: Pushbutton location**

- a) Pushbutton is on side furthest from the center of the intersection for Sabino Canyon crossing (as per MUTCD guidance).
- b) Pushbutton for crossing Tanque Verde, photo on left, is on side closest to the intersection.
- c) Cut-through gathers trash and gravel along the edges, as can be seen in these photos, particularly one on left.

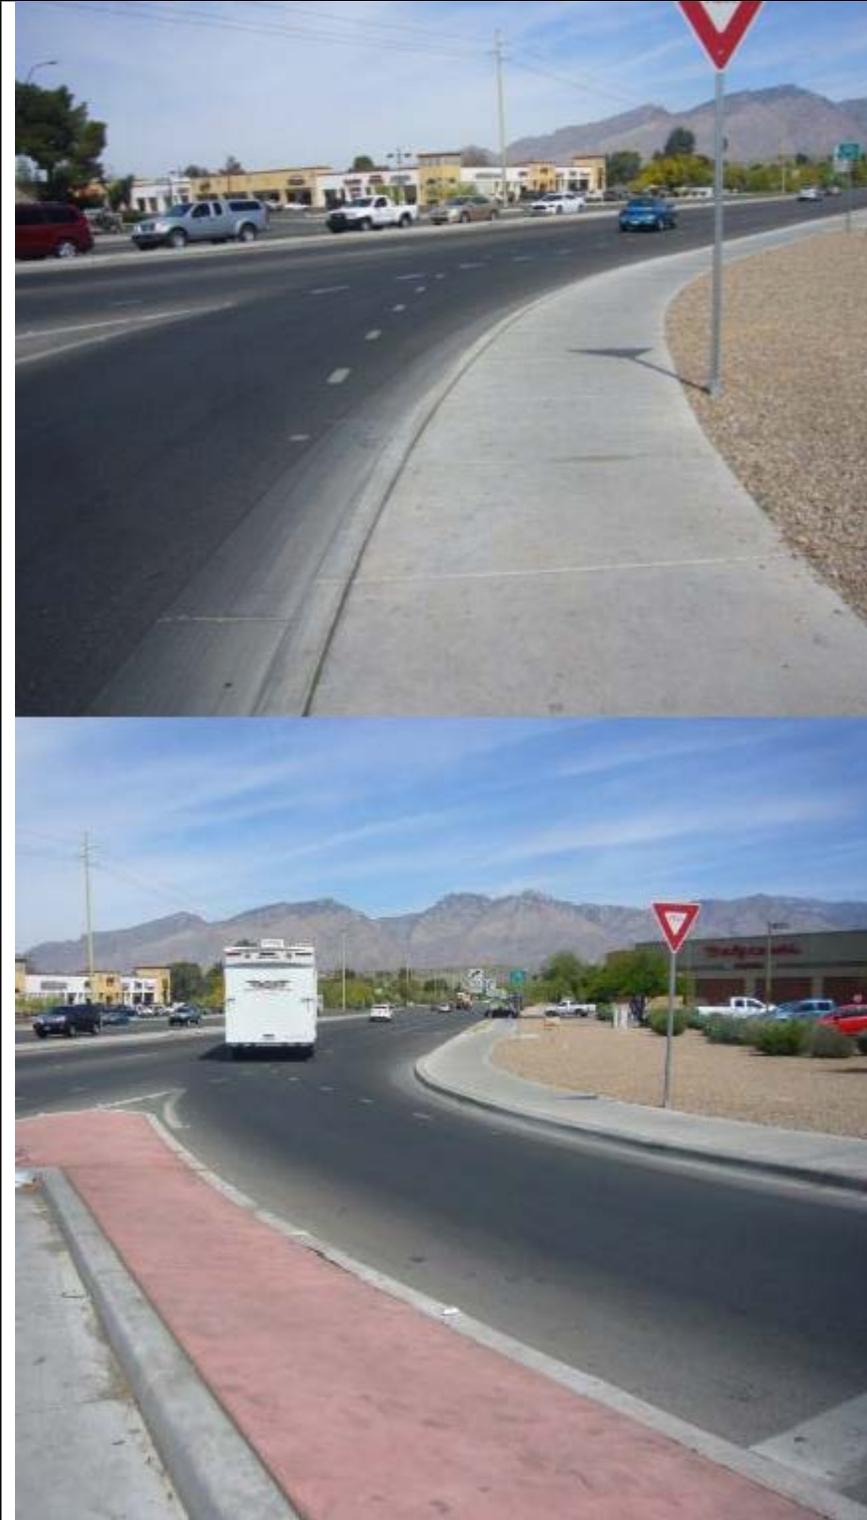
**Figure 12-31: Vehicular downstream lane merge**

**a) There's a lane that could be used as acceleration lane, but is really decel lane for shopping center entrance. Most vehicles did merge directly into the main travel lanes.**

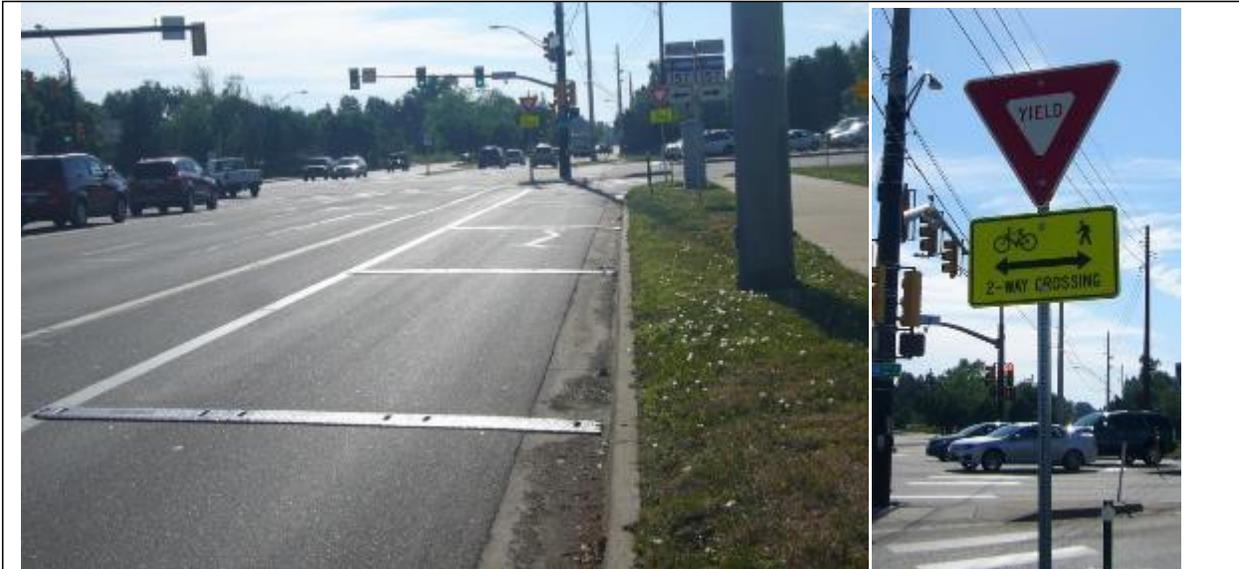
Figure 12-32: Drivers' view on approach (SW corner)

- a) Yield sign at crosswalk.
- b) Placard below yield sign: bicycle symbol, pedestrian symbol, two-headed arrow and 2-WAY CROSSING (photo at right).
- c) Bicycle lane between right turn lane and through lanes.
- d) Controller might restrict driver's view of pedestrian.
- e) Sound strips in deceleration lane.
- f) Lane width of CTL relatively narrow.

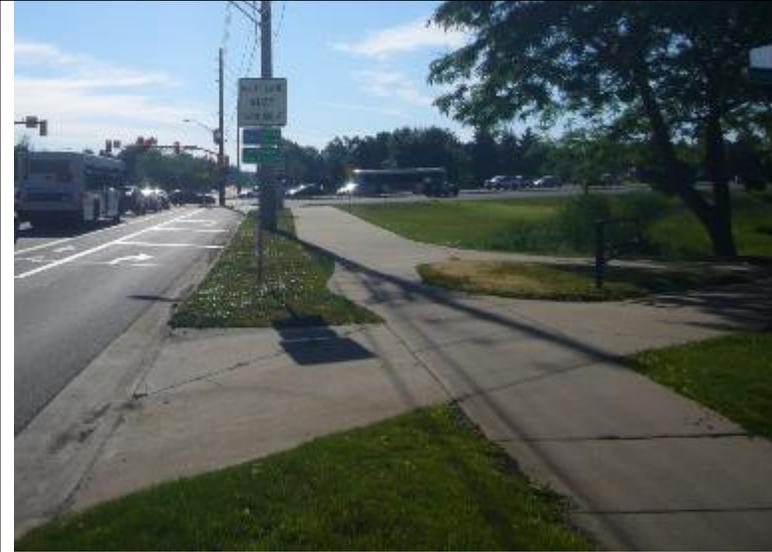
**Figure 12-33: Shared use path joins sidewalk**

**a) Path from right, sign: MULTIUSE PATH USE CROSSWALK THROUGH INTERSECTION.**

**b) Bicycle ramp from street to trail/path.**

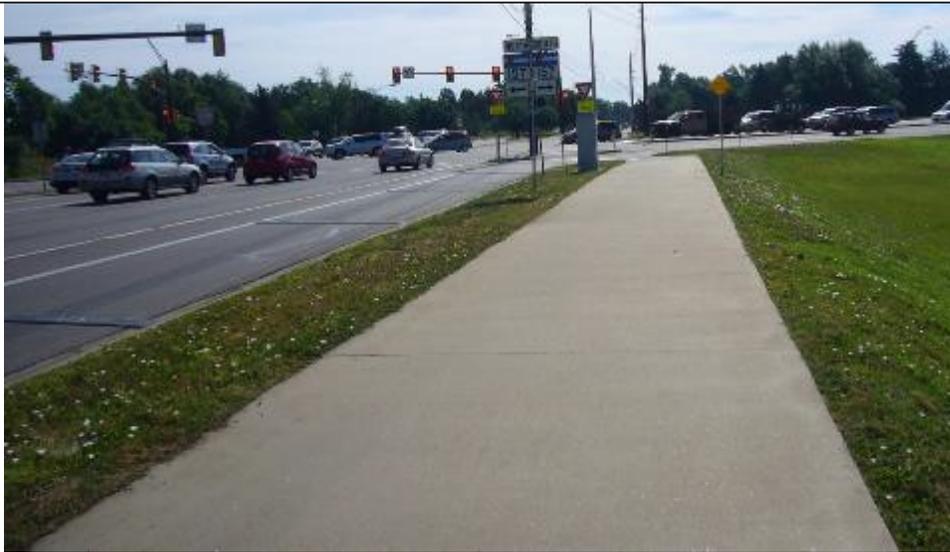
**Figure 12-34: Pedestrian's view on approach**

**a) Wide shared use path.**

**d) Sidewalk turns toward crosswalk.**

**e) VEHICLE CROSSING sign before crosswalk.**

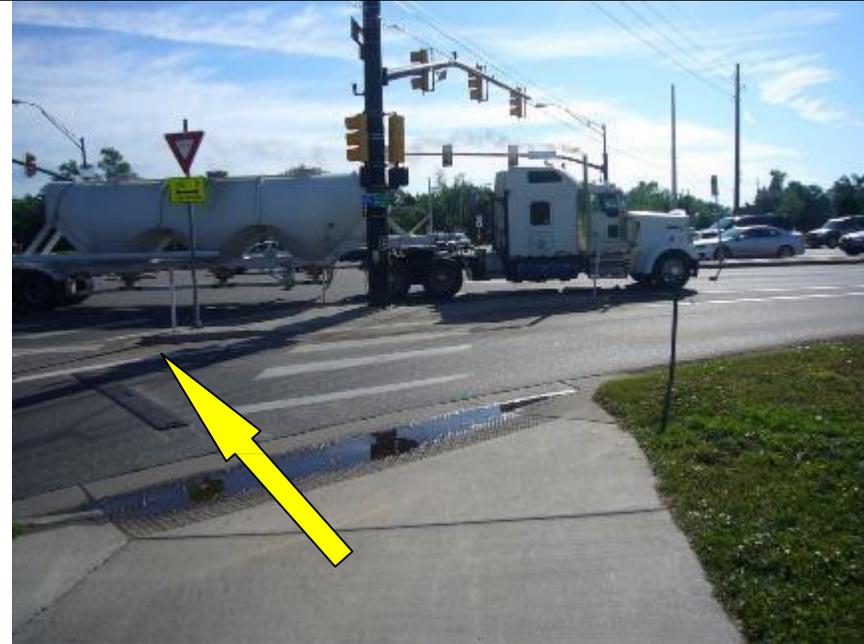
**Figure 12-35: Closer view of crosswalk**

- a) Ramp and curb line not aligned with crosswalk
- b) Ramp slope and detectable warning alignment may direct pedestrian past end of island (to left), particularly if they have been trailing sidewalk on the side closest to street (common technique observed with several participants in research); arrow approximates their path, sometimes hitting the sound strip and going around it.
- c) Continental pavement marking on crosswalk somewhat worn.
- d) Water puddle at base of ramp (may have affected alignment of some participants who moved to side to avoid it).
- e) Sound strip closest to crosswalk visible at left.

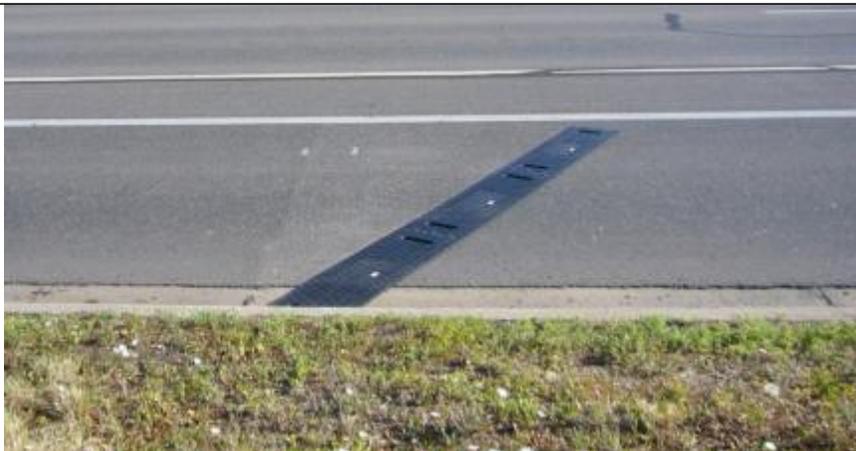
**Figure 12-36: Sound strips**

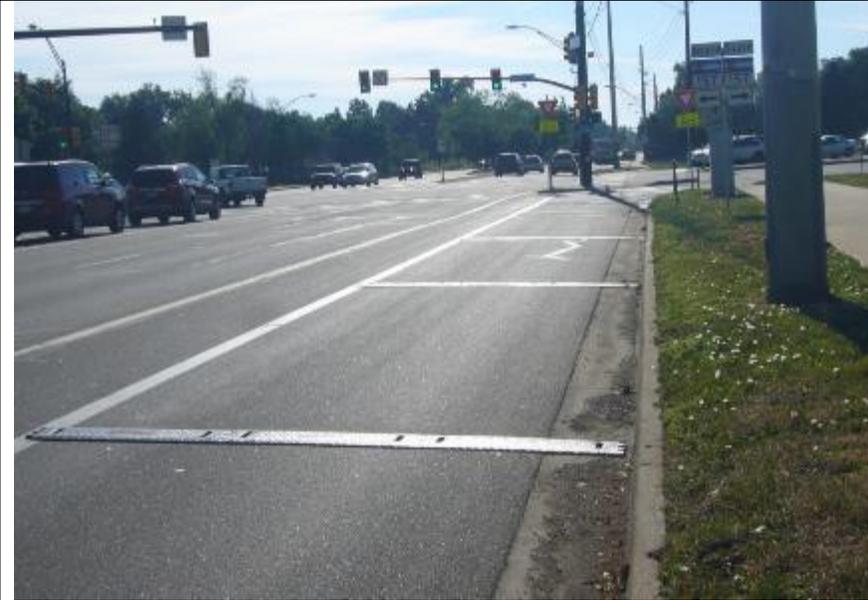
**Figure 12-37: Sound strips in deceleration lane**

Six strips installed across lane, spaced 30 feet apart (Road Quake temporary rumble strips).

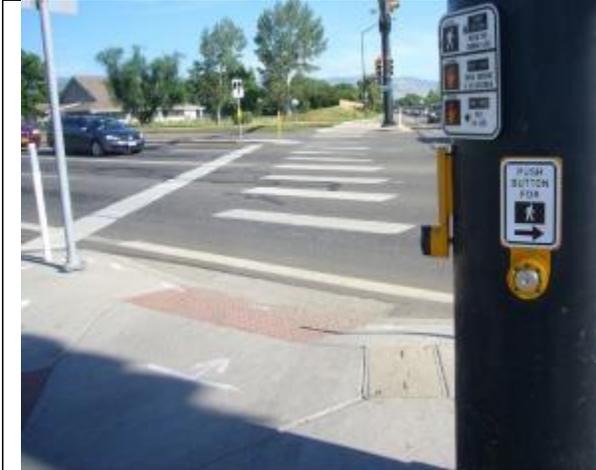
**Figure 12-39: Aligning to cross Baseline Road from island**

- a) Ramp sloped toward center of intersection.
- b) Detectable warnings, ramp slope, and island curb line, as well as perpendicular traffic, if used for alignment, aimed participant toward the center of the intersection; parallel traffic was heavy and provided a good alignment cue if participants waited for it.
- c) Face of pushbutton relatively well aligned with crosswalk direction.
- d) Pushbuttons had visual arrows but no tactile or audible features.

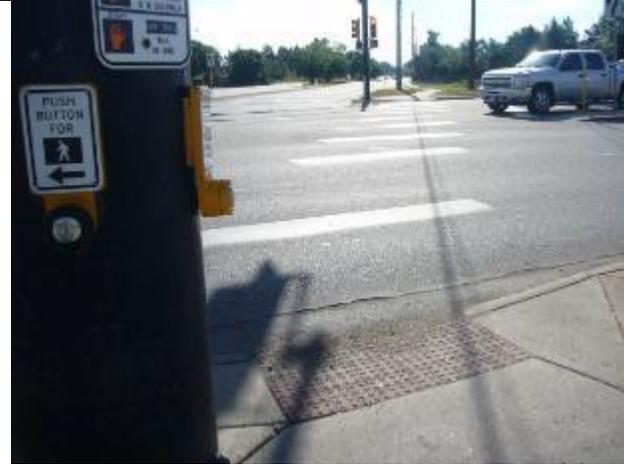
**Figure 12-40: Aligning to cross Foothills Parkway from island**

- a) Ramp sloped toward center of intersection.
- b) Detectable warnings, ramp slope, and island curb line, as well as perpendicular traffic, if used for alignment, aimed participant toward the center of the intersection; parallel traffic was heavy and provided a good alignment cue if participants waited for it.
- c) Face of pushbutton relatively well aligned with crosswalk direction.
- d) Pushbuttons had visual arrows but no tactile or audible features.

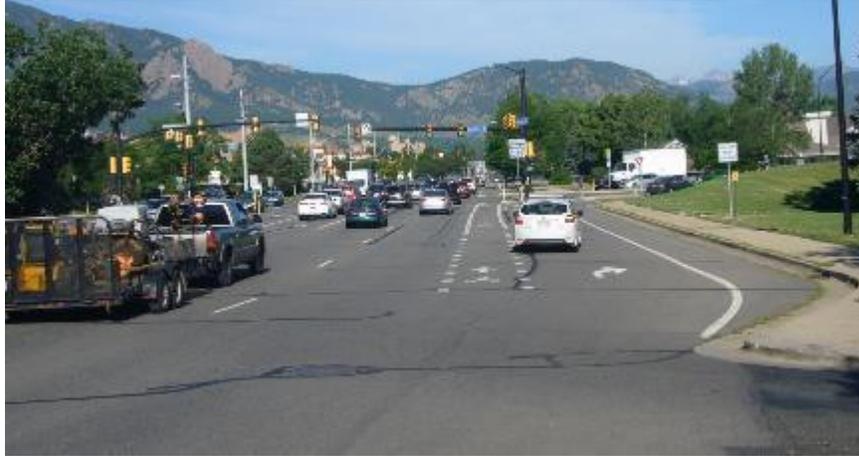
Figure 12-42: Drivers' view on approach (NE corner)

- a) Deceleration lane.
- b) Yield sign at crosswalk.
- c) Bicycle lane between deceleration lane and through lanes.

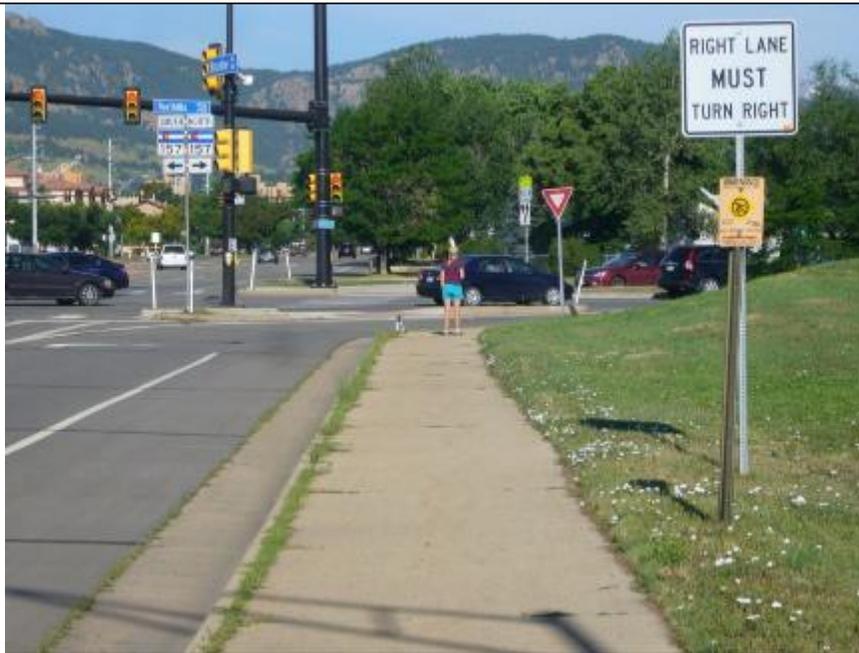
Figure 12-43: Pedestrian view on approach

- a) Sidewalk at back of curb.
- b) Grass growing in crack between sidewalk and curb.
- c) Crosswalk around corner just past the yield sign (NOT where pedestrian is standing in photo).

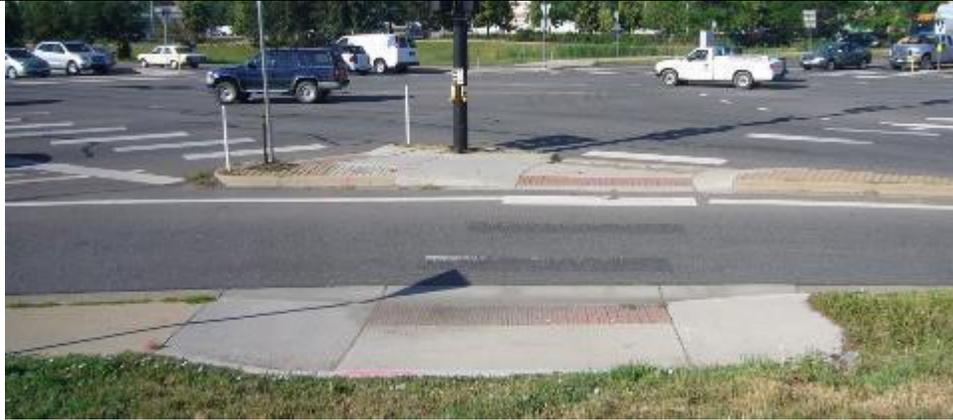
**Figure 12-44: View of crosswalk and island**

- a) Pavement marking worn and almost non-existent from curb to island.
- b) Parallel curb ramp (sidewalk slopes down to level landing area at crossing).
- c) Sidewalk ends at crosswalk.
- d) Detectable warning surfaces have gathered debris and dirt.
- e) Pushbuttons on signal pole on island.
- f) Raised curb on left side of crosswalk to cross Foothills Parkway (not present on other ramps). Rough (bricklike) surface of areas outside of ramps and crosswalks did not deter blind participants from traveling on or lining up on that surface.

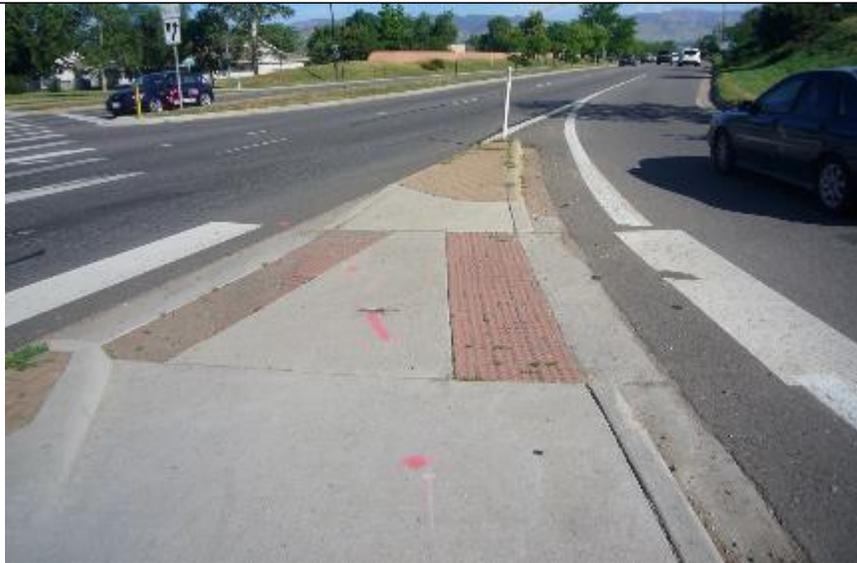
**Figure 12-45: Narrow island crossing**

- a) Island was quite narrow, disconcerting to some participants to be so close to heavy traffic.
- b) Detectable warning surface near Foothills Parkway was depressed, rather than level with the crossing area.

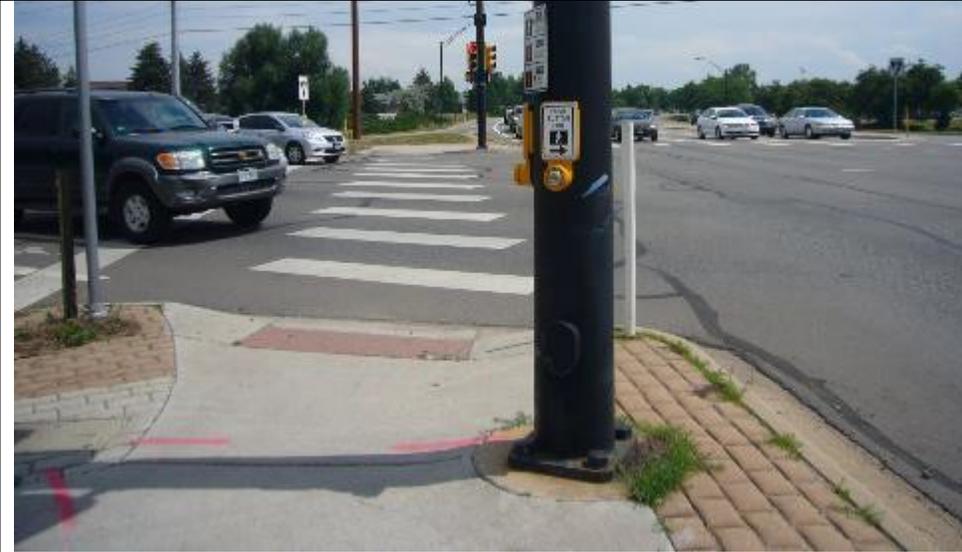
**Figure 12-46: Pushbutton to cross Foothills Parkway (road to right in photo)**

- a) Quite a distance from the crosswalk. (Photographer is standing at crosswalk.)**
- b) No audible or tactile features.**

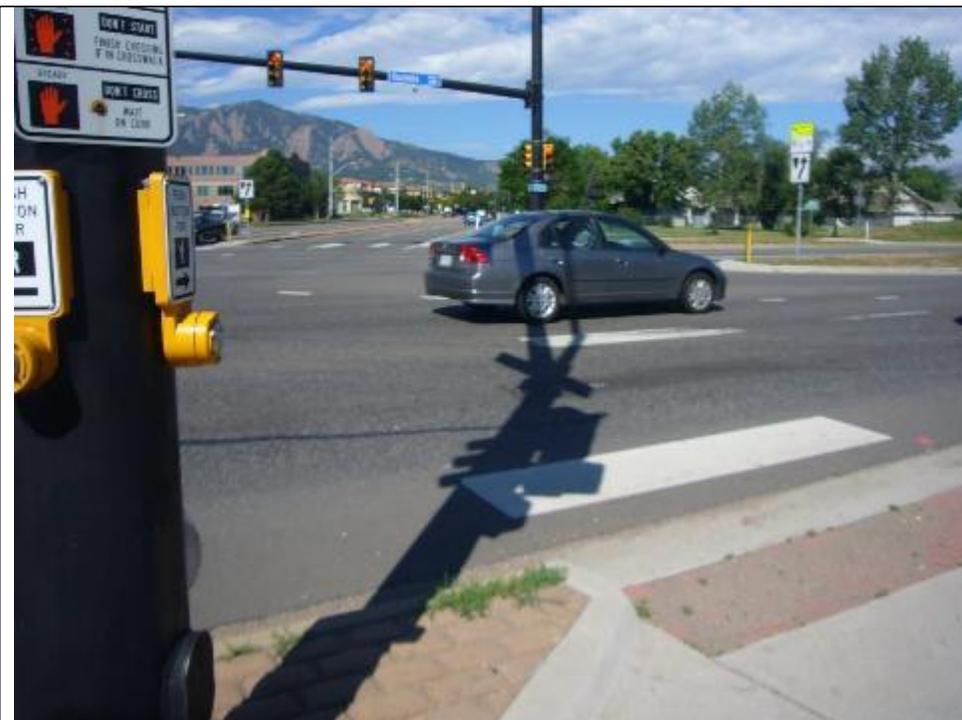
**Figure 12-47: Aligning to cross Foothills Parkway**

- a) Pushbutton aligned with crossing but not possible to reach it from crosswalk area.**
- b) Curb between detectable warning surface and pushbutton.**

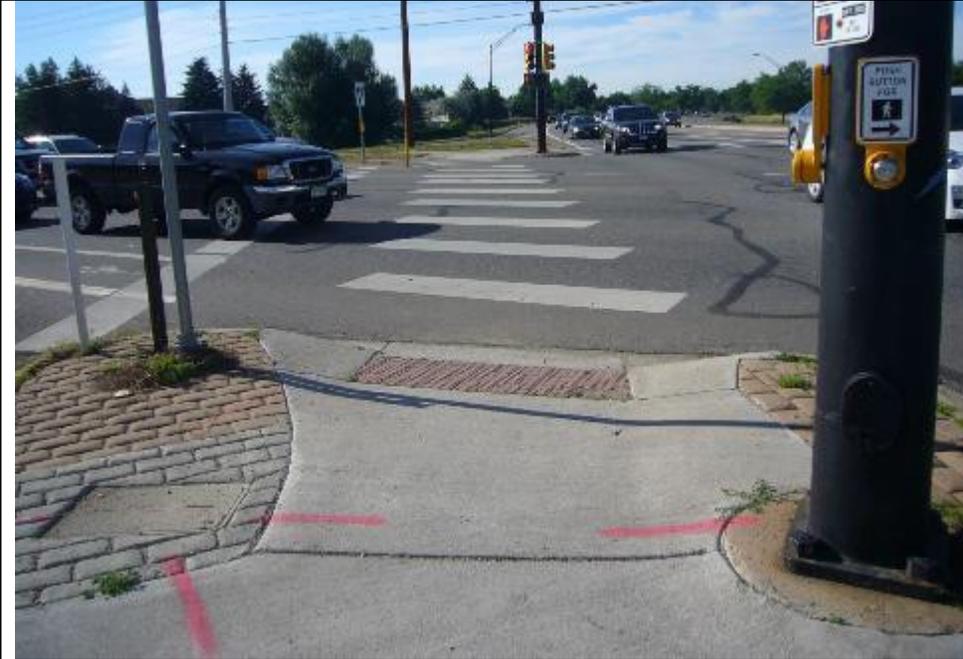
**Figure 12-48: Aligning to cross Baseline Road**

**a) Ramp, detectable warnings and curb line angled toward center of intersection; may direct someone toward traffic lanes.**

**b) Pushbutton on signal pole near crosswalk, but face of pushbutton and sign are aligned toward the intersection rather than in line with the crosswalk.**

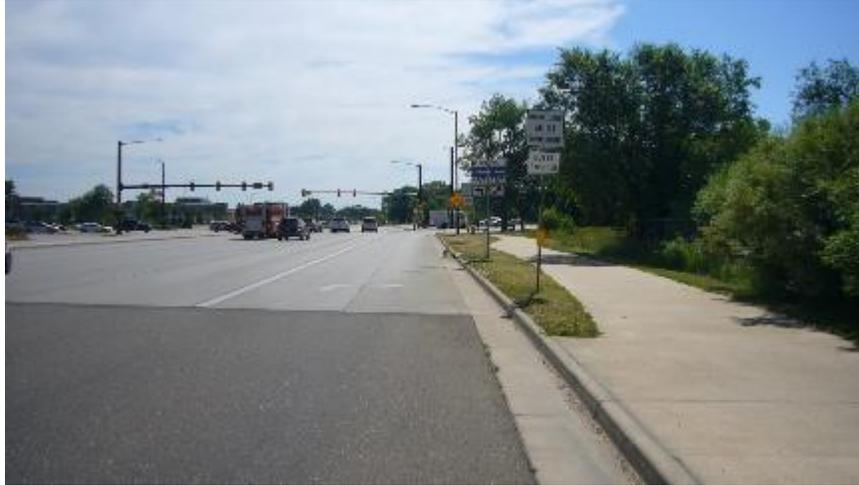
Figure 12-49: Driver's approach to CTL along Arapahoe

- a) Wide deceleration lane.
- b) Sign: **RIGHT LANE MUST TURN RIGHT, BUSES EXCEPTED.**
- d) Sign: **SLOW RAISED X-WALK.**
- d) Yield sign at crosswalk.

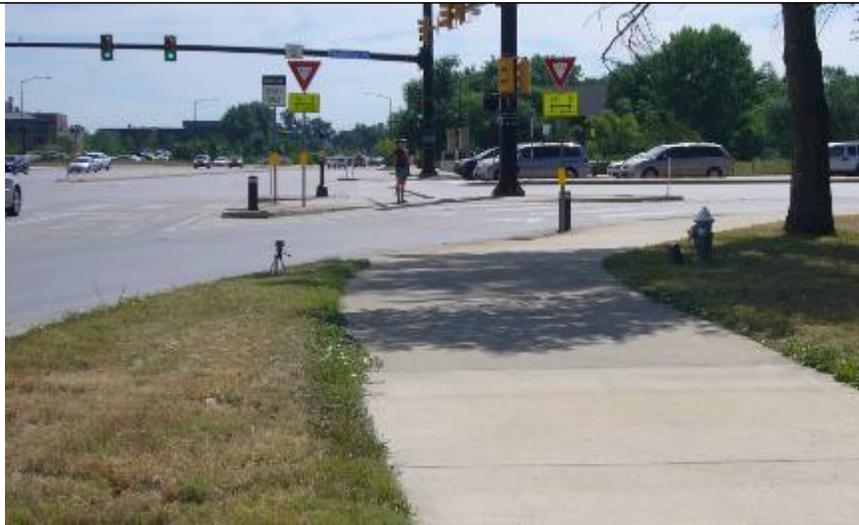
Figure 12-50: Pedestrian's view of approach to CTL

- a) Wide sidewalk/shared use path.
- b) Landscaping on both sides of path, ends on street side before crosswalk.
- c) Yield sign at crosswalk.
- d) Bollard before crosswalk.

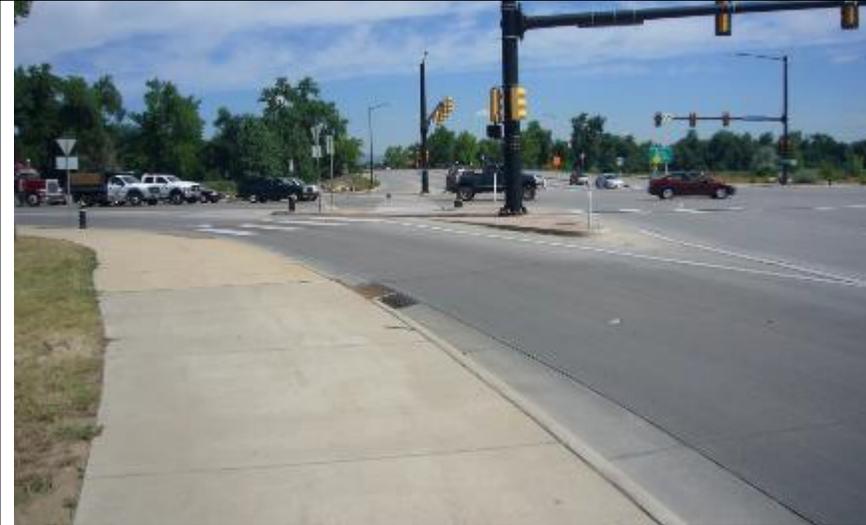
**Figure 12-51: Pedestrian view from downstream sidewalk**

- a) Wide sidewalk at back of curb.
- b) Raised crosswalk at sidewalk level.

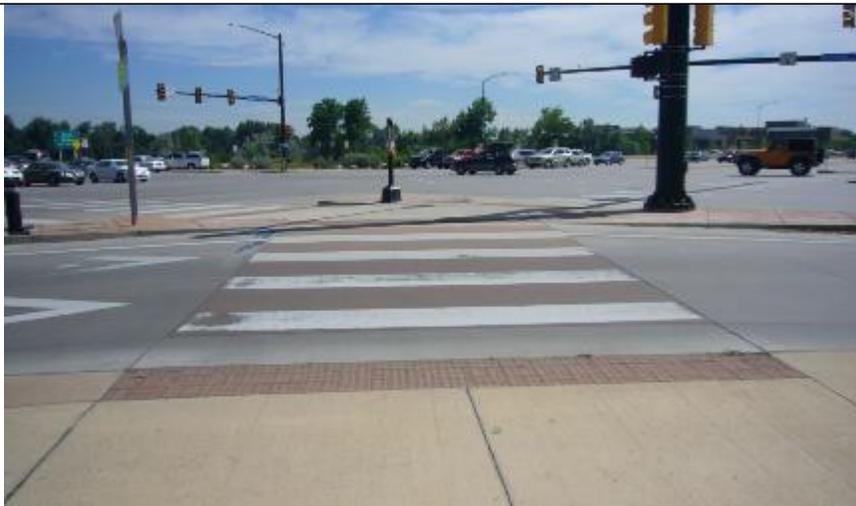
**Figure 12-52: Crosswalk view**

- a) Raised crosswalk.
- b) Wide crosswalk with continental stripes.
- c) Detectable warnings at edge of street and for full width of crosswalk, but do not extend the full width of area of the sidewalk that is level with the street. (Sidewalk is level with the street for almost a foot past marked edge of crosswalk.)
- d) Island is large, paved area with a wide curb ramp to each street.
- e) Returned curbs on edge of each ramp.

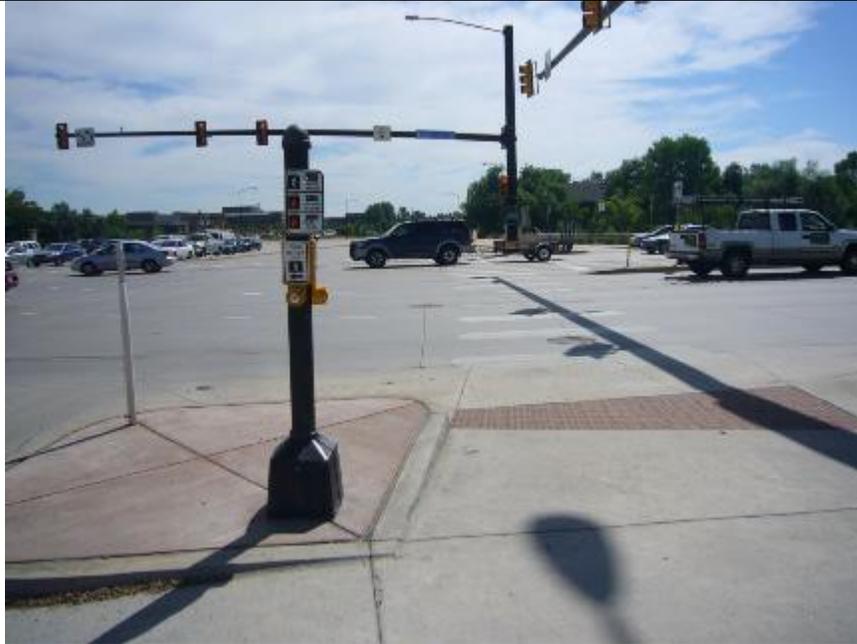
**Figure 12-53: View of crosswalk across Foothills Parkway**

- a) Ramp with returned curbs on side.
- b) Aligned with crosswalk direction.
- c) Two pushbuttons on one pole between ramps for the two streets.
- d) Detectable warning at curb edge for full width of ramp.

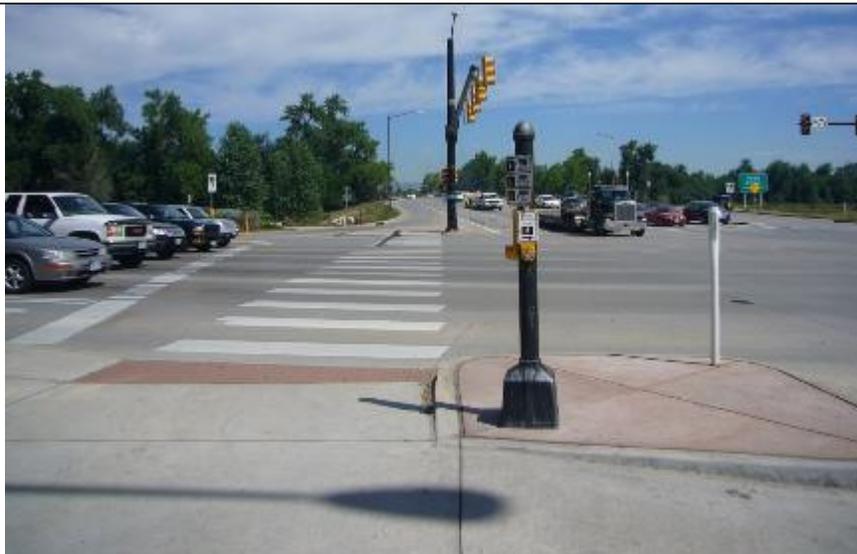
**Figure 12-54: View of crosswalk across Arapahoe**

- a) Same basic setup as crosswalk across Foothills Parkway.

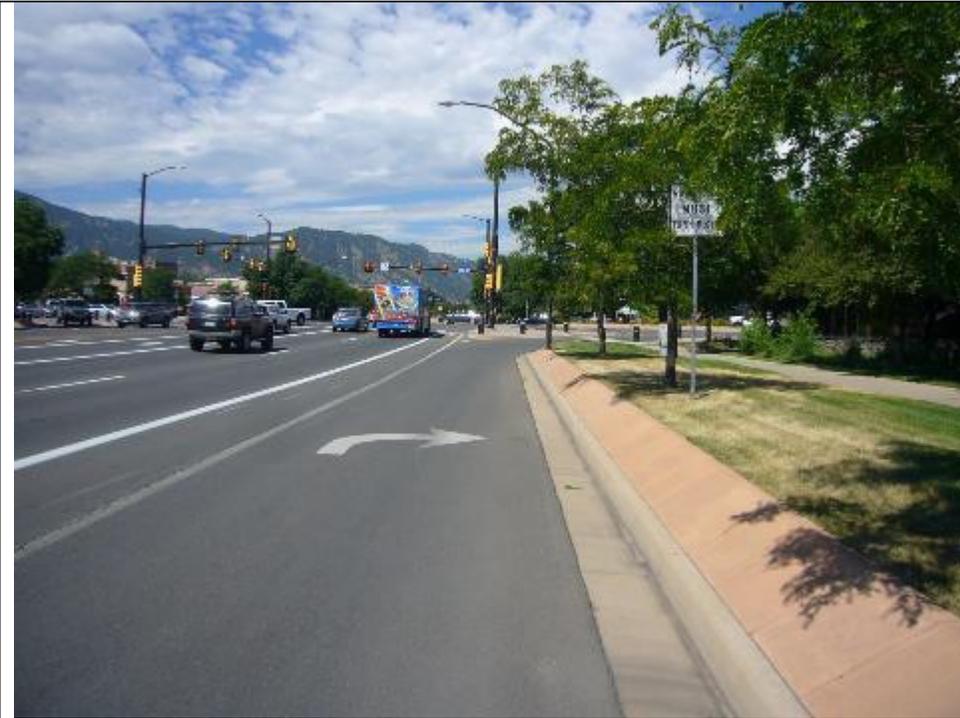
Figure 12-55: Drivers view on approach to 28th Street on Pearl

- a) Right turn decel lane.
- b) RIGHT LANE MUST TURN RIGHT sign, partially obscured by trees.
- c) Right turn arrow lane markings.
- d) Bicycle lane to left of right turn lane.
- e) High curb on street.

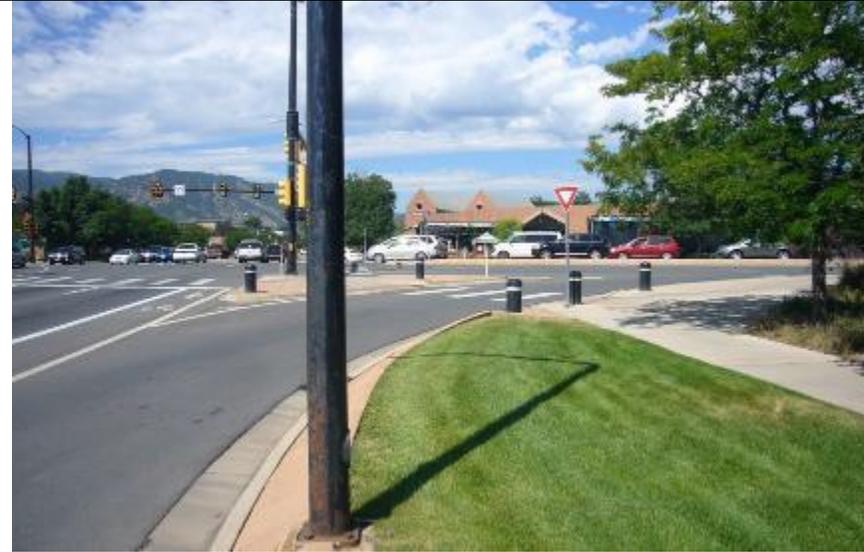
**Figure 12-56: Driver's view of crosswalk (NE Corner 28<sup>th</sup> and Pearl)**

- a) Marked crosswalk, not raised.**
- b) Bollards on the curb and island.**
- c) Yield sign just before crosswalk on right.**

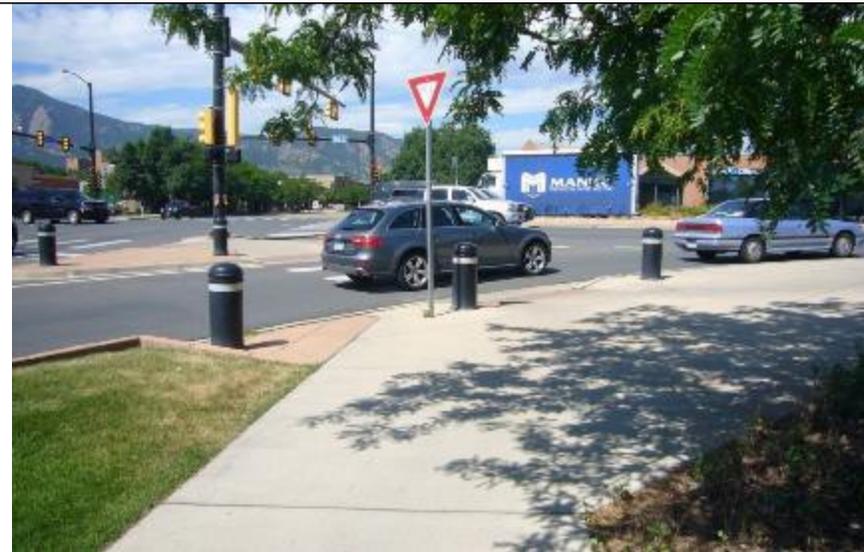
**Figure 12-57: Pedestrian's view on approach**

- a) Sidewalk widens at corner.**
- b) Landscaping ends before crosswalk.**
- c) Bollards on each side of crosswalk and other locations on curve.**
- d) Perpendicular ramp at crosswalk.**

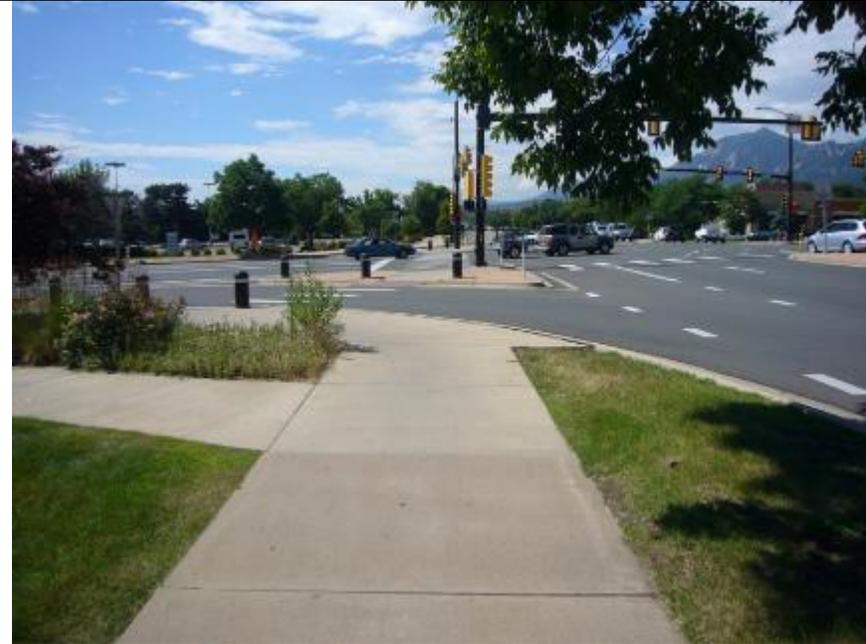
**Figure 12-58: Pedestrian approach from downstream street**

- a) Wide sidewalk with landscaping between street and sidewalk that ends before crosswalk.
- b) Crosswalk around curve of CTL.

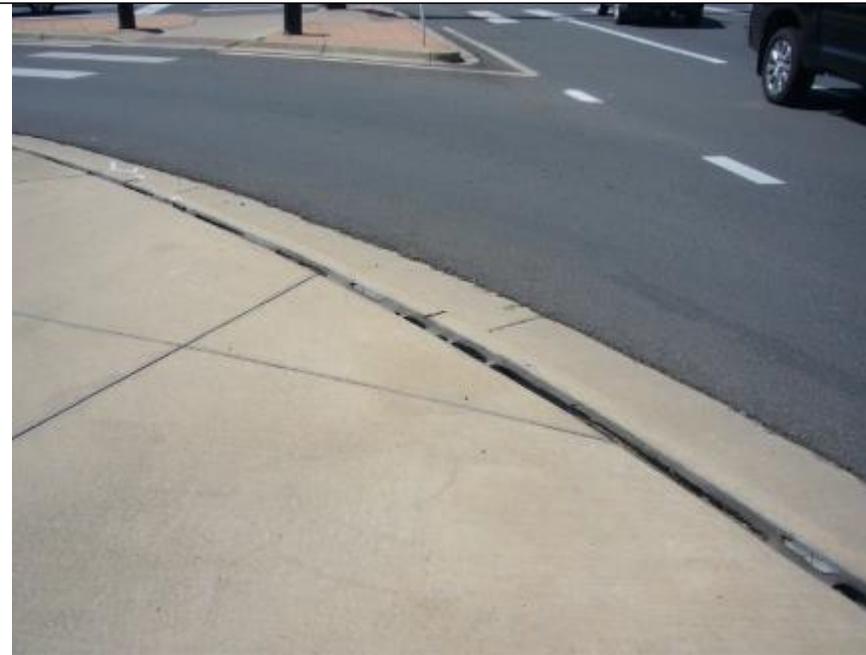
**Figure 12-59: Gap between SW and curb**

- a) Dave commented that the 1 to 2 inch gap confused some participants on approach.

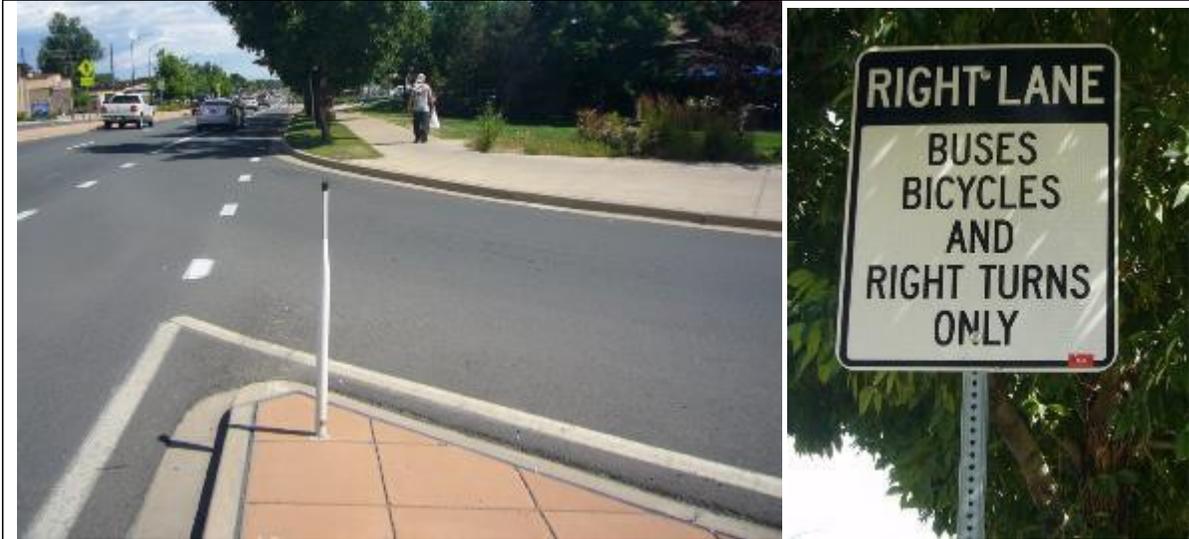
Figure 12-60: View of downstream merge area

a) Pavement markings in shade, **BIKE BUS ONLY**. b) Sign on left hidden behind trees in photo on right.

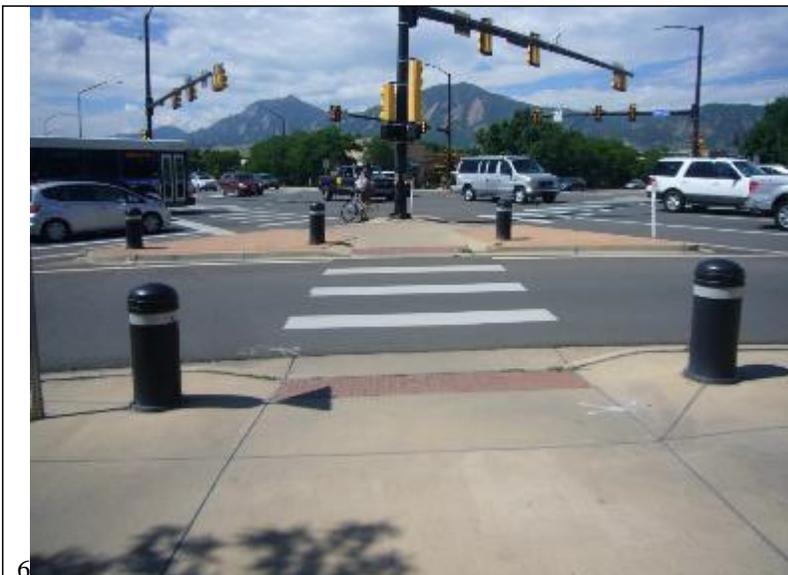
Figure 12-61: View of crosswalk and island

- a) Bollards on each side of crosswalk.
- b) Wide crosswalk with continental markings.
- c) Detectable warnings, ramp slope and gutter in line with crosswalk direction.
- d) Island raised and paved with somewhat rough textured material outside of concrete path.
- e) Bollards on each side of crosswalk on island.
- f) Pushbuttons on one signal pole between crosswalks.
