## Guidelines for the Application of Crossing Solutions at Roundabouts and Channelized Turn Lanes for Pedestrians with Vision Disabilities

Bastian Schroeder, Lee Rodegerdts, Pete Jenior, Edward Myers, Christopher Cunningham, Katy Salamati, Sarah Searcy, Sarah O'Brien, Janet Barlow, and Billie Louise (Beezy) Bentzen; National Cooperative Highway Research Program; Transportation Research Board; National Academies of Sciences, Engineering, and Medicine

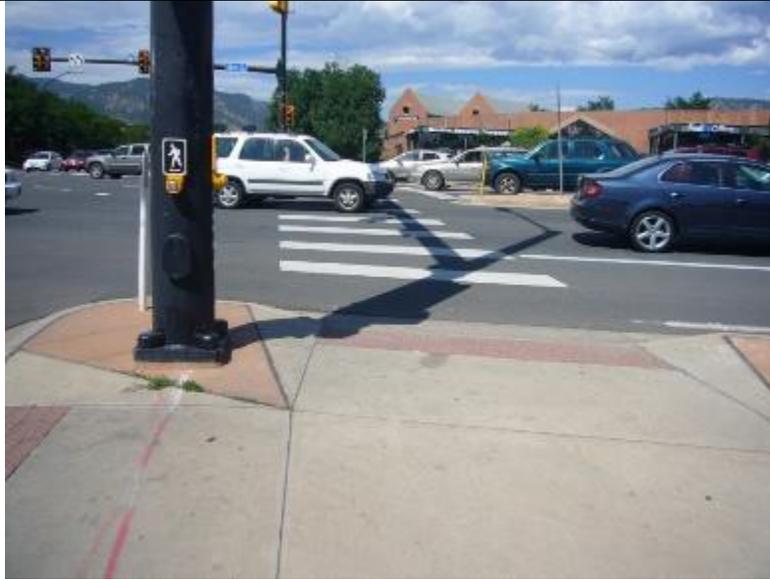
**Figure 12-62: Crosswalk across 28th Street from island**

- a) Crosswalk slope, detectable warning and gutter aim to right of crosswalk direction toward median.
- b) Pushbutton (non-audible) on pole to intersection side of crosswalk.
- c) No level landing at pushbutton.

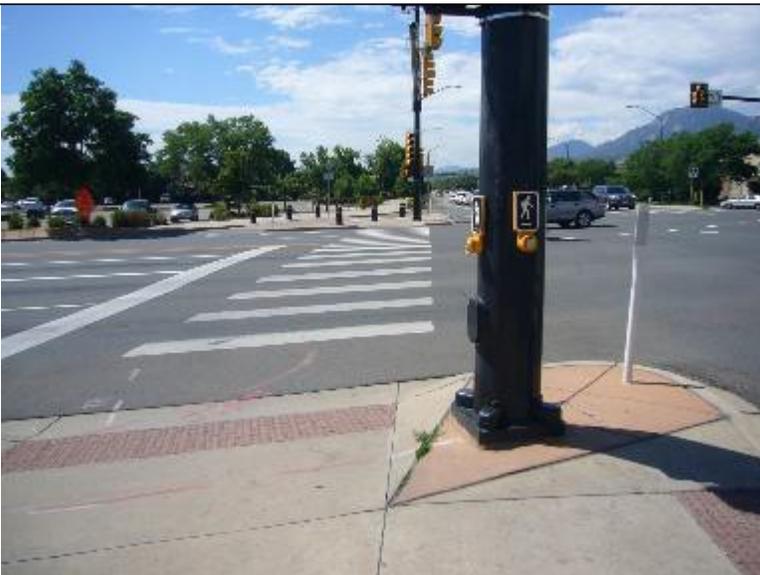
**Figure 12-63: Crosswalk across Pearl Street from island**

- a) Wide crossing, 7 lanes.
- b) Gutter, detectable warning, and ramp aligned slightly left of crosswalk direction.
- c) Pushbutton to right of crosswalk (on parallel street side).
- d) No level landing at pushbuttons.

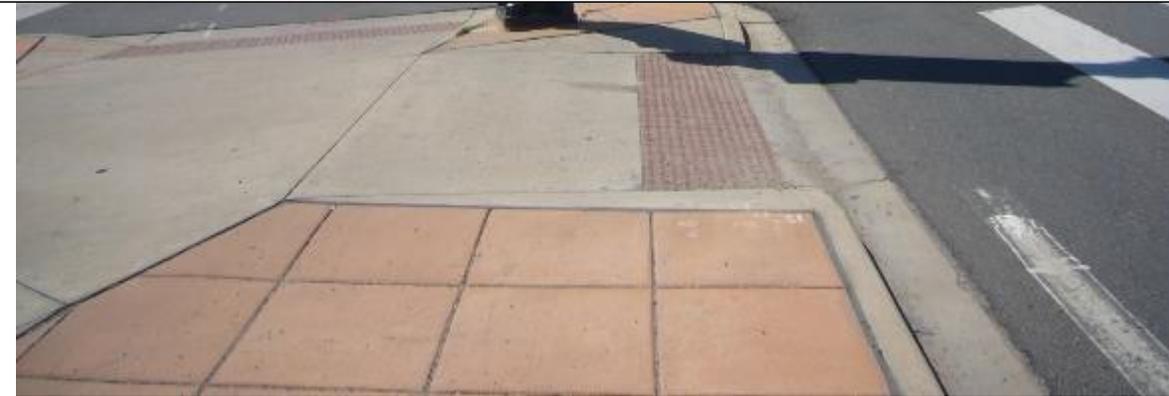
**Figure 12-64: View of island surface**

- a) Slight color difference of area outside walking path.**
- b) No discernible texture difference for blind participants.**

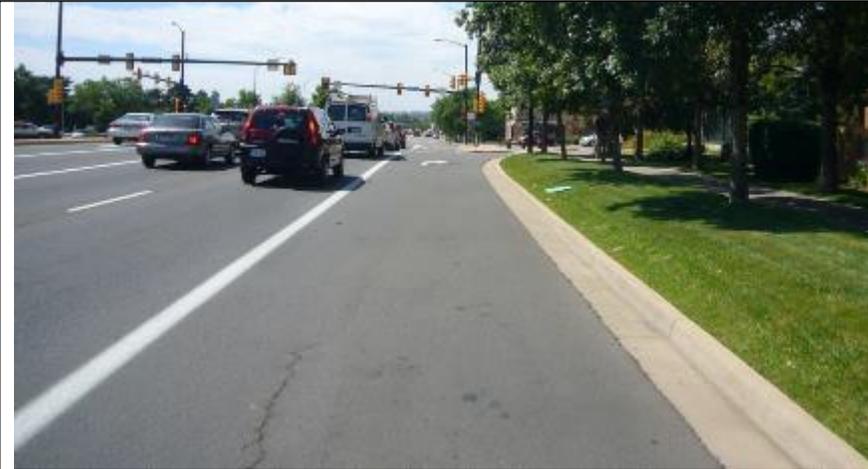
Figure 12-65: Driver's view on approach, northwest corner

- a) Decel lane.
- b) Tree-lined road.

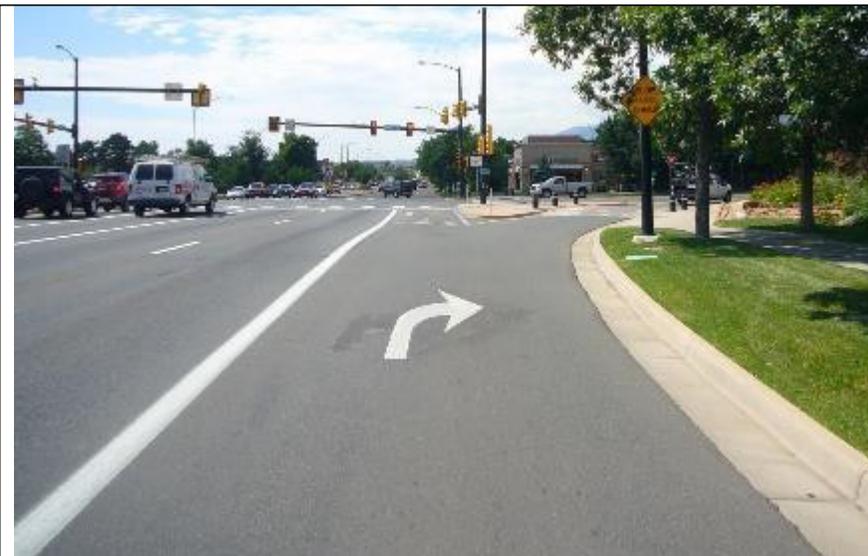
Figure 12-66: Closer view of crosswalk

- a) Right turn arrow.
- b) Lane continues straight with bus only markings.
- c) SLOW RAISED CROSSWALK sign.
- d) Yield sign at crosswalk.
- e) Bollards on each side of crosswalk on curb and island.

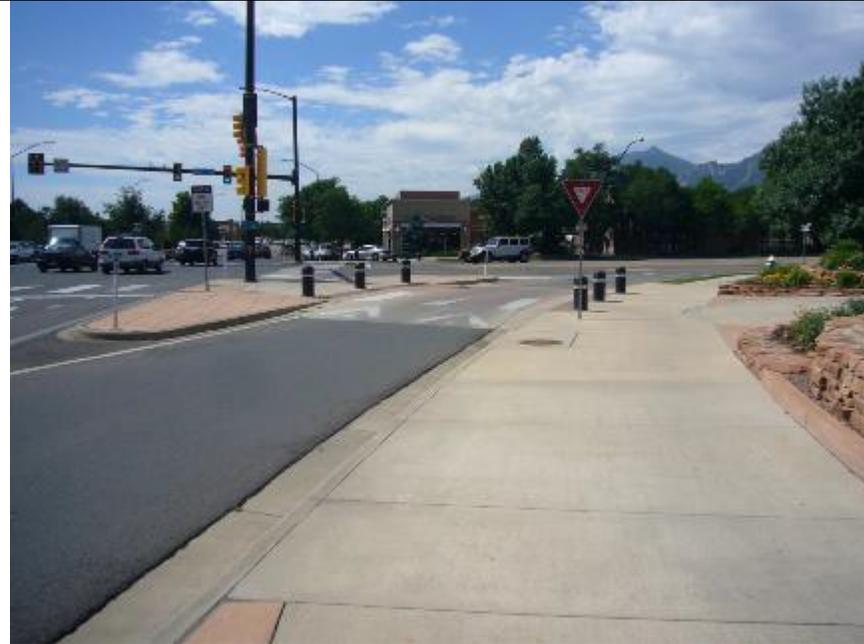
**Figure 12-67: Pedestrian approach to crosswalk**

- a) Wide sidewalk.
- b) Sidewalk at back of curb.
- c) Yield sign just before crosswalk.
- d) Raised crosswalk.
- e) Bollards at each side of crosswalk and in middle of crosswalk area.
- f) Entrance to buildings at right.

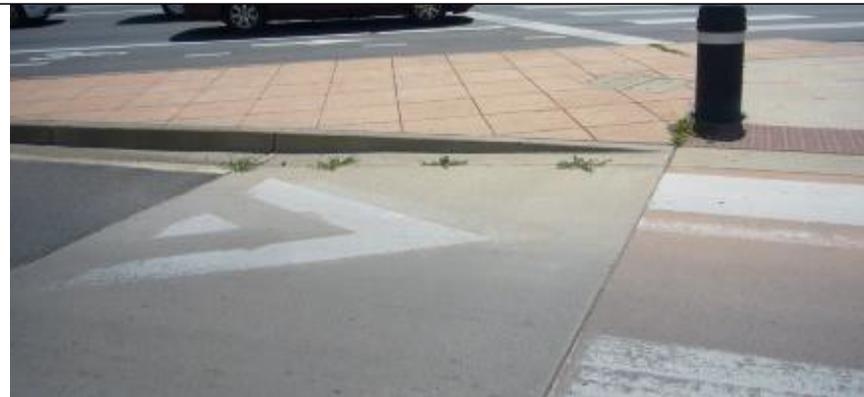
**Figure 12-68: Photo showing slope, for vehicles, of raised crosswalk.**

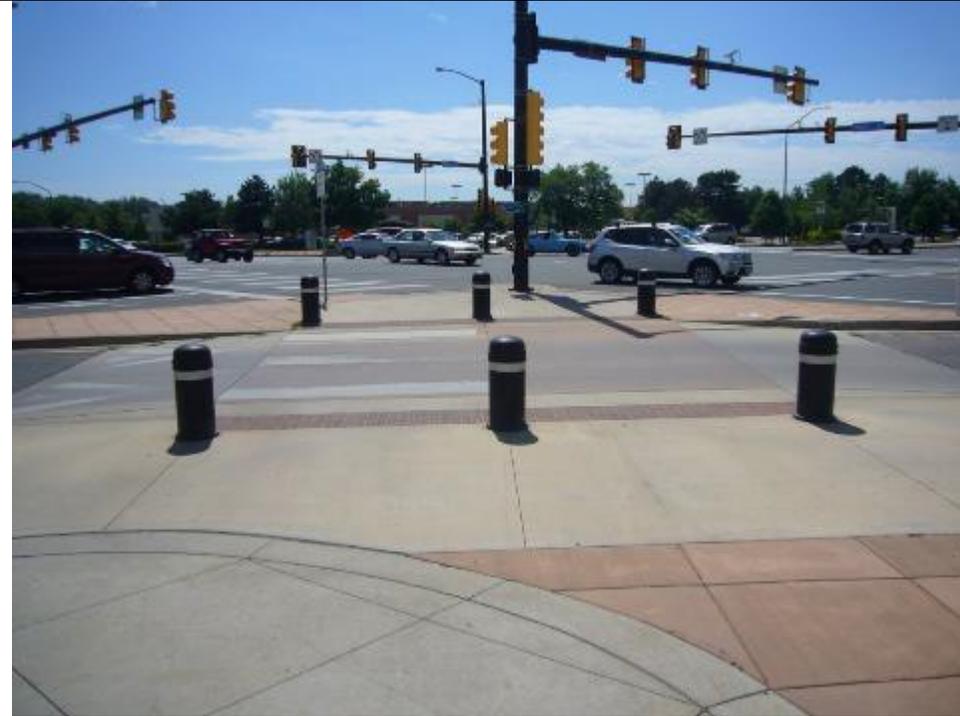
**Figure 12-69: View across crosswalk and island**

- a) Wide crosswalk.**
- b) Somewhat faded markings.**
- c) Detectable warnings on both ends of crosswalk.**
- d) Bollards at each side and in center of crosswalk area.**
- e) Relatively large island, all paved with curb ramps to signalized sections of crossing.**
- f) Two pushbutton on one pole on island.**

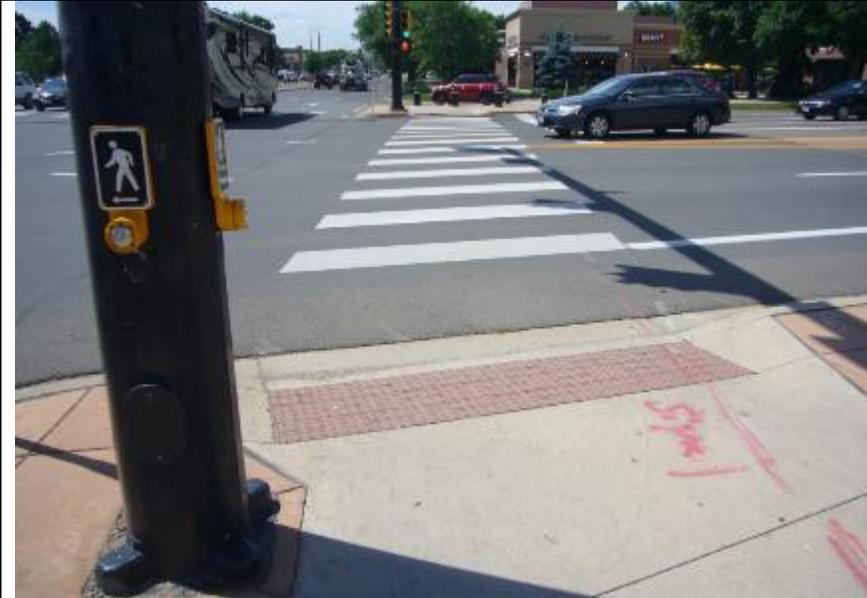
**Figure 12-70: Crosswalk across Pearl Street on west side**

- a) Pushbuttons beside curb ramp (no level landing).**
- b) Detectable warning, gutter and slope of ramp aim left of crosswalk.**

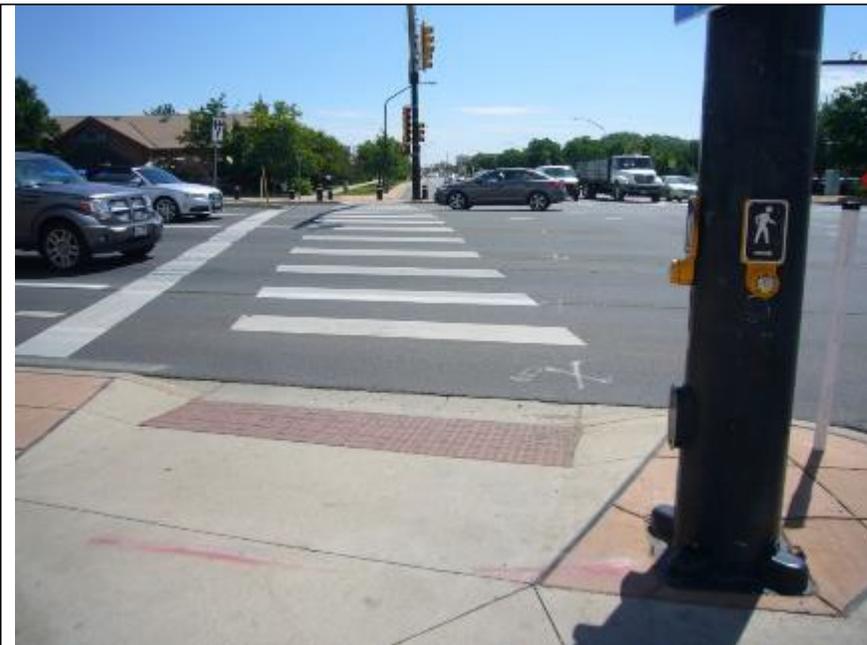
**Figure 12-71: Crosswalk across 28th Street**

- a) Pushbutton on left, street side, of ramp.**
- b) Face of button aligned with crosswalk directions.**
- c) Detectable warning, ramp slope, and gutter all aligned to right of crosswalk direction.**

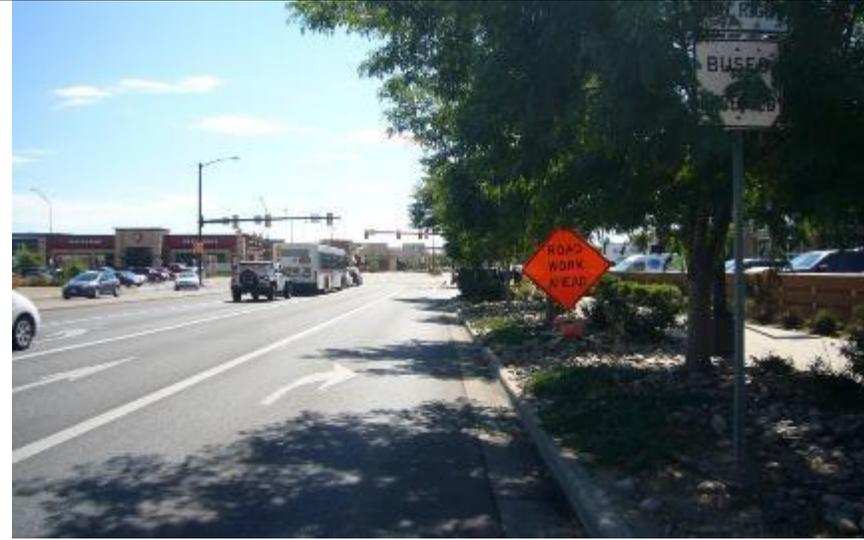
**Figure 12-72: Driver's view of approach to crosswalk**

- a) Deceleration lane.
- b) **RIGHT LANE MUST TURN RIGHT, BUSES EXCEPTED** on sign hidden by trees.
- c) Right turn arrow pavement markings.

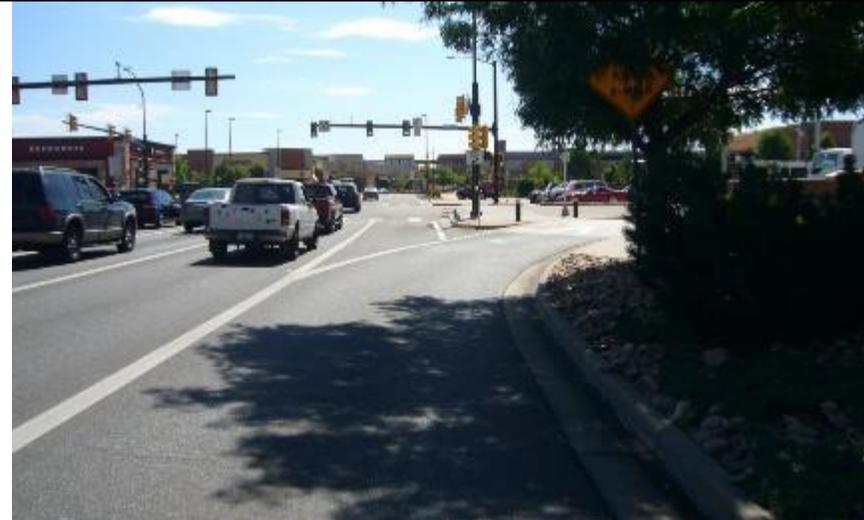
**Figure 12-73: Driver's view of crosswalk when approaching**

- a) Raised crosswalk markings.
- b) Raised crosswalk warning sign, obscured by trees.
- c) Pedestrian waiting on curb side hidden by bushes, with restricted line of sight.

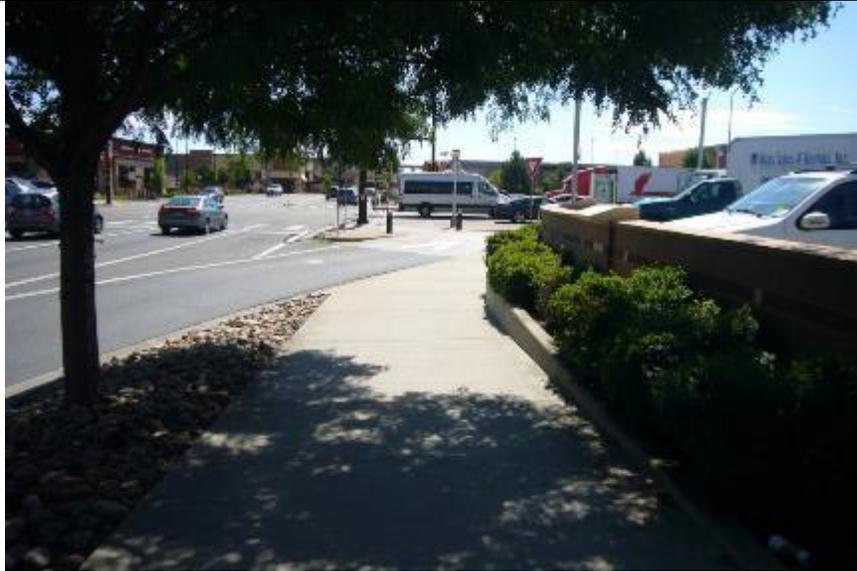
**Figure 12-74: Pedestrian approach to crosswalk along Pearl**

- a) Wide sidewalk.
- b) Shaded by trees.
- c) Landscaping and wall on side away from street.
- d) Landscaping on street side until about 25 feet before crosswalk, then sidewalk at back of curb.

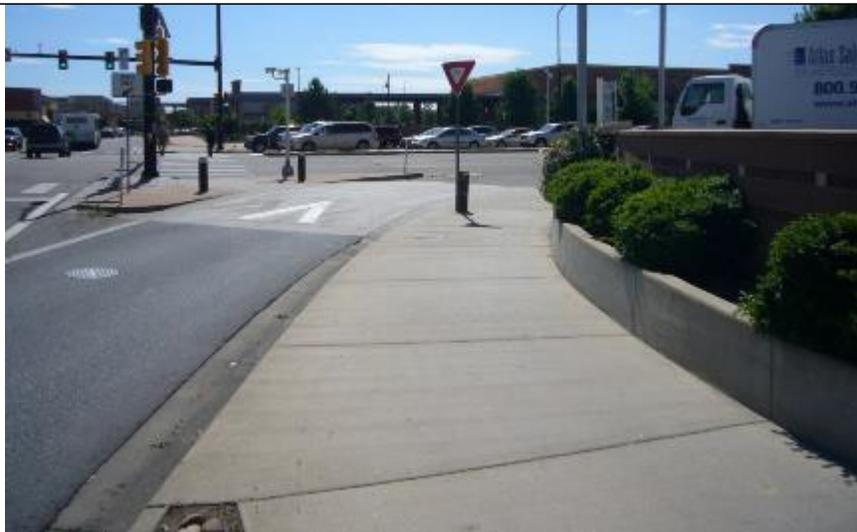
**Figure 12-75: Pedestrian and driver view from close to crosswalk**

- a) Yield sign just before crosswalk on curb side.
- b) Bollards at each edge of raised crosswalk.
- c) Concrete raised crosswalk.

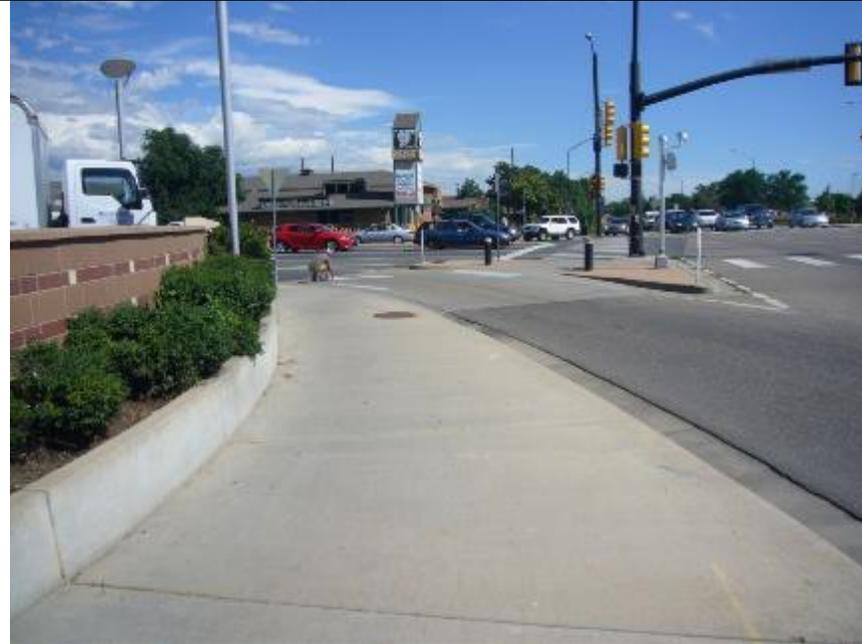
**Figure 12-76: View of crosswalk from downstream end of CTL**

**a) Wide sidewalk at back of curb.**

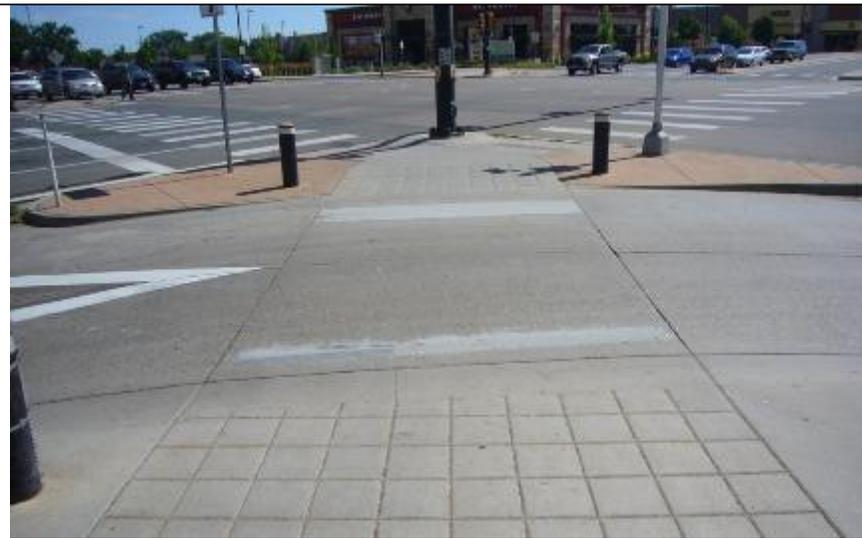
**Figure 12-77: Pedestrian view across crosswalk and island**

- a) Scoring on sidewalk at raised crosswalk.**
- b) No detectable warning at edge of street.**
- c) Worn, almost non-existent crosswalk markings.**
- d) Flat paved island, with curb ramps to each signalized crossing.**
- e) Bollards on each side of raised crosswalk.**

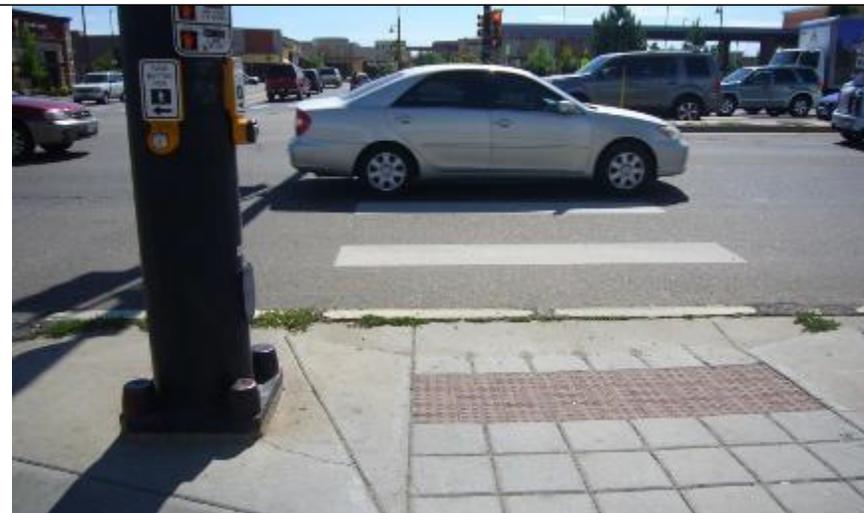
**Figure 12-78: Crosswalk across 28th Street**

- a) Island all paved.
- b) Perpendicular curb ramp.
- c) Two pushbuttons on pole near crosswalk (no level landing).
- d) Detectable warning at base of curb ramp.
- e) Marked crosswalk.

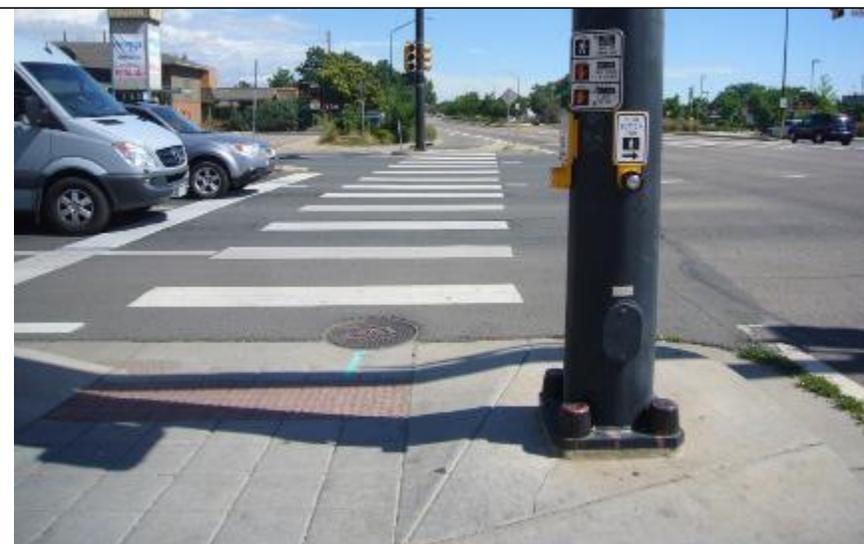
**Figure 12-79: Crosswalk across Canyon Boulevard**

- a) Curb ramp aligned slightly left of crosswalk direction.
- b) Marked crosswalk.
- c) Pedestrian pushbutton on pole.
- d) Detectable warning at base of curb ramp.

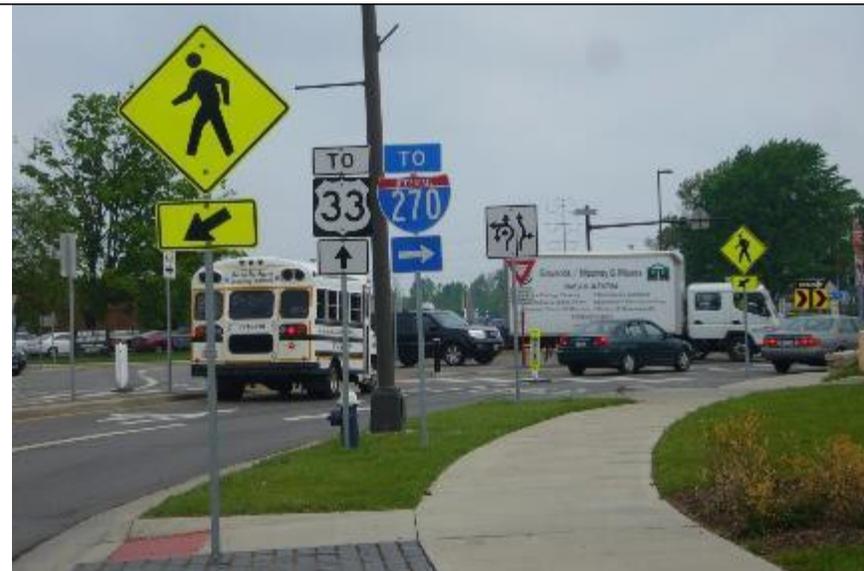
**Figure 12-81: Signs on approach from south**

Extensive signage between the two closely spaced roundabouts. Highway guide signs, followed by lane control sign, then almost immediately followed by the pedestrian crosswalk on the south side of roundabout.

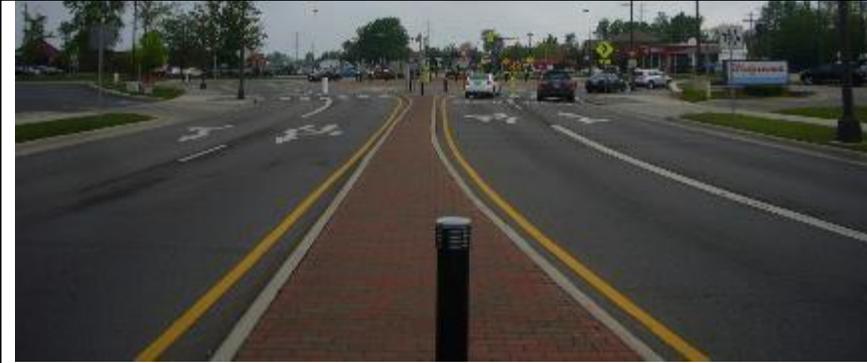
**Figure 12-82: View of roundabout from south median, at north pedestrian crosswalk for Scioto Darby Road roundabout**

Lane control pavement markings and sign are shown here.

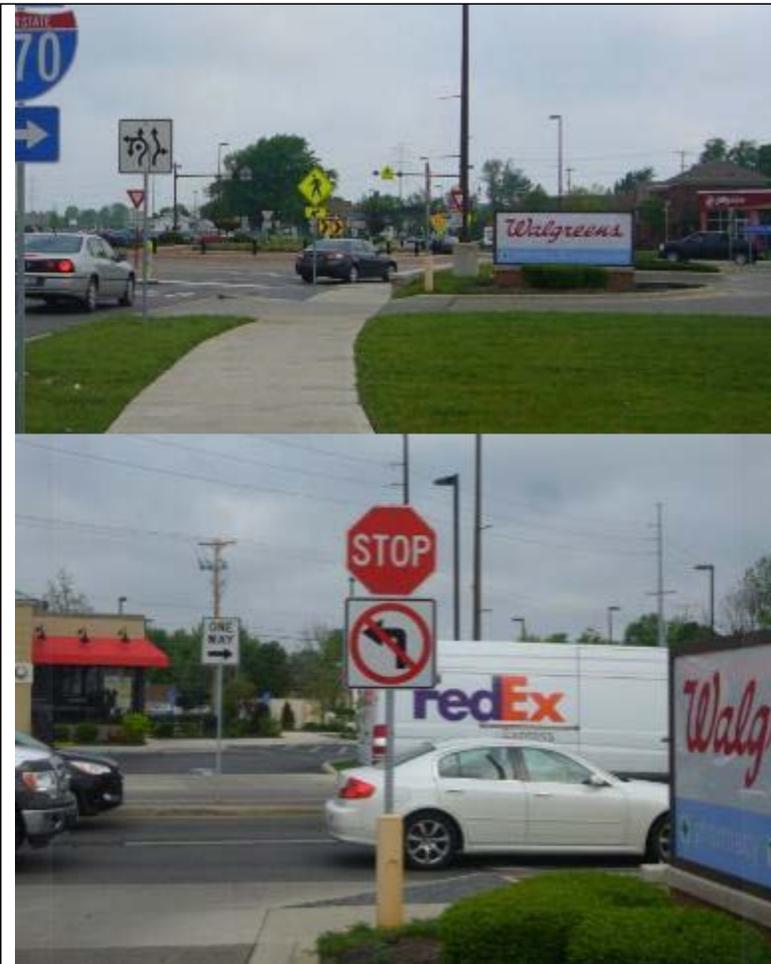
**Figure 12-83: Driveways close to roundabout**

On all approaches, there were driveways quite close to the roundabout, just beyond the pedestrian crosswalk. Exits from driveways had stop signs and no left turn signs, as well as one way signs on the median, as shown in photo on right.

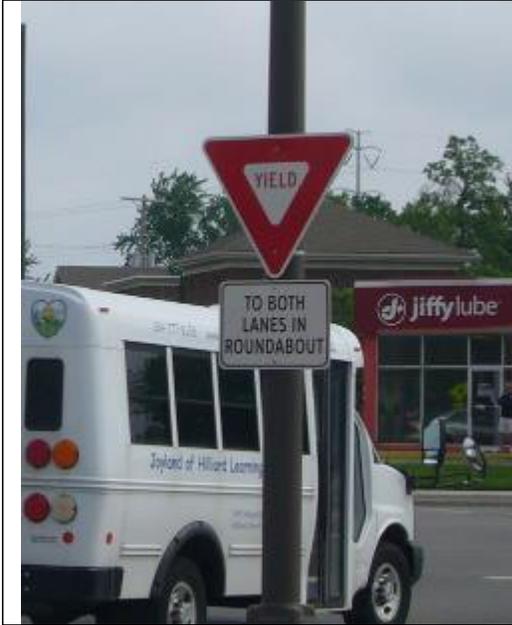
**Figure 12-84: TO BOTH LANES IN ROUNDABOUT plaque added below YIELD sign on all approaches.**

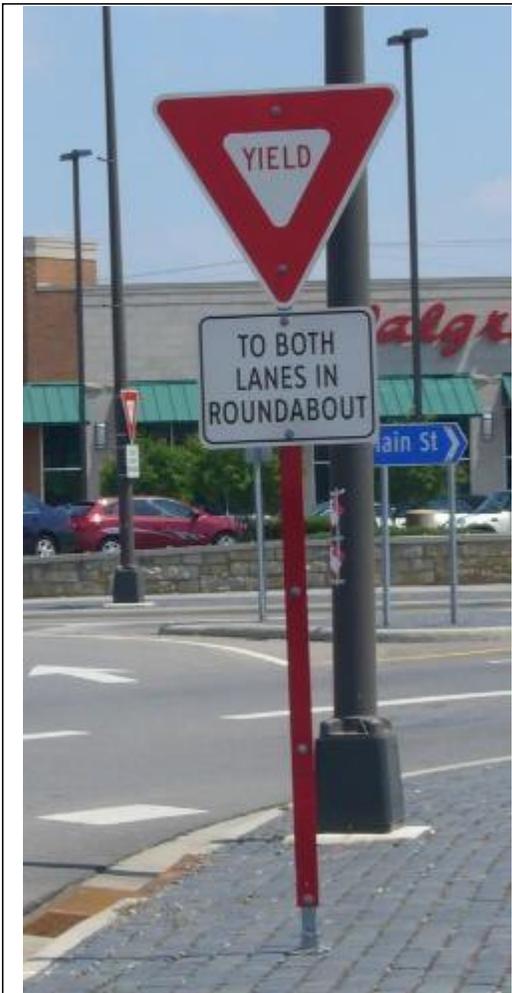
**Figure 12-85: Red reflective sheeting was added on posts of some YIELD signs.**

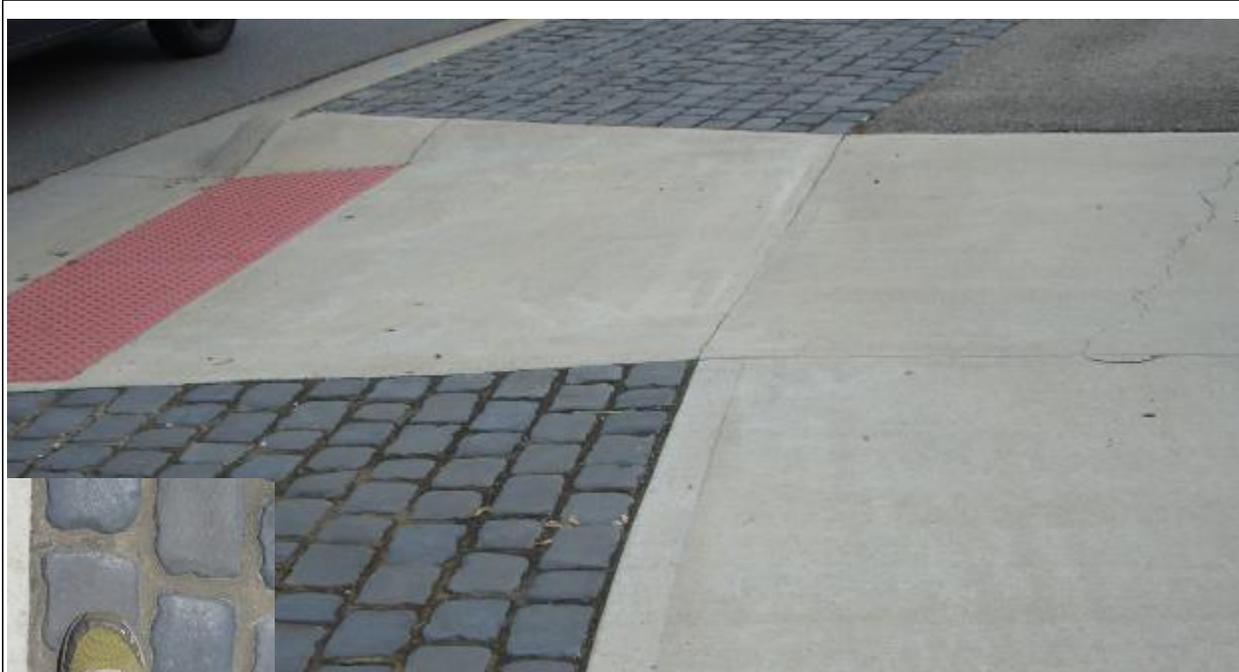
**Figure 12-86: Rough "cobblestone" surface used to separate sidewalk and roadway**

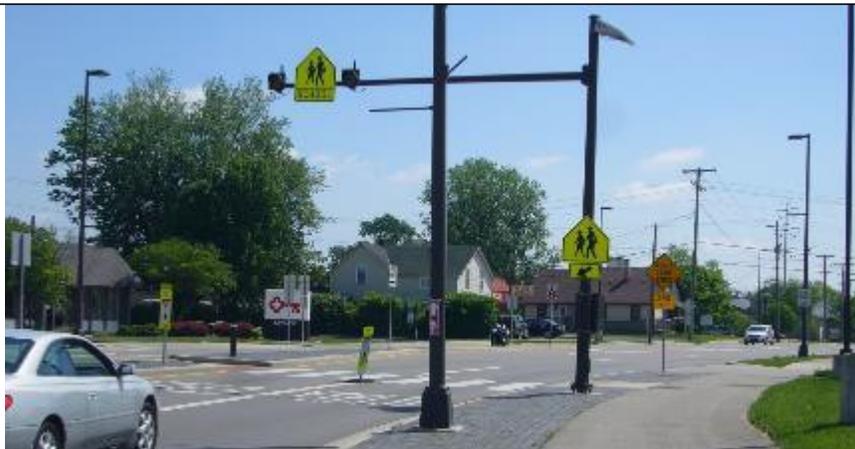
**Figure 12-87: Overhead school crossing flashers**

Overhead school crossing flashers installed on north and east crosswalks. Flash from 7:00 – 7:40 am and 2:10 – 2:52 pm, Monday – Friday during school days for school arrival and departure. They do not operate in the summer months.

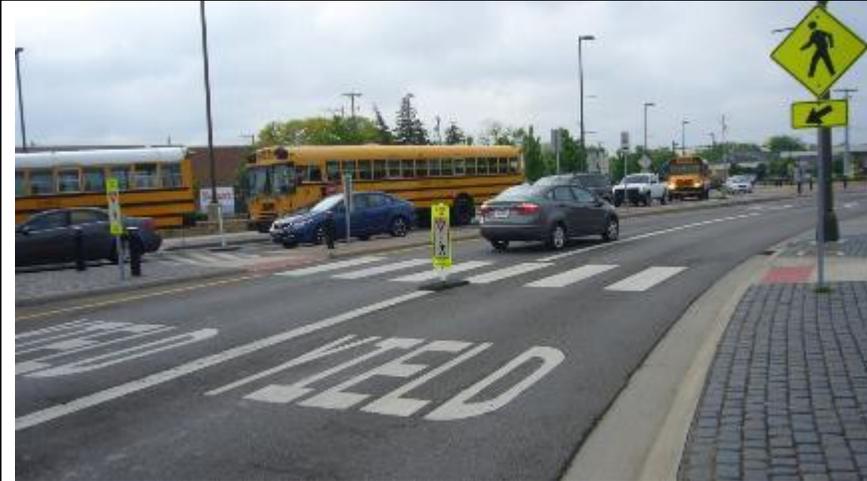
Figure 12-88: Yield signs and markings at crosswalk

- a) Crosswalks were marked with continental style markings.
- b) Had yield pavement markings before the crosswalk, and pedestrian crossing warning signs on curb side (W11-2 with a diagonal downward pointing arrow, W16-7P plaque).
- c) In addition, there were in-crosswalk STATE LAW YIELD TO PEDESTRIANS IN CROSSWALK signs (R1-6), which were also installed on posts on the splitter islands.

Signs varied from crosswalk to crosswalk; pavement word markings YIELD were installed on all approaches; School crossing signs (rather than pedestrian crossing signs) were used at the east and north crosswalks, accompanied by overhead mounted flashers. Pedestrian crossing warning signs were used on the west and south crosswalks. All crosswalks had the in-crosswalk signs on the center lane line and post-mounted on the splitter.

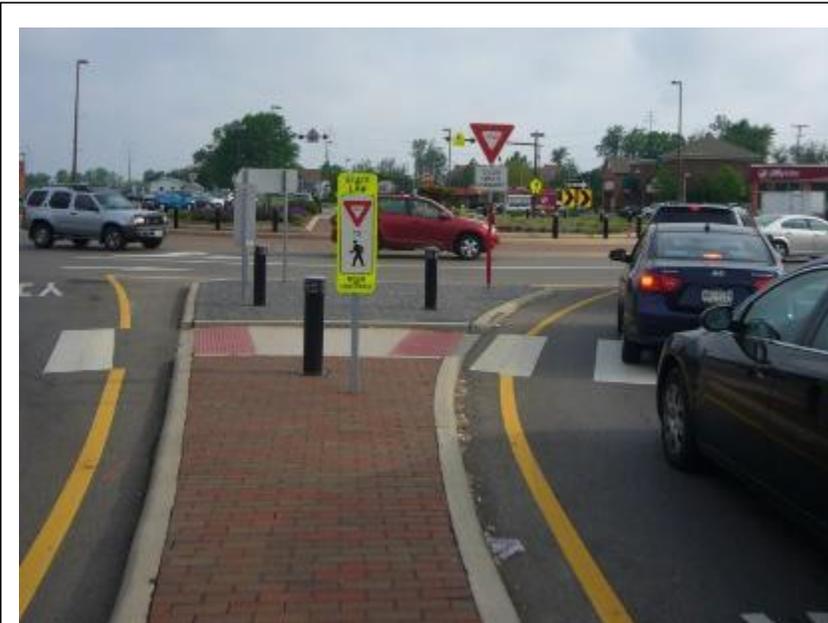
Figure 12-89: R1-6 used as post mounted signs on splitter islands

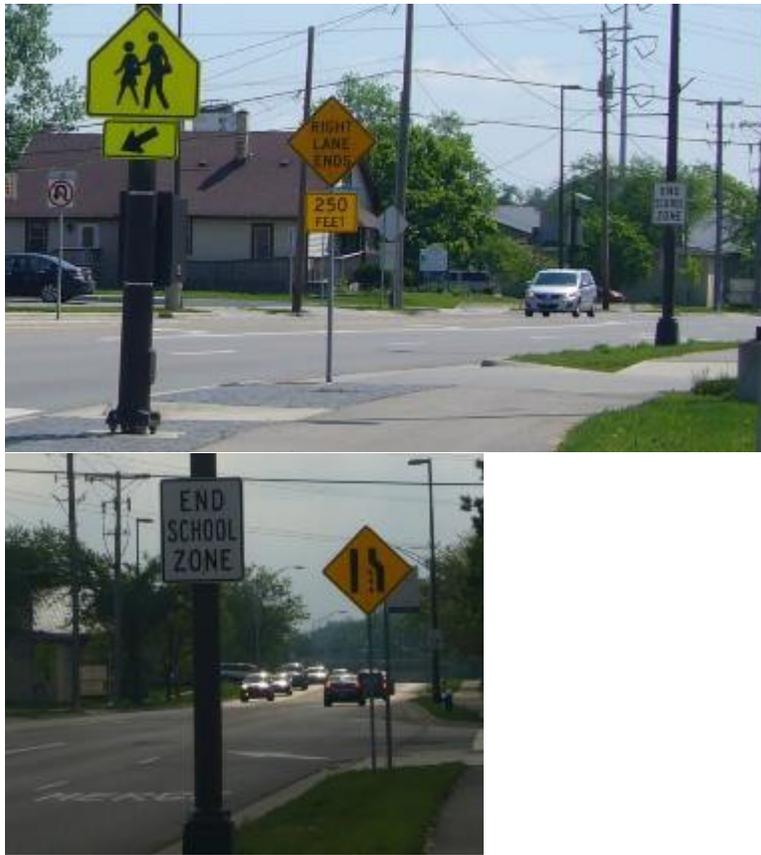
**Figure 12-90: Lane drop just past roundabout**

There was a lane drop on east, and north exits of the roundabout. Sign, **RIGHT LANE ENDS (W9-1)**, just beyond crosswalks followed by **END SCHOOL ZONE** and **LANE ENDS (W4-2)** sign and pavement markings.

Lots of signs right near crosswalk.

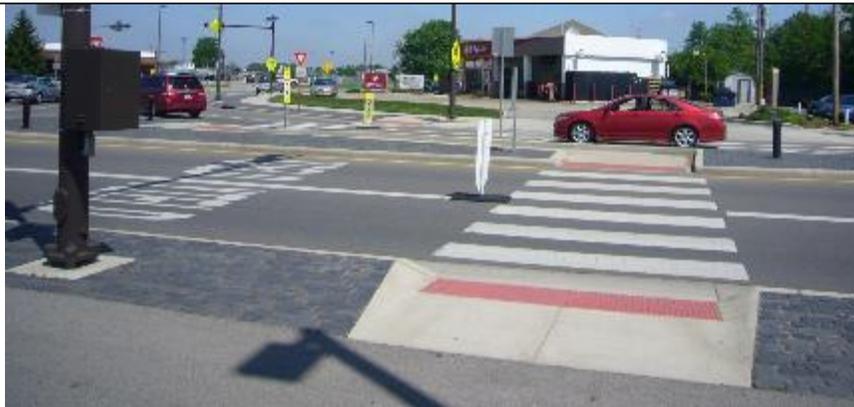
**Figure 12-91: Crosswalk for exit set back from circulatory roadway (east crosswalk)**

Crosswalk for exit is further from circulatory roadway than the entry crosswalk with zig-zag cut-through median. Is it better for pedestrians? Higher speeds at crosswalk?

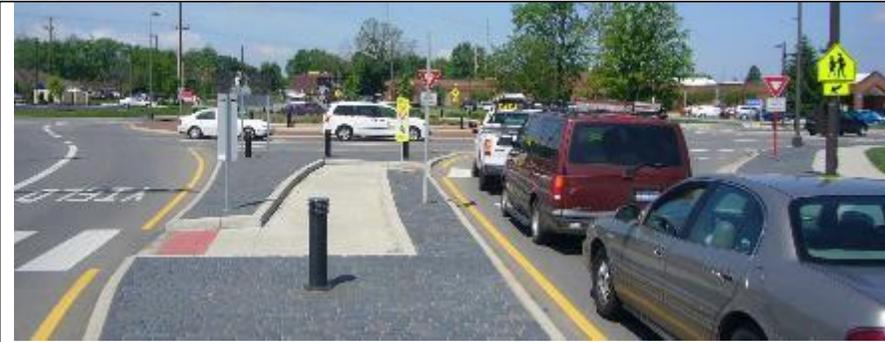
**Figure 12-92: Zig-zag cut-through of island**

Island cut-through with zig-zag to guide to offset exit and entry crosswalks; detectable warnings at edge of streets, cut-through curbs aligned with direction of crosswalk; cut-through area is smooth concrete; rest of island is the dark cobblestone pavers; small solar-powered lights on splitter near crosswalk cut-through.

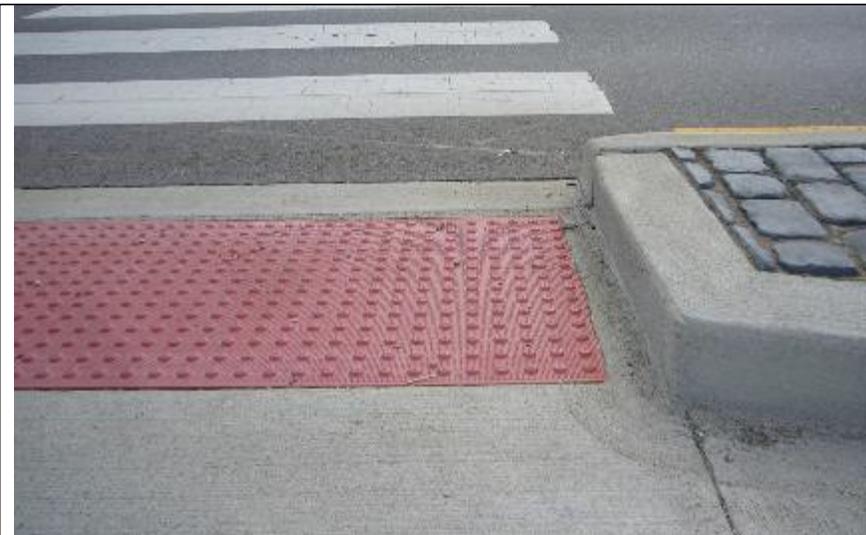
**Figure 12-93: Island cut-through edge is aligned with crosswalk (photo at north crosswalk)**

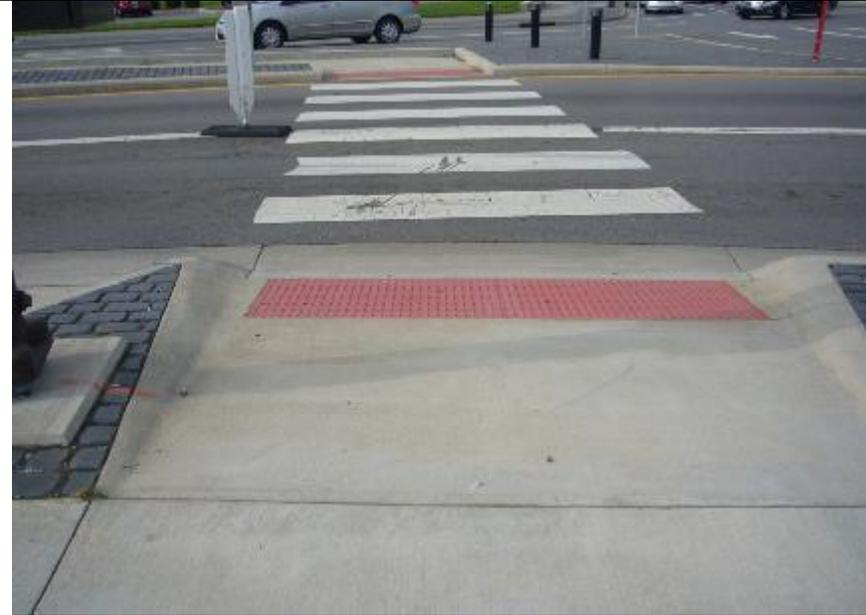
**Figure 12-94: Ramp is generally aligned with crosswalk**

**(east crosswalk)**

**a) Slightly angled right due to rbt curvature at entry.**

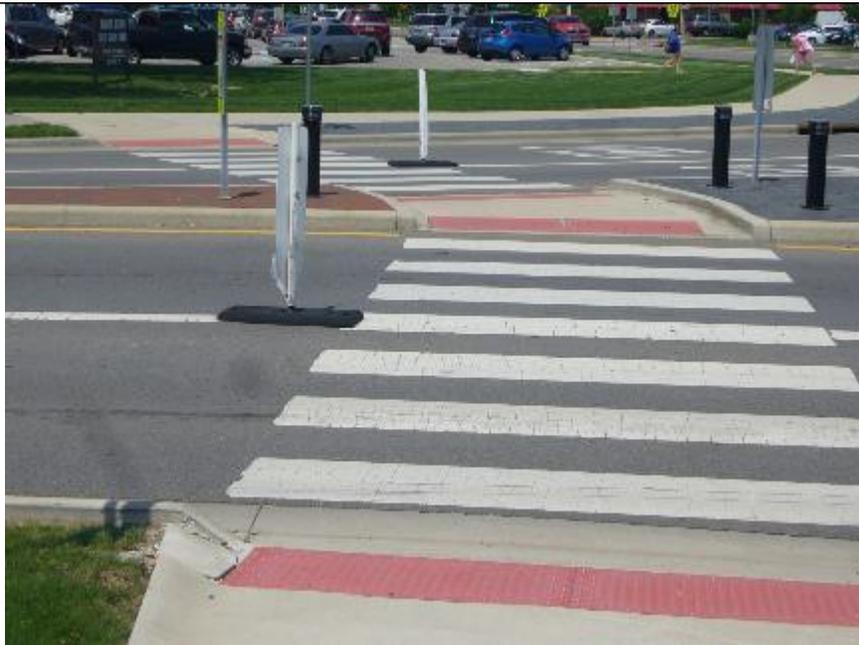
**Figure 12-95: Narrow splitter islands on west and south approaches**

**Island on west and south legs were much narrower than north and east legs. Island was cut-through with detectable warnings installed. Curbs on island cut-through were generally aligned with the crosswalks.**

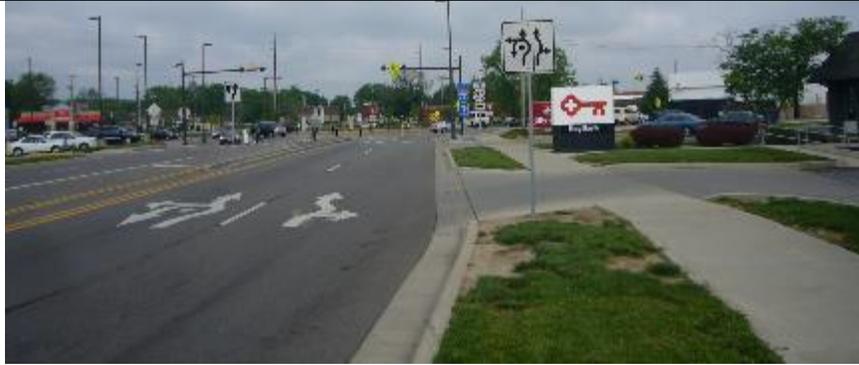
Figure 12-96: View of roundabout when approaching from east

Roundabout sign, GMI signs, overhead flashers, pavement markings, etc.

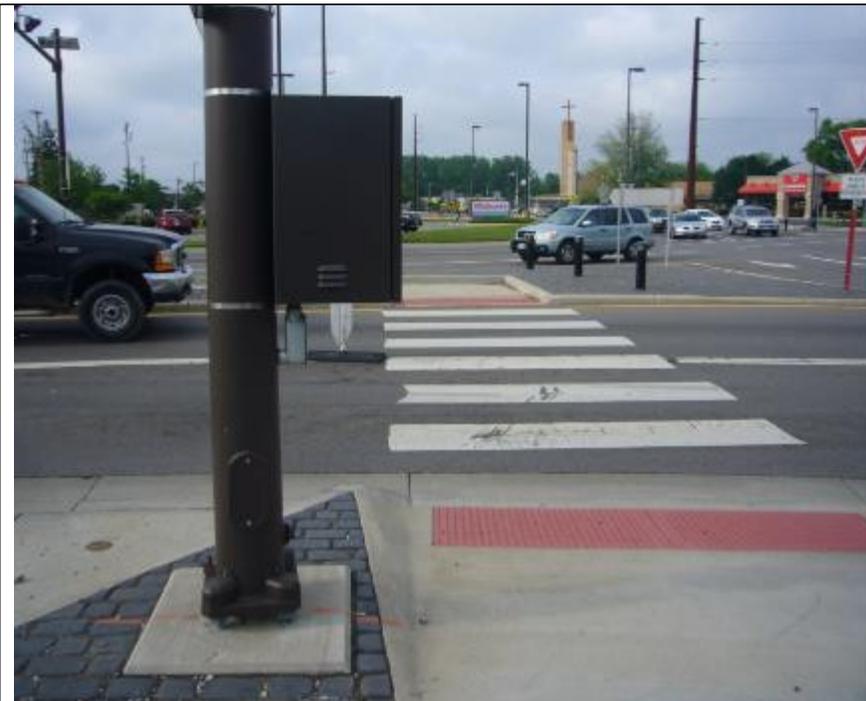
**Figure 12-100: Control box extended into crosswalk approach area at head height for pedestrians who are blind.**

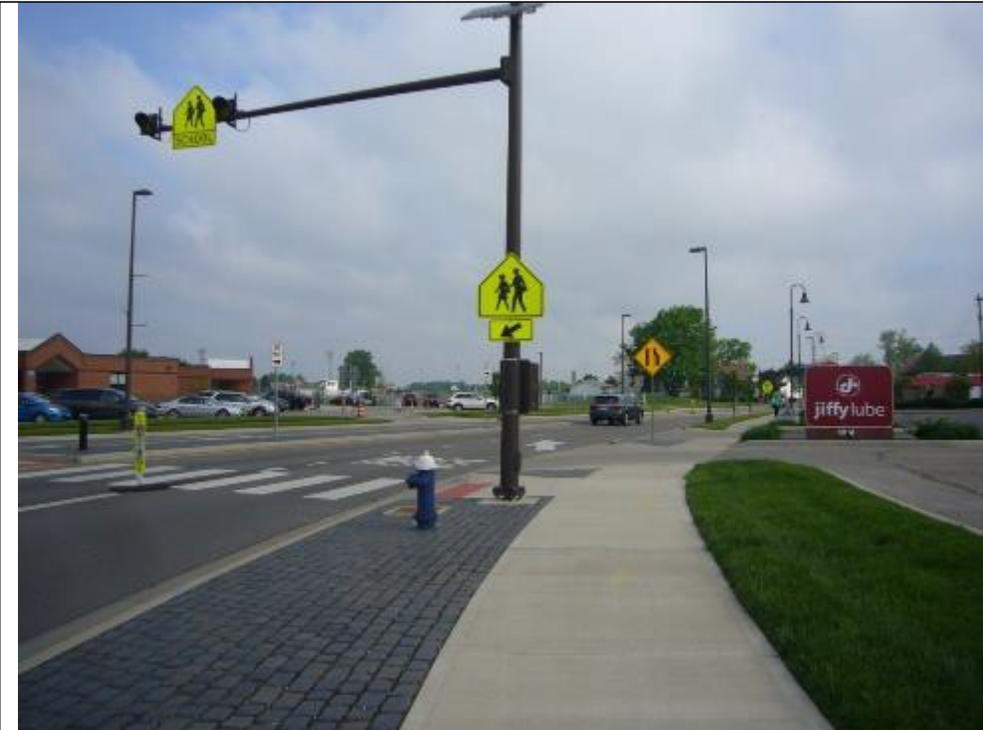
**Figure 12-101: North crosswalk exit lane crossing**

North crosswalk also has pedestrian flashers, school crossing sign, and a lane drop shortly beyond the crosswalk (no LANE ENDS sign here).

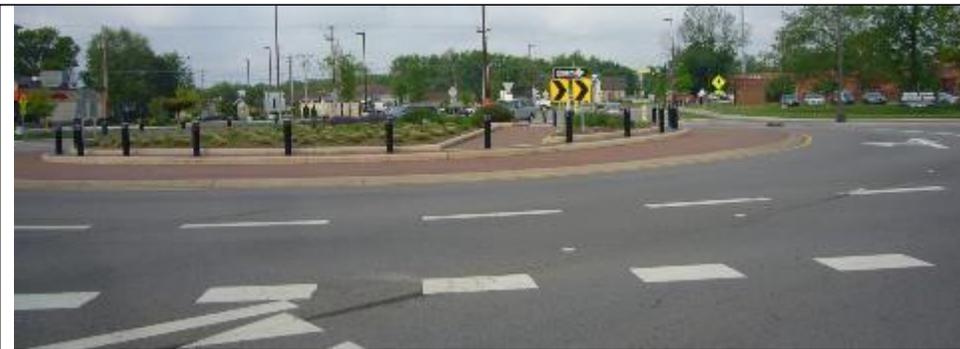
**Figure 12-102: Island decorative elements**

A rather unusual planting arrangement has a section that almost looks like a sidewalk. This is just an architectural element rather than a sidewalk; may also be used by maintenance crews.

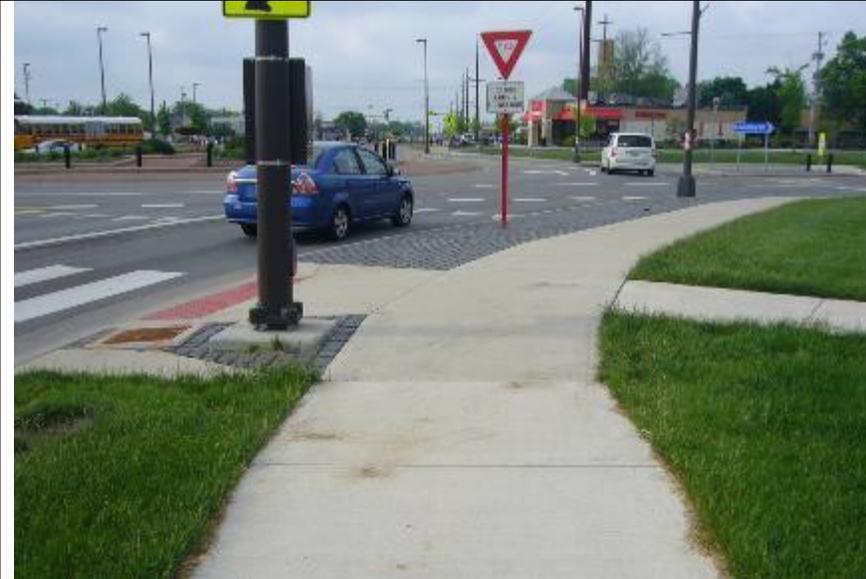
**Figure 12-103: Sidewalk dip near crosswalk was confusing to some blind participants**

The sidewalk sloped down and back up relatively steeply, just north of the crosswalk (north crosswalk, west end), which some blind participants mistook for a ramp to the crossing. More than one lined up, in line with the sidewalk, at the bottom of the dip and thought they were at the street edge. Under foot and with a cane, it seemed like the gutter at the edge of the street; it may be that the dip was related to water flow; not sure why it was there.

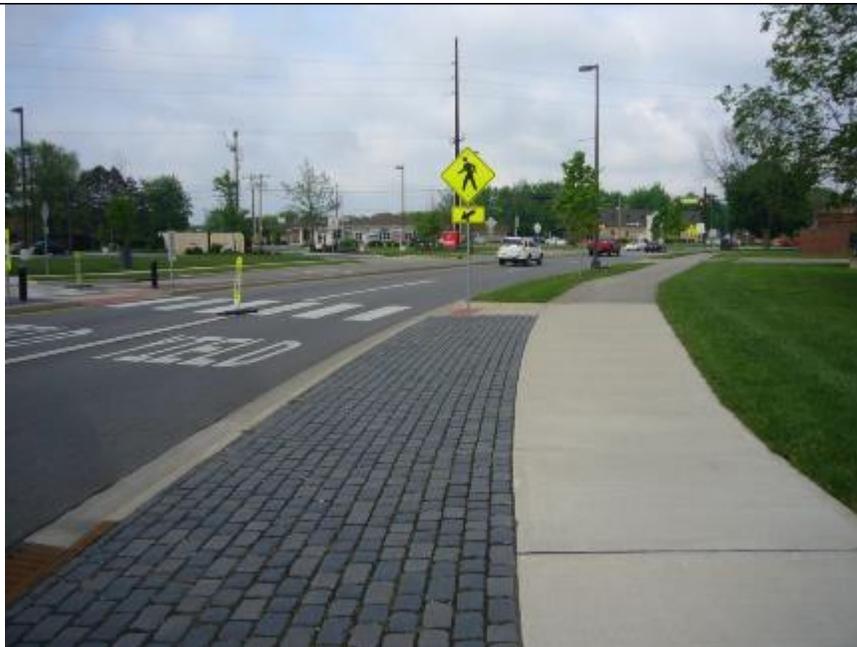
**Figure 12-106: West crosswalk**

**a) Pedestrian crossing warning sign.**

**b) In-crosswalk sign.**

**c) Lane drop is around curve, but most drivers stay in left lane (probably because of lane drop).**

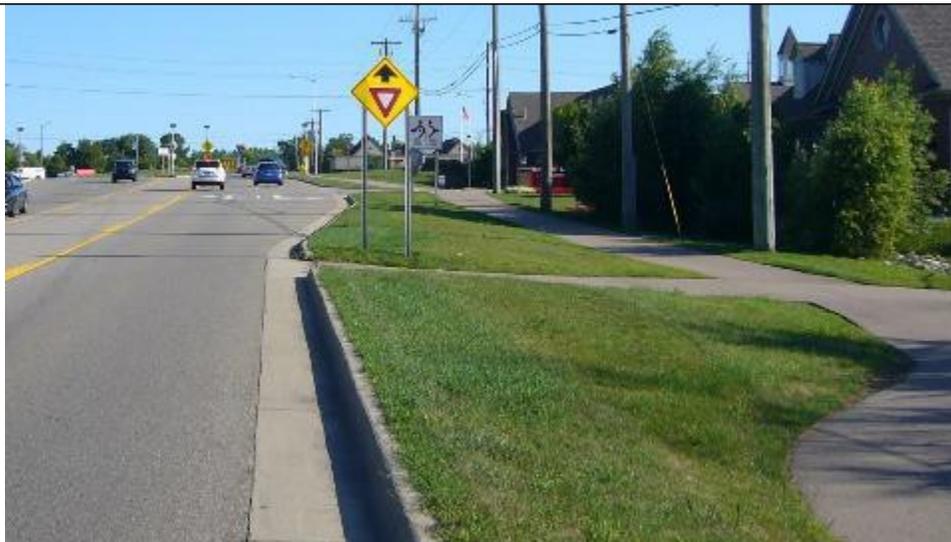
**Figure 12-110: Driver's view on approach**

- a) Yield ahead sign
- b) Road widens to two lanes
- c) Pavement markings and sign with lane assignments
- d) Pedestrian warning signs and RRFB's at crosswalk (barely visible in this picture).
- e) NO sign regarding raised crossing or speed hump.

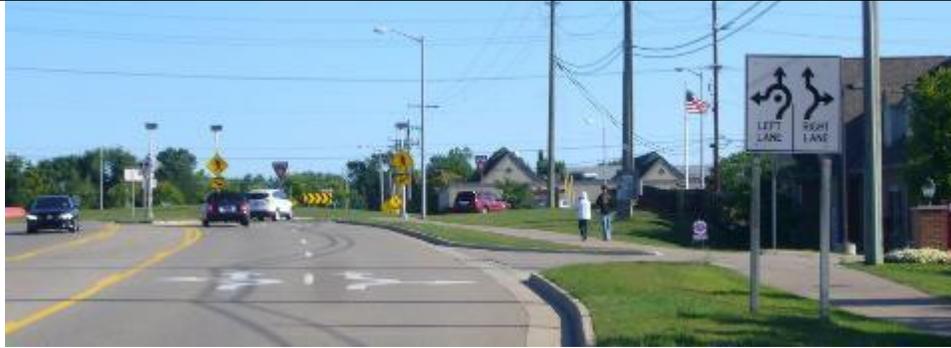
**Figure 12-111: Driver's view - closer to crosswalk.**

- a) Lane control assignment pavement markings and sign.
- b) Pedestrian warning sign and RRFBs.
- c) White triangular markings on edge of raised crosswalk visible (only notice of presence of raised crosswalk).
- d) NOTE: Raised crosswalks only on south leg entry, east leg entry and exit, and north leg exit; drivers entering from west didn't encounter raised crosswalk until/unless they exited on east or north leg.
