## Guidelines for the Application of Crossing Solutions at Roundabouts and Channelized Turn Lanes for Pedestrians with Vision Disabilities

Bastian Schroeder, Lee Rodegerdts, Pete Jenior, Edward Myers, Christopher Cunningham, Katy Salamati, Sarah Searcy, Sarah O'Brien, Janet Barlow, and Billie Louise (Beezy) Bentzen; National Cooperative Highway Research Program; Transportation Research Board; National Academies of Sciences, Engineering, and Medicine

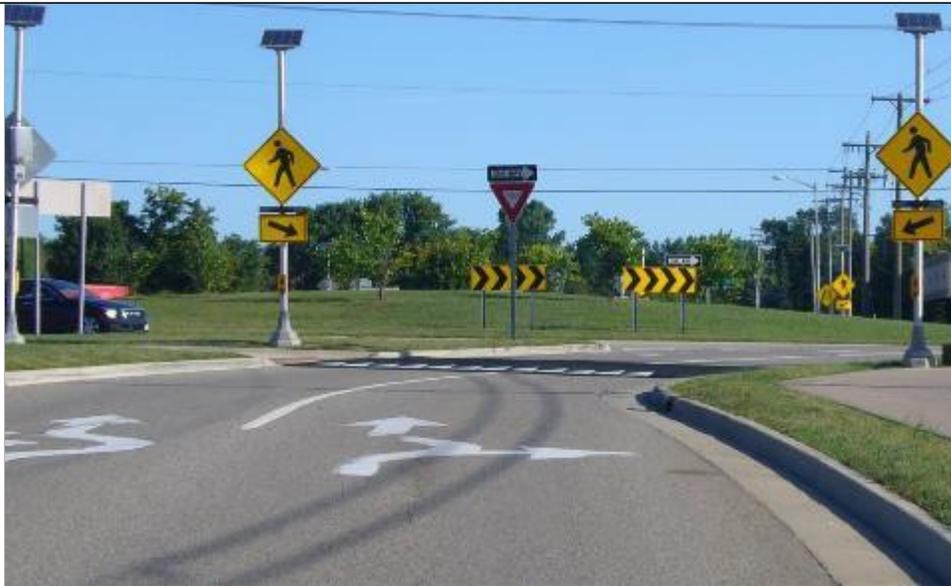
**Figure 12-112: Driver's view of raised crosswalk from 100 feet back**

- a) Additional lane assignment markings, just before crosswalk.
- b) Temporary raised crosswalk.
- c) RRFBs at crosswalk.
- d) Yield sign at entry, with one way placard on top.
- e) Yellow and black chevrons on island.

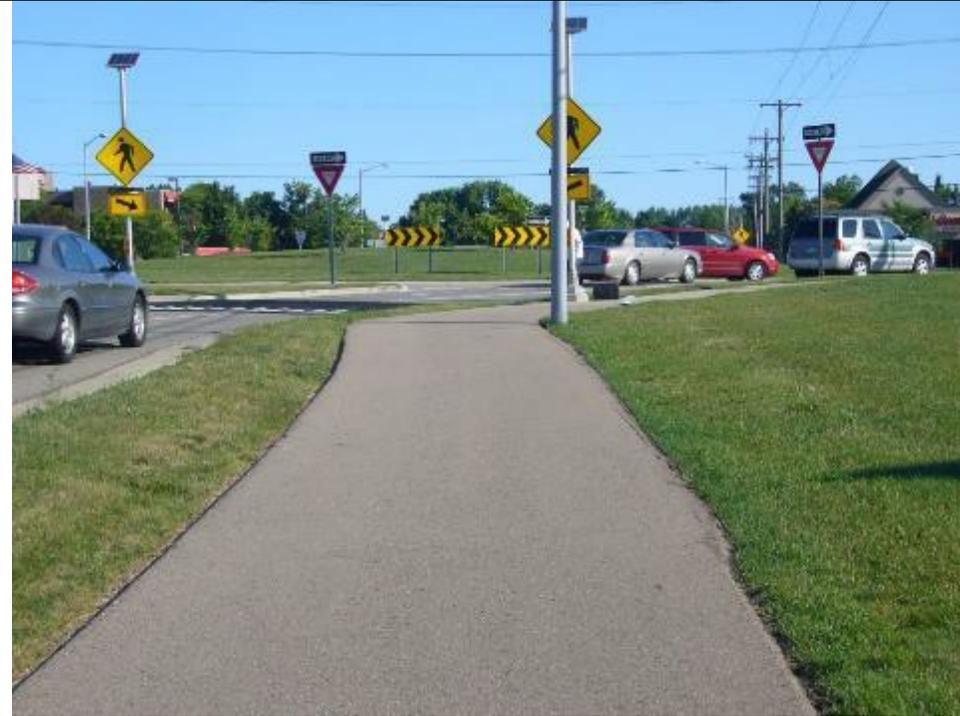
**Figure 12-113: Pedestrian view of approach**

- a) Grass landscaping on both sides of sidewalk/path at all locations around roundabout except at crosswalks.
- b) RRFBs and pedestrian warning signs at crosswalk.

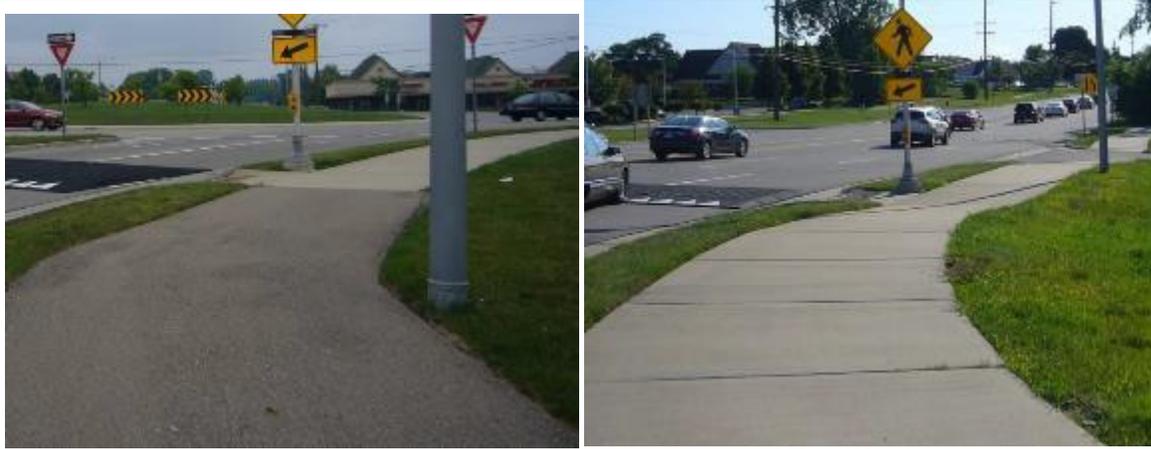
**Figure 12-115: Different ramp configurations**

**Photo on left: south crosswalk, entry lanes:**

**Photo on right: east crosswalk, exit lane side:**

- a) Parallel combo ramp.
- b) Sidewalk slopes down to level landing at crosswalk location.
- c) Small slope down to street level at detectable warning.
- d) Raised crosswalk installed.

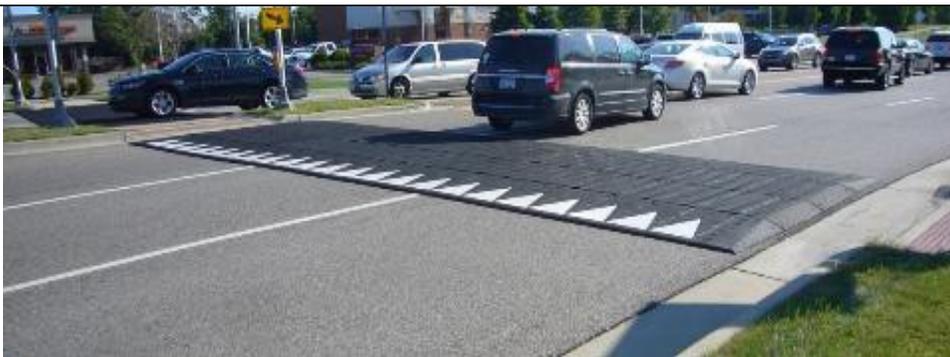
**Figure 12-116: View of temporary speed humps installed as raised crosswalks**

- a) Triangular marking on edge of speed hump.
  - b) No crosswalk markings.
  - c) Rubber material.
  - d) Raised approximately 3 to 4 inches for vehicles.
  - e) Steep slope up from gutter for pedestrians is not ADA compliant.
- (NOTE: this was installed temporarily for research.)

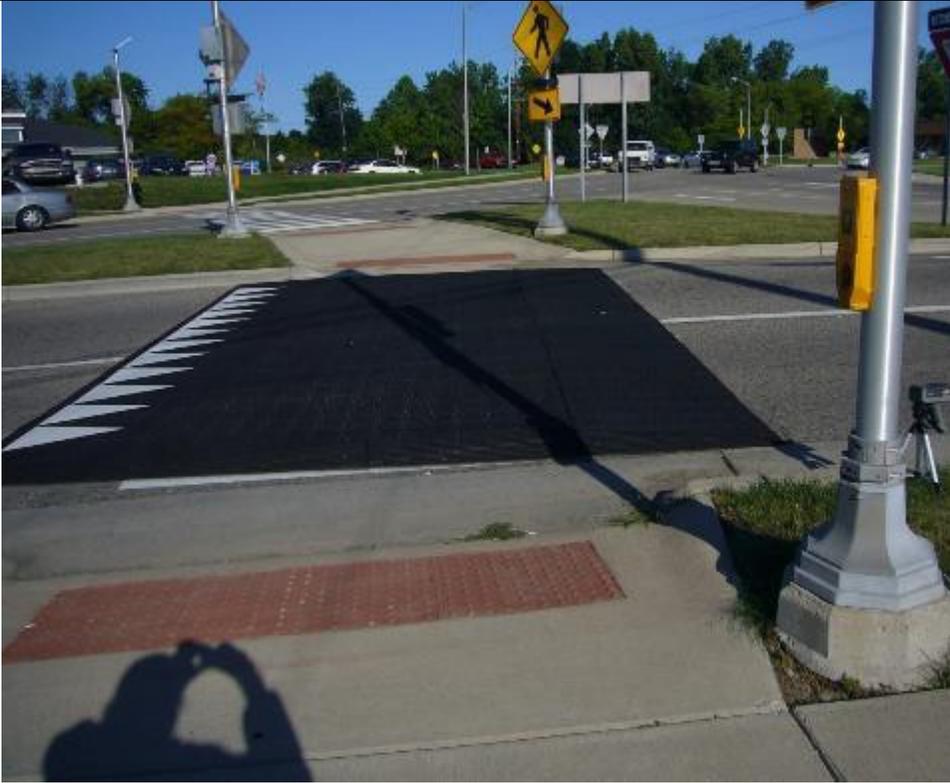
**Figure 12-117: Pedestrian view of crosswalk: south crosswalk**

- a) Detectable warning at edge of street.**
- b) Ramp slope and DW line up slightly to left of direction of travel on the crosswalk.**
- c) Pushbutton on pole next to crosswalk.**
- d) RRFBs installed with crosswalk warning device (or audible information device) on pole with pushbutton locator tone and speech message, “The yellow lights are flashing” when button is pressed.**
- e) RRFBs flash for approximately 20 seconds.**
- f) Temporary speed hump material installed as raised crosswalk on entry lanes only.**

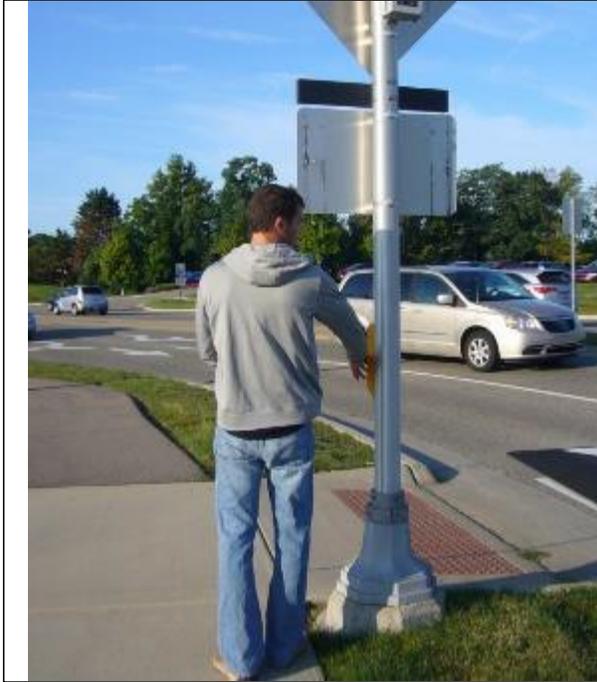
**Figure 12-118: RRFB mounted too low**

RRFBs were mounted so the lower edge of the arrow sign was at head height for a 6-foot-tall person. One of the blind participants almost hit his head while reaching for the pushbutton. Signs and RRFB need to be raised so the bottom edge is above 7 feet.

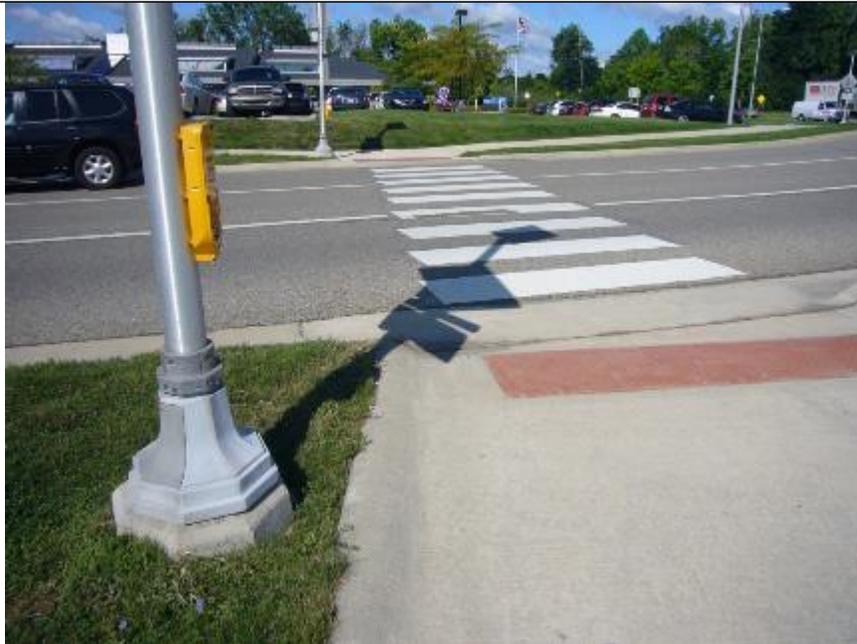
**Figure 12-119: Island, lining up to cross exit lanes; south crosswalk.**

- a) Gutter aligned perpendicular to crosswalk.
- b) Cut-through concrete not aligned with crosswalk direction.
- c) DW not in line with crosswalk.
- d) RRFB and pushbutton on downstream side, more than 5 feet back from curb.

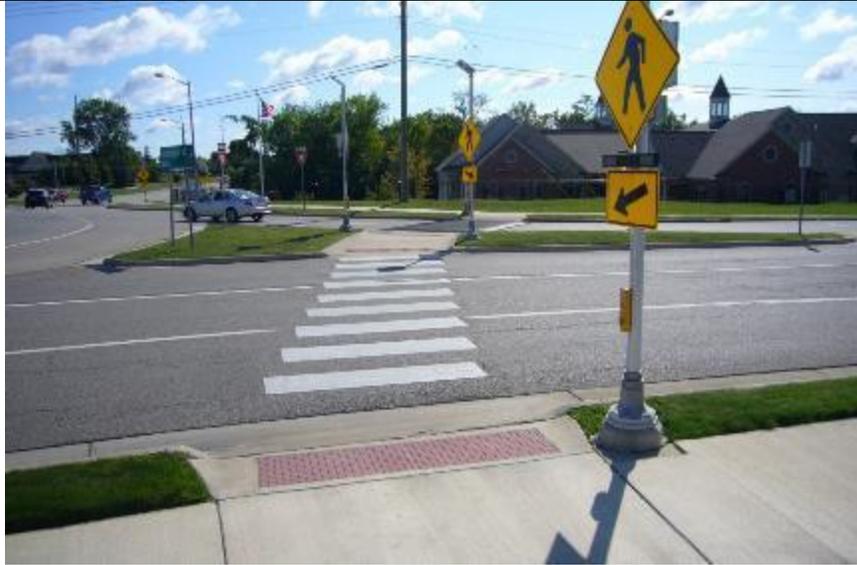
**Figure 12-120: South crosswalk exit lane; used for wayfinding trials**

- a) Ramp, DW and gutter aligned to left of crosswalk direction.
- b) No raised crosswalk.
- c) Three-lane crossing.

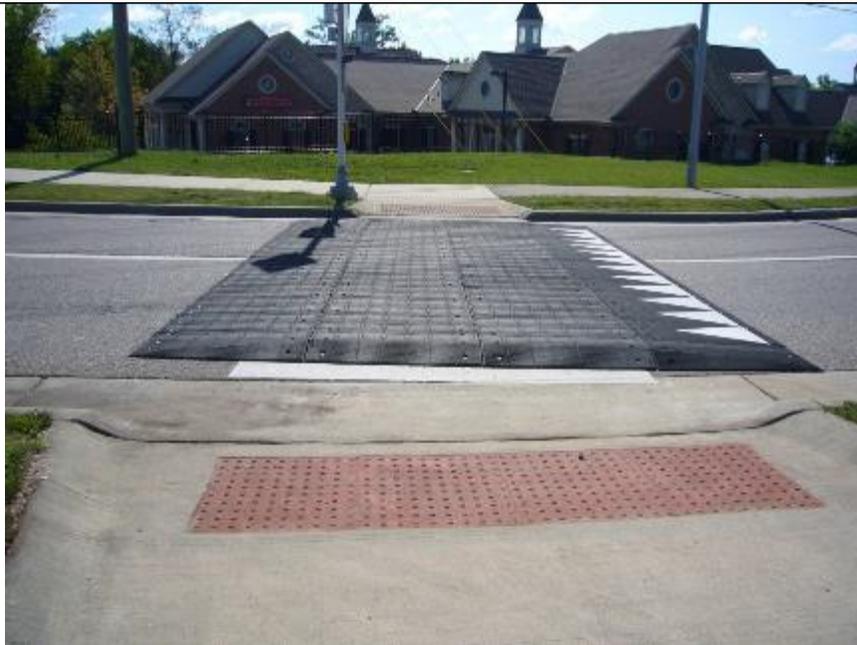
**Figure 12-121: Island, alignment of crossing for entry lanes, south crosswalk**

- a) DW and gutter aligned to left of crosswalk direction.
- b) Raised crosswalk.

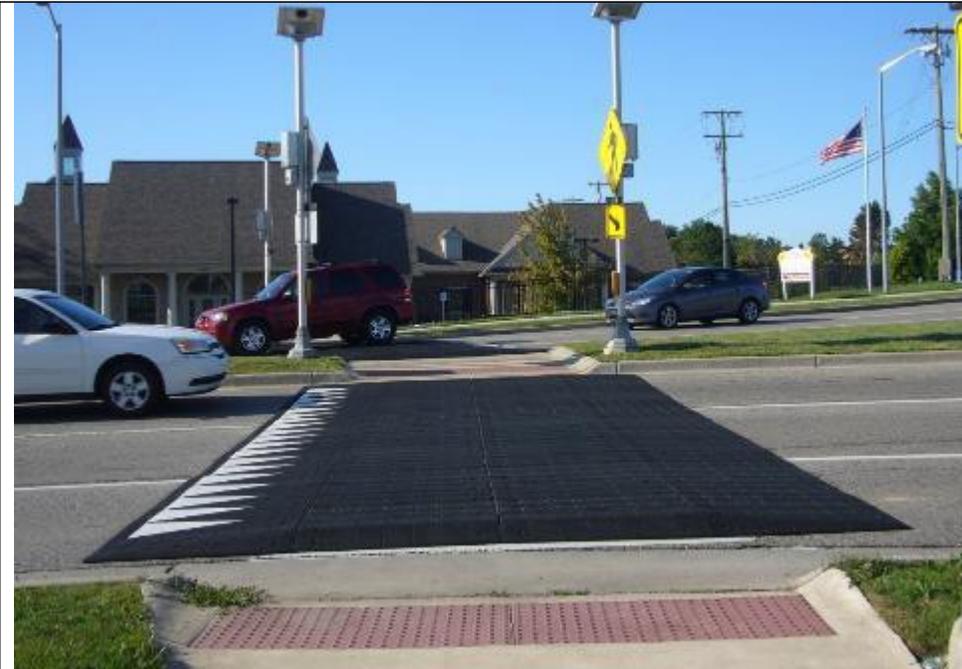
**Figure 12-124: Pedestrian view of east crosswalk (looking north)**

- a) Three lane crossings.**
- b ) Detectable warning at edge of street.**
- c) Raised crosswalk for entry and exit lanes.**
- d) Narrow splitter island with pushbuttons for RRFBs installed on downstream side for each crossing.**

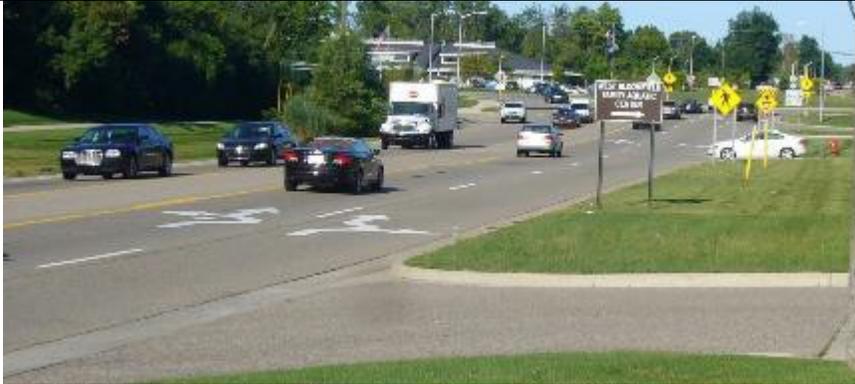
**Figure 12-125: Signage and markings on approach from east**

- a) Lane assignment pavement markings.
- b) Informational sign.
- c) Pedestrian crossing warning sign.
- d) Yield ahead sign.
- e) Lane assignment sign and pavement markings.

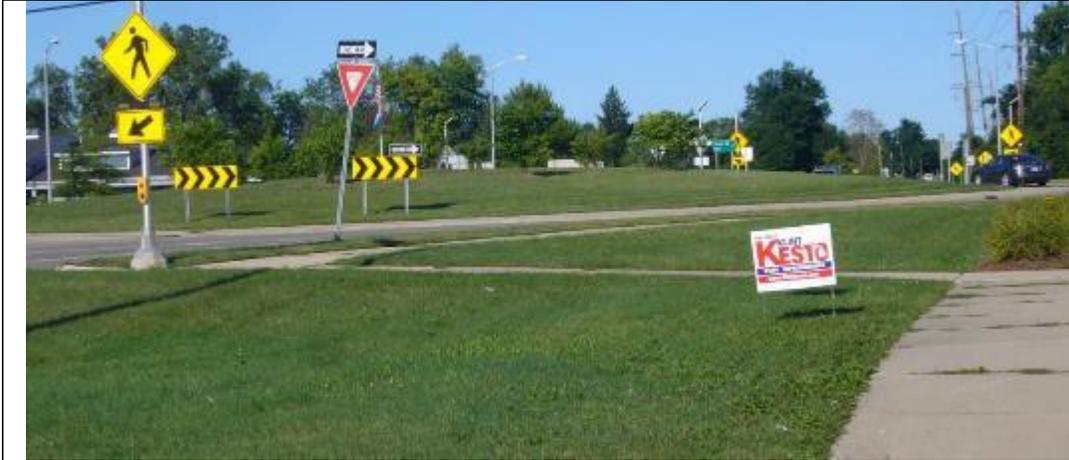
**Figure 12-127: Sidewalk on east leg, north side**

**On the north side of Maple Road, the sidewalk is over 20 feet from street approaching the intersection. It turns toward the roundabout at the crosswalk and continues with about a 4 foot landscape strip around the roundabout. Some wayfinding trials for this leg (crosswalk on left) began from a location near the lower edge of the photo.**

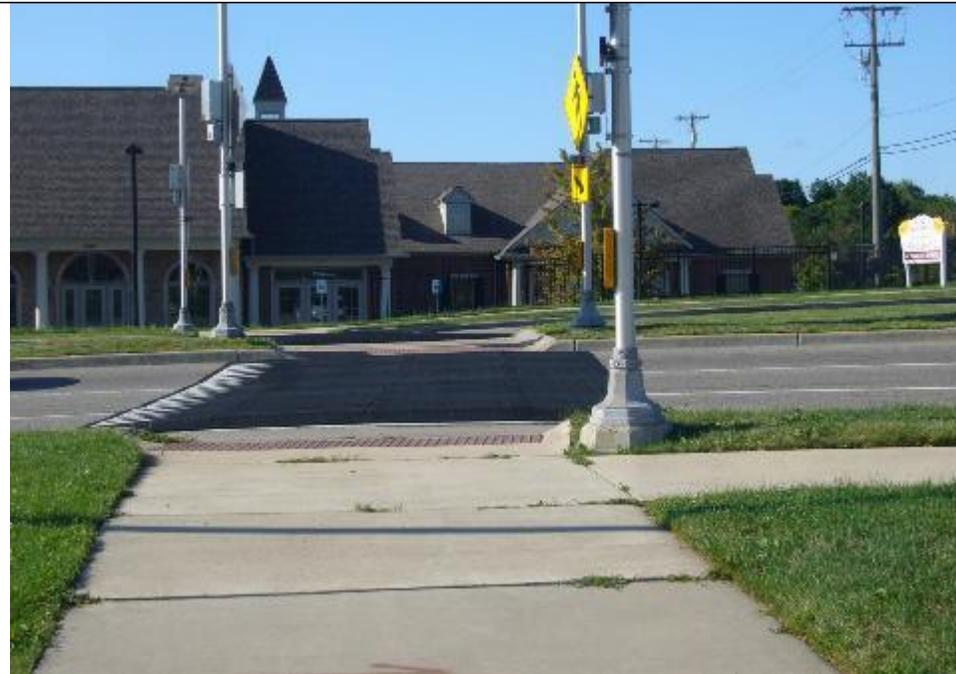
**Figure 12-128: View of east entry leg pedestrian crosswalk**

- a) Crosswalk aligned with gutter and detectable warning, slightly out of alignment with approach sidewalk.**
- b) RRFB and pushbutton for RRFB on downstream side of crosswalk.**
- c) Participants commented that the pushbutton locator tone on audible information device was hard to hear at this location.**

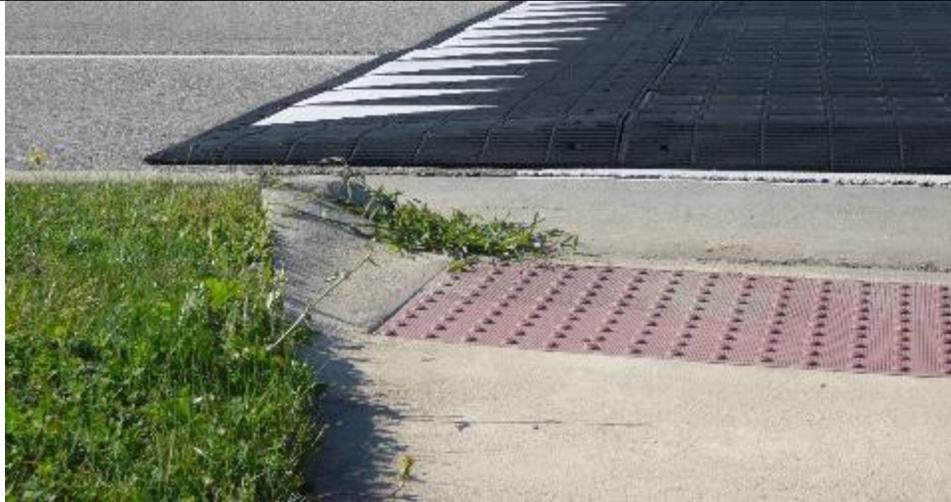
**Figure 12-129: View of raised crosswalk**

- a) Note steep rise on edge, somewhat of a tripping hazard for pedestrians.
- b) May have thrown off alignment for some individuals.

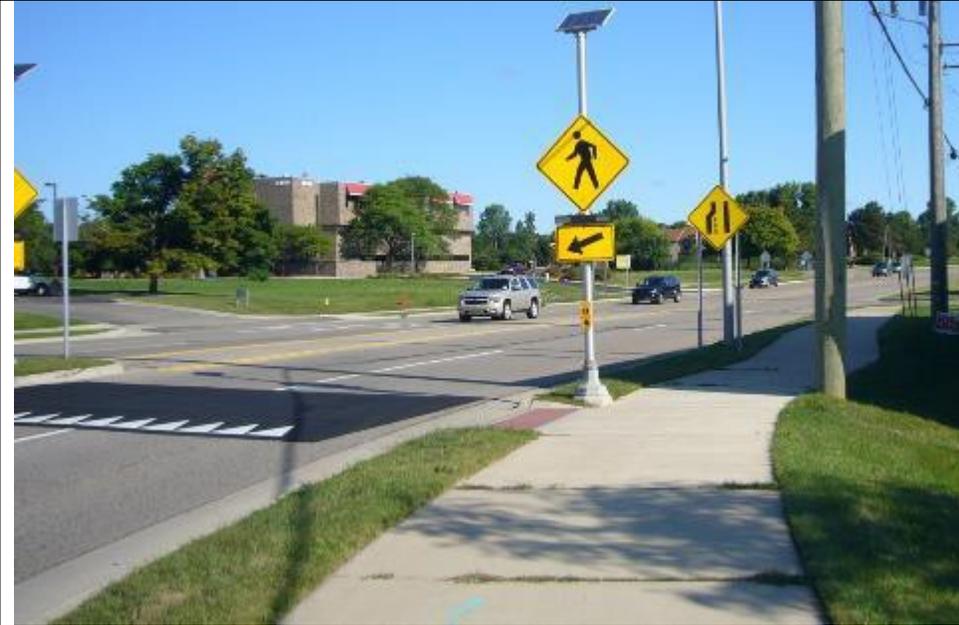
**Figure 12-131: View of North crosswalk**

**a) RRFBs, raised crosswalk.**

**b) Note lane drop just past crosswalk.**

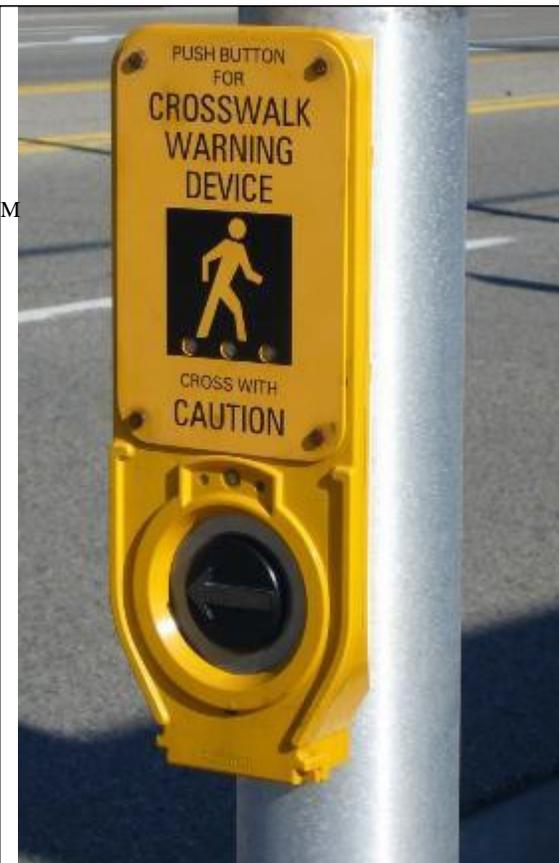
**Figure 12-132: Closeup view of audible information device**

**a) Speaker in device.**

**c) Message repeated.**

**d) Tactile arrow on device aligned with direction of crosswalk.**

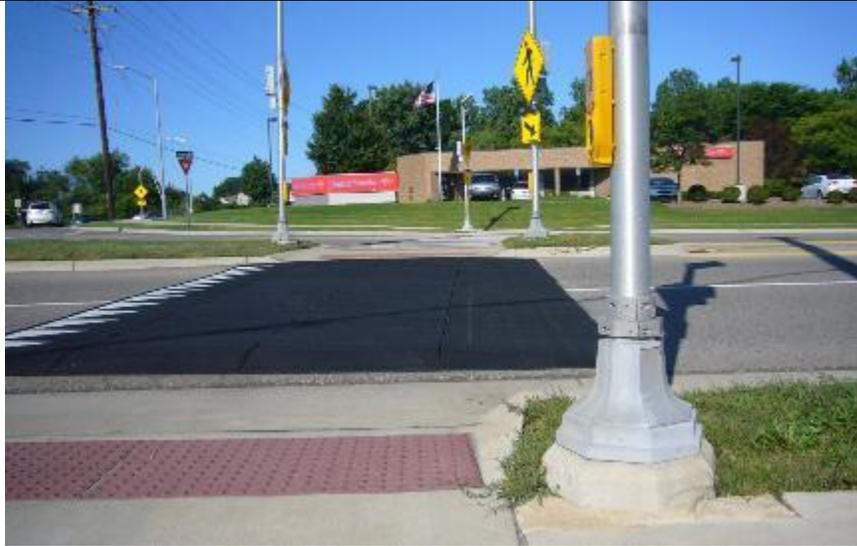
**Figure 12-133: North crosswalk and island pedestrian view**

- a) Curb ramp and DW aligned slightly left of crosswalk direction.
- b) Returned curb aligned very slightly to left.
- c) Pushbutton on downstream side of crosswalk.
- d) Island grass outside of cut-through area.

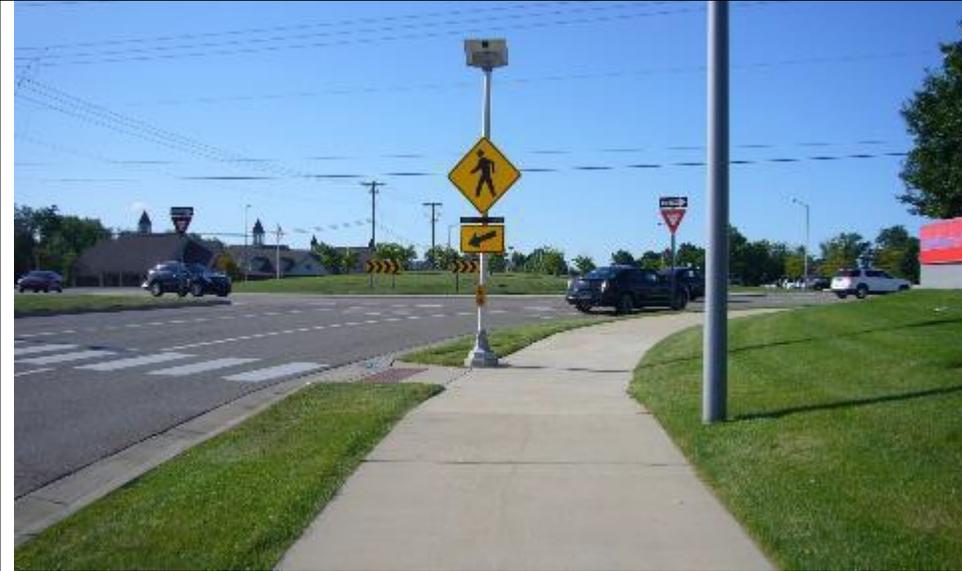
Figure 12-135: View of west crosswalk

a) West crosswalk - RRFBs and audible information devices installed but no raised crosswalk.

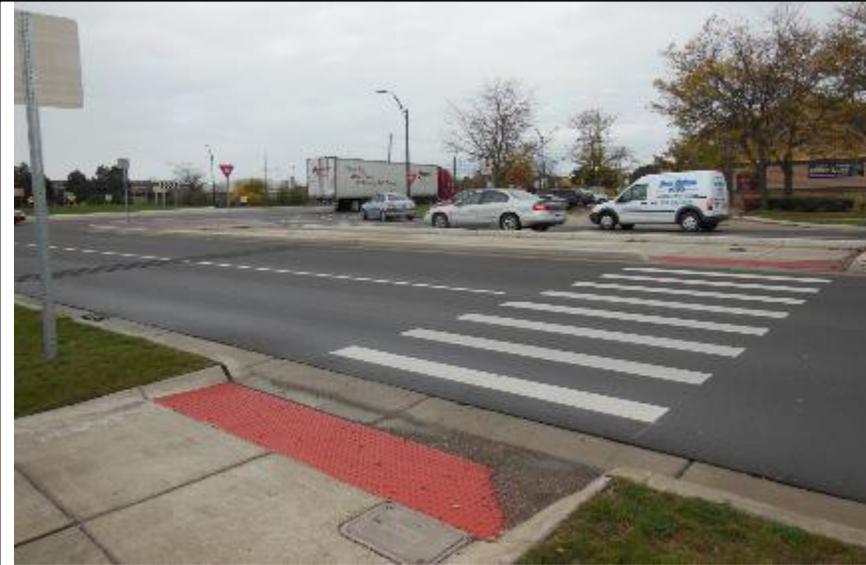
**Figure 12-137: East leg exit lane crossing**

- a) Two- lane crossing.
- b) Zig-zag cut-through in island.
- c) Rumble strips before crosswalk.
- d) Continental crosswalk markings.

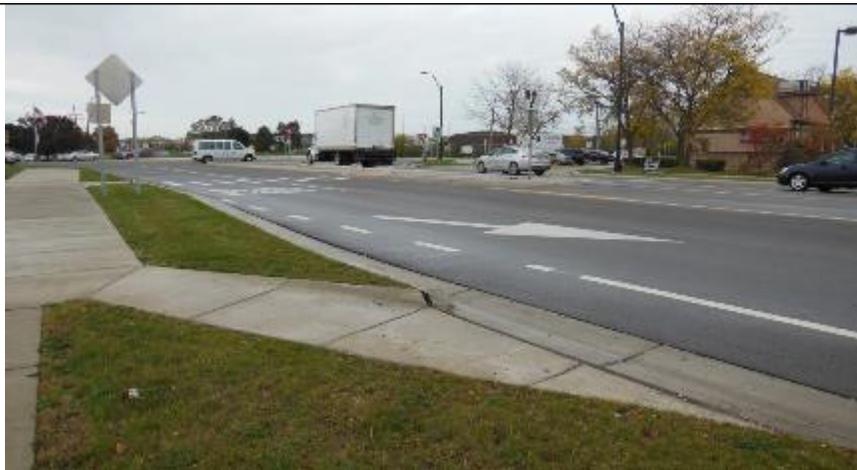
**Figure 12-138: Approach to roundabout, looking west from east leg**

- a) Lane drop shortly past crosswalk.
- b) Bike ramp merging from sidewalk into bike lane on street in foreground of photo.

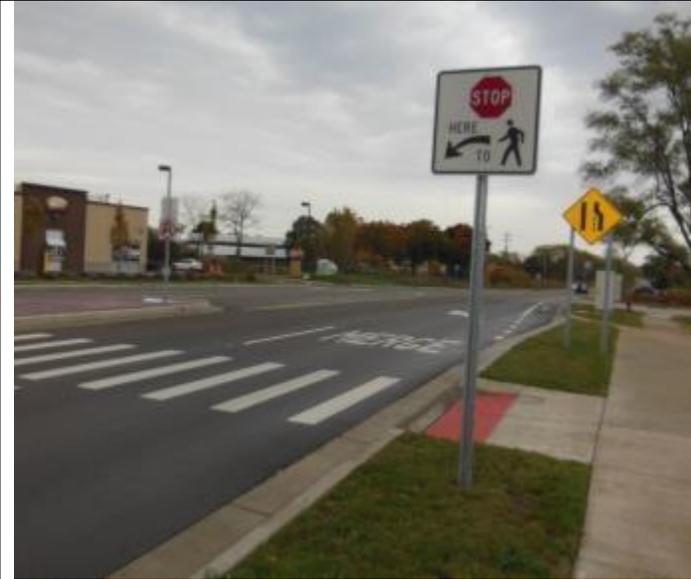
**Figure 12-139: Drivers' view of crosswalk**

- a) Stop here to pedestrians sign before crosswalk.**
- b) Lane ends sign shortly after crosswalk.**
- c) On-street bicycle lane resumes shortly after crosswalk.**

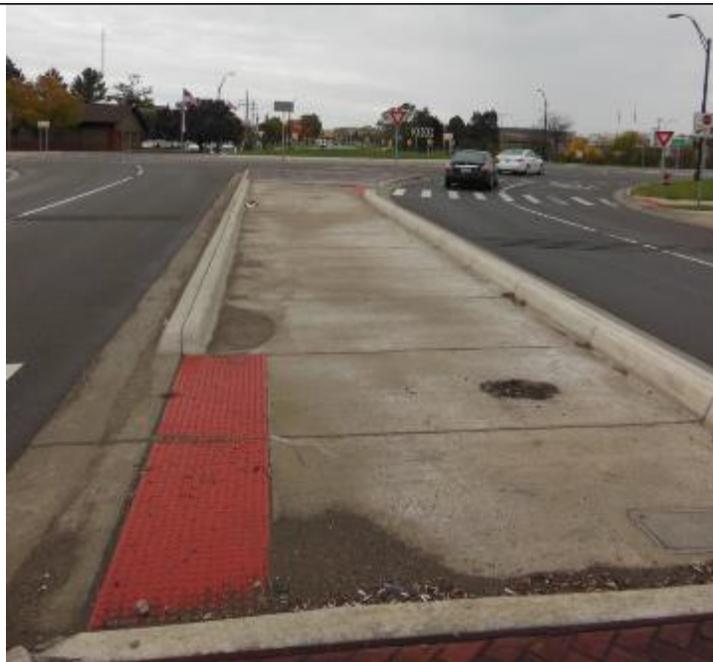
**Figure 12-140: View of zig-zag cut-through island**

- a) Detectable warning surface at opening.**
- b) Curbed area of island around walkway.**

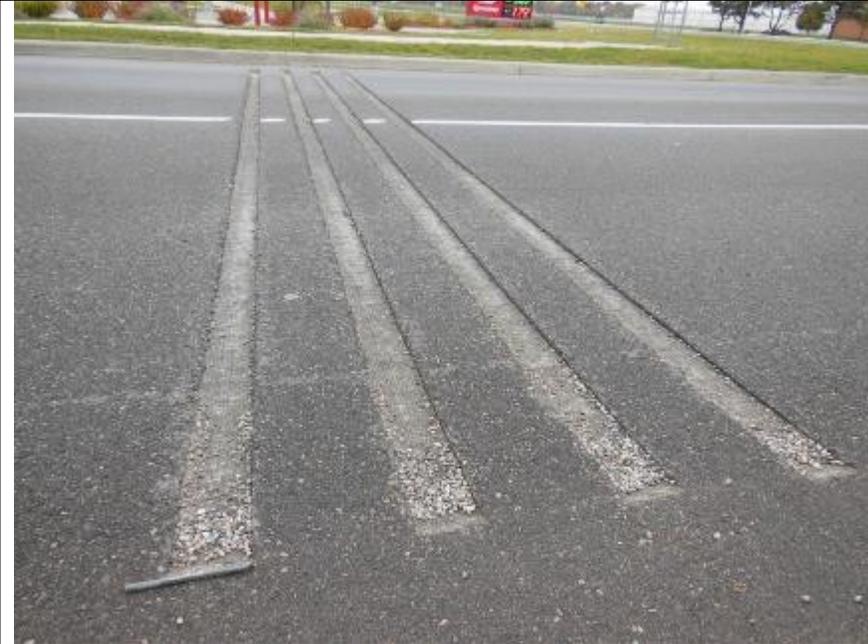
**Figure 12-141: Rumble strips in pavement**

**a) Pen at bottom left for size comparison.**

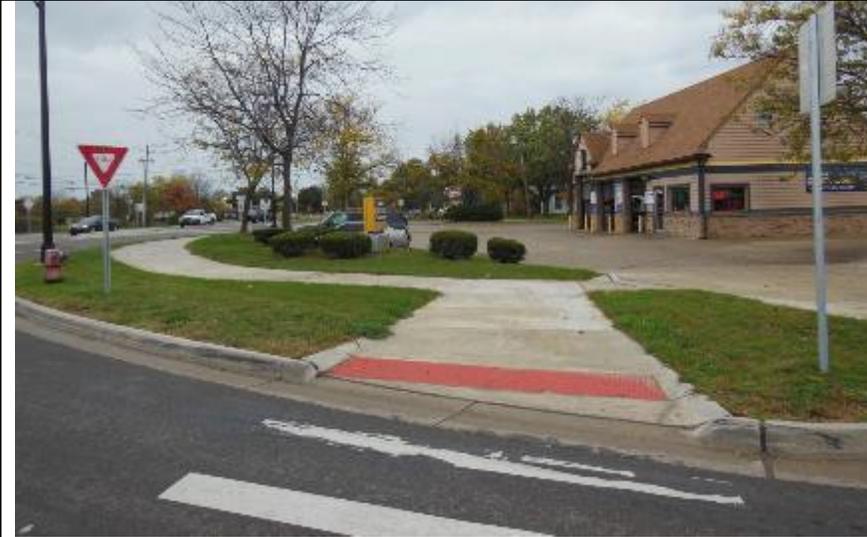
**Figure 12-143: View of curb and detectable warning surface and alignment of sidewalk at east entry**

- a) Detectable warning surface and curb line/gutter not aligned the same.
- b) DW aligned with crosswalk?
- c) Short distance between crosswalk and yield sign.

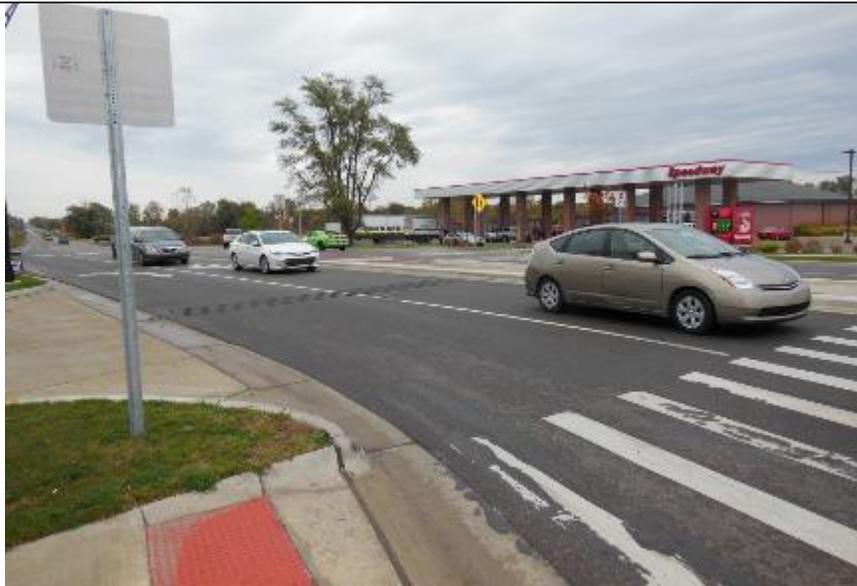
**Figure 12-144: Looking back at entry rumble strips and lane markings**

- a) Rumble strip about 20 feet before crosswalk.
- b) Pavement markings with lane designation before rumble strips.

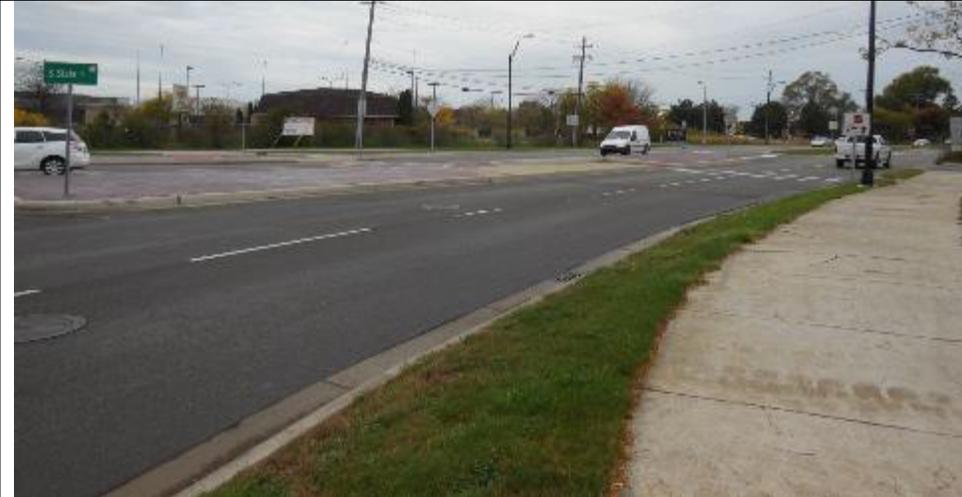
**Figure 12-145: View of north crosswalk exit lanes**

- a) Landscape strip between sidewalk and roadway.
- b) Stop here to pedestrians sign just before the crosswalk.
- c) Light pole right before crosswalk.
- d) Continental markings for crosswalk.

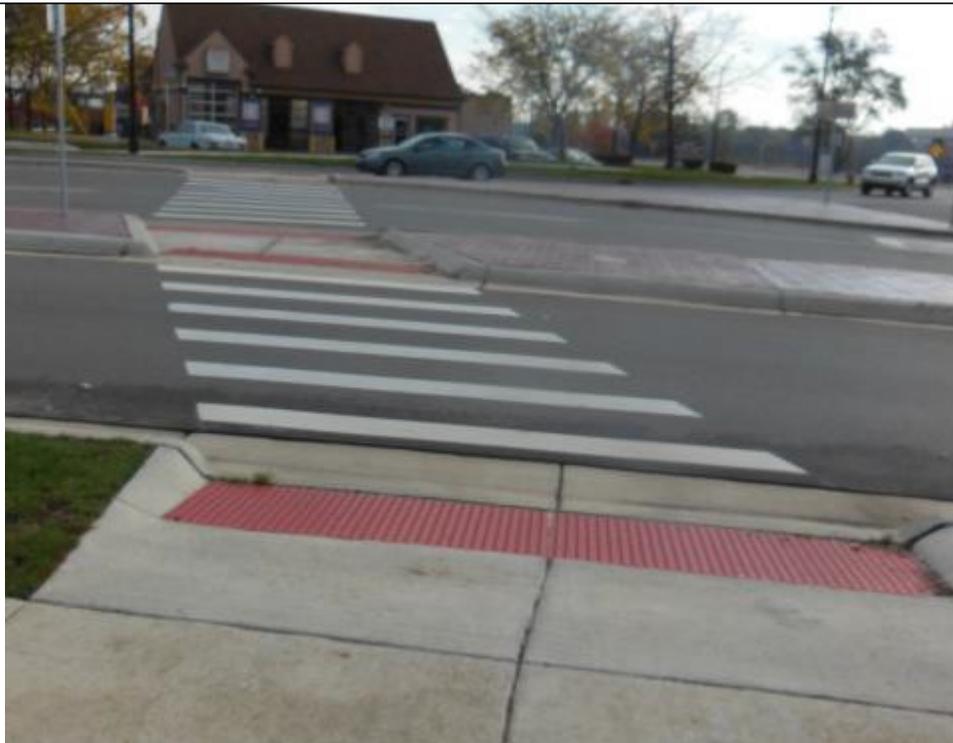
**Figure 12-148: North crosswalk, crossing exclusive right turn**

- a) Narrow island without zig zag and then wider island with zig-zag between opposing entry and exit lanes.
- b) Ramp, detectable warnings and gutter/curb line not aligned with crosswalk direction here.

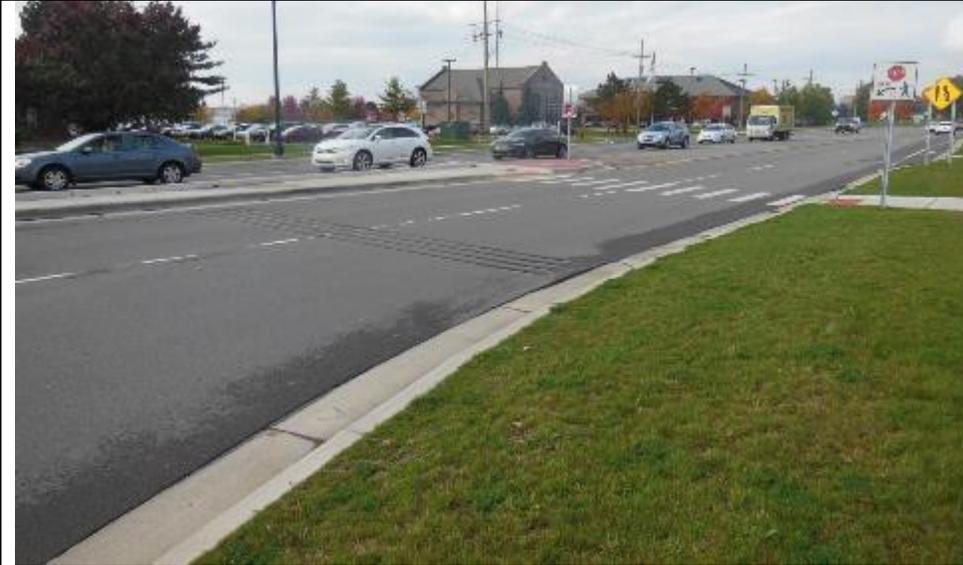
**Figure 12-149: Exit lanes – west crosswalk (studied)**

- a) Rumble strips in pavement.
- b) Stop here to pedestrians sign.
- c) Continental crosswalk markings.
- d) Lane ends sign just past crosswalk.
- e) Bike lane resumes just past crosswalk.
- f) Zig-zag cut-through splitter island.

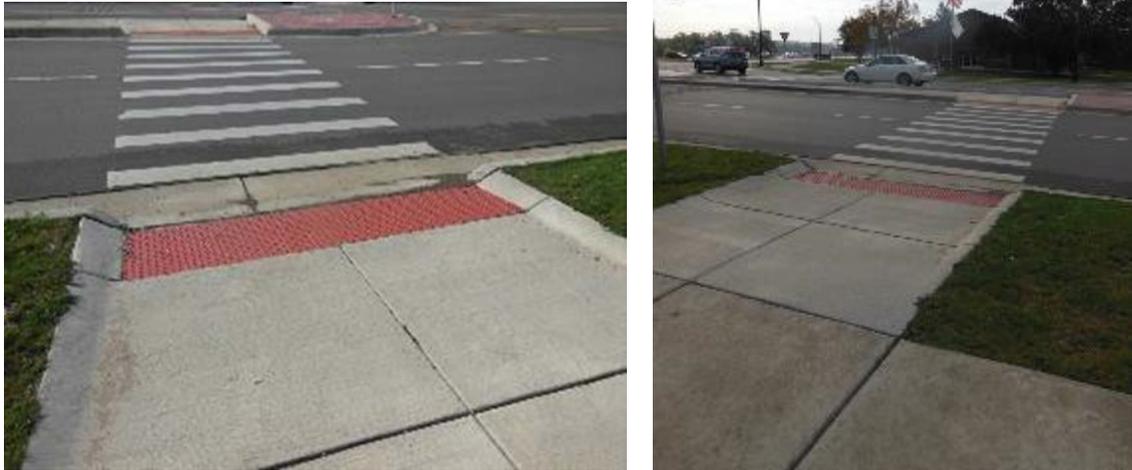
**Figure 12-151: Pedestrian view of west crosswalk exit lane crossing**

- a) Curb ramp with returned curbs aligned with crosswalk direction.
- b) Detectable warnings at base of ramp.
- c) Crosswalk perpendicular to curb line/gutter.

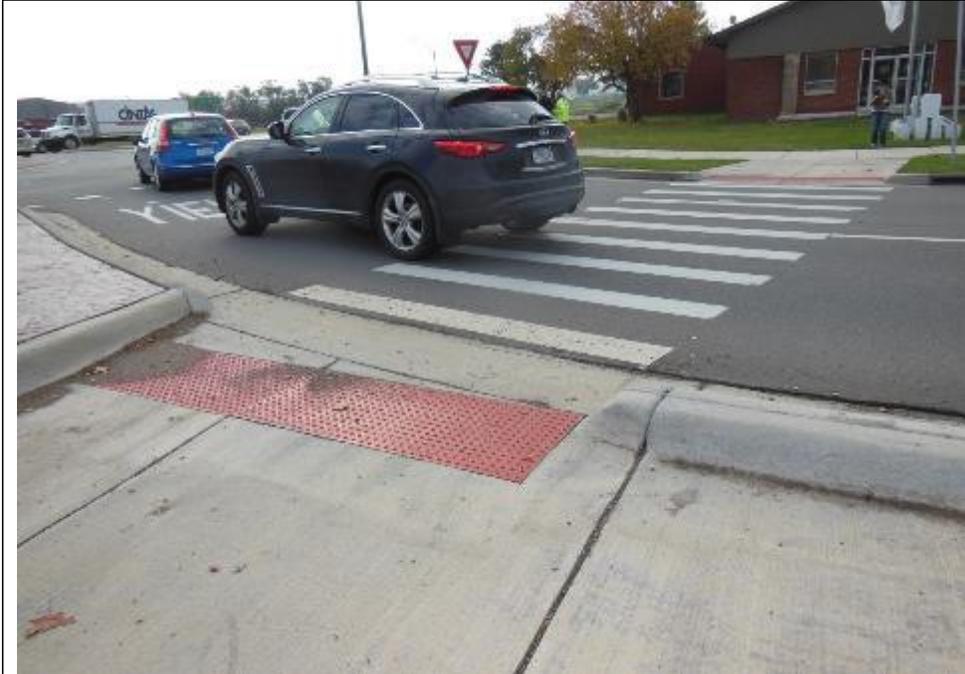
**Figure 12-153: Entry lane crosswalk from island west leg**

- a) Detectable warning at edge of island.**
- b) Gutter and curbs angle slightly right of DWalignment.**

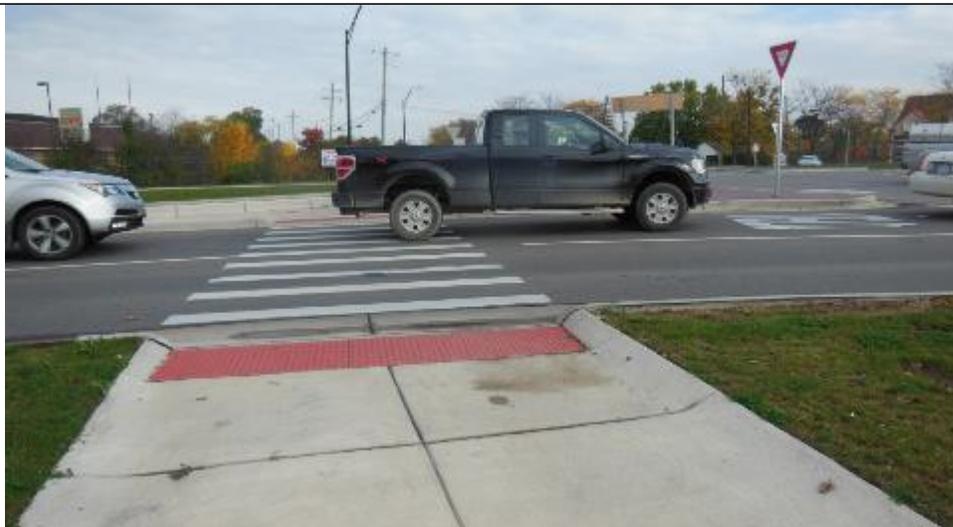
**Figure 12-154: Pedestrian view of entry leg crossing west crosswalk**

- a) Wide crosswalk.**
- b) Landscaping on each side of walkway/ramp.**
- c) Detectable warning the full width of the ramp.**
- d) Curb and gutter aligned perpendicular to crosswalk.**

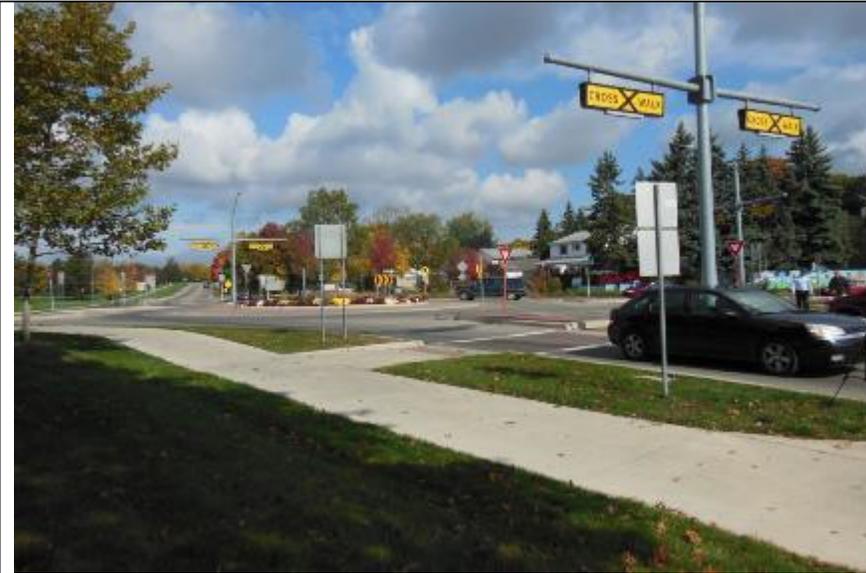
**Figure 12-155: View of overhead crosswalk signs**

**Signs were internally illuminated at night.**

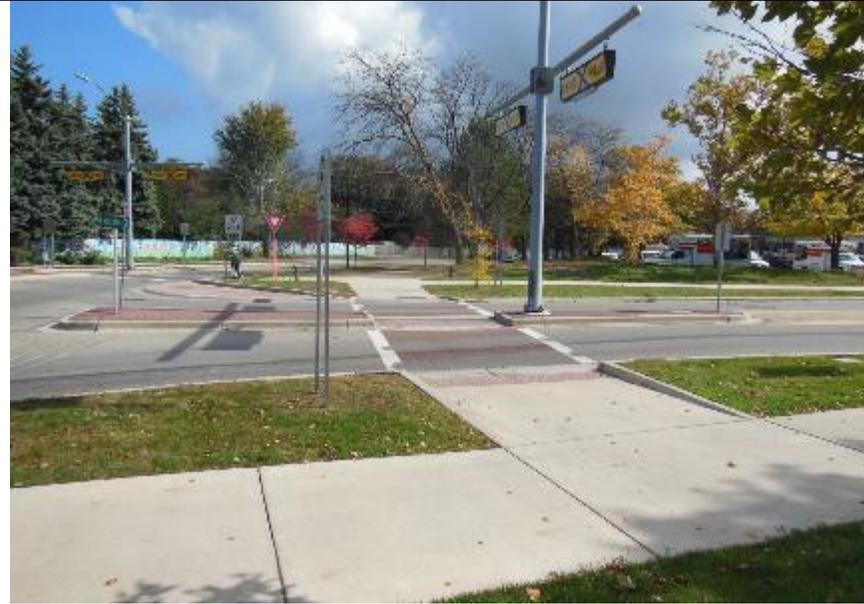
**Figure 12-157: View of crosswalk studied, sidewalk and landscaping**

- a) Landscaping between sidewalk and road.
- b) Rumble strips at exit from roundabout.
- c) Crosswalk marked with transverse lines.
- d) Worn brick stamped texture and color on crosswalk (see later photo).
- e) Yield here to pedestrians sign before crosswalk.
- f) Curb ramp with returned curbs, aligned slightly left of crosswalk.
- g) Narrow splitter island.

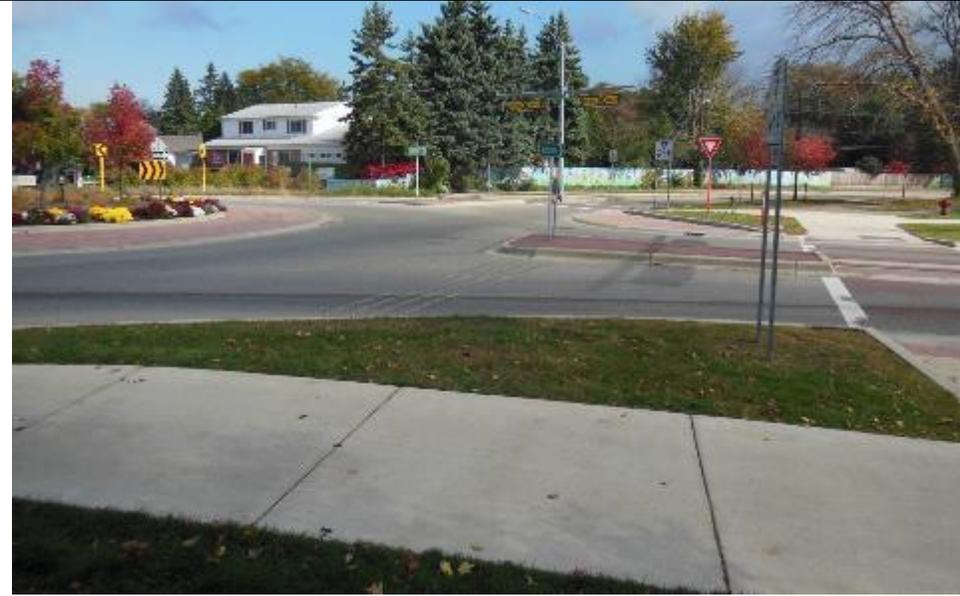
**Figure 12-159: Small diameter circle**

- a) Truck apron in center and at entry.**
- b) Chevron signs on island.**
- c) Directional street name signs on splitters.**

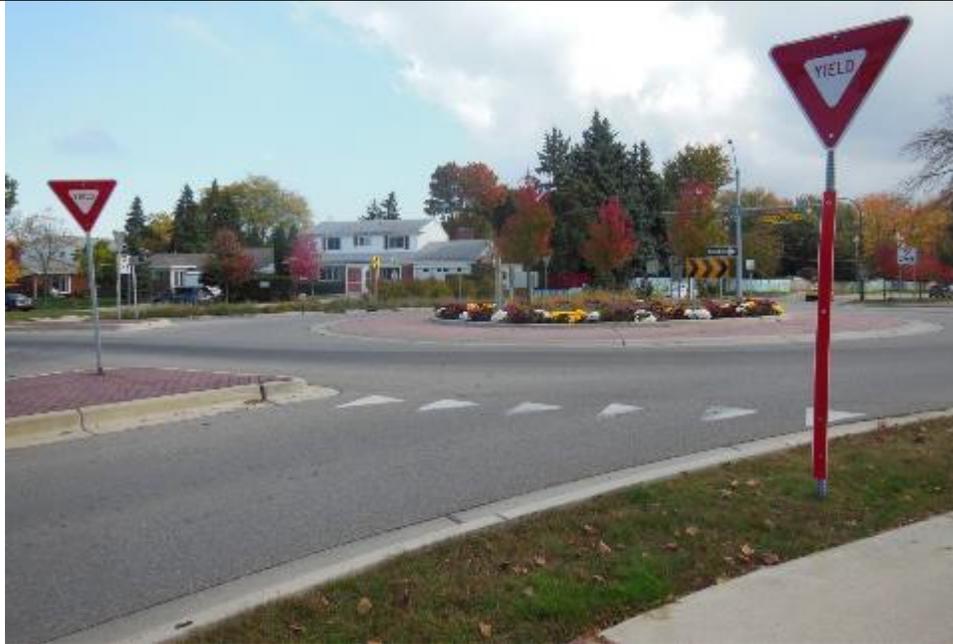
**Figure 12-161: Yield signs**

- a) Yield sign posts with reflective tape.
- b) Yield sign on left angled for driver looking left.
- c) Sharktooth yield line used at roundabout entry.

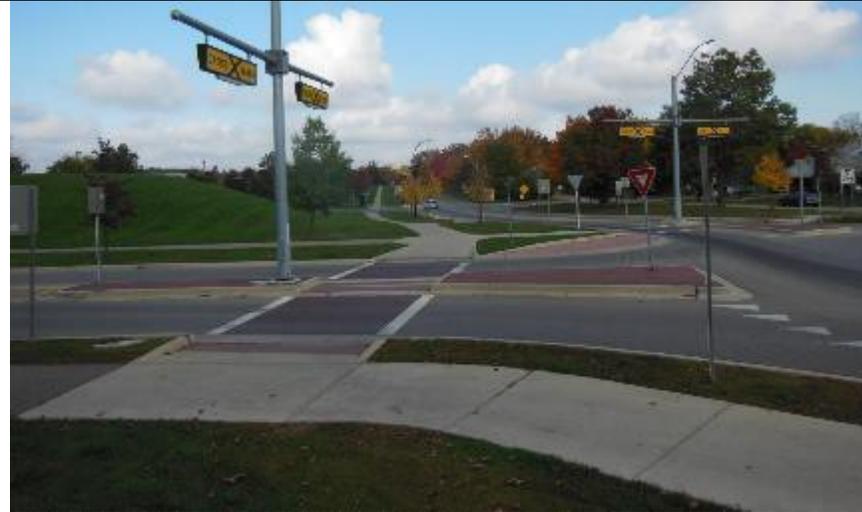
**Figure 12-163: View of crosswalk lighting (west crosswalk)**

- a) Note light over crosswalk in addition to overhead signs.
- b) Overhead signs were illuminated at night.

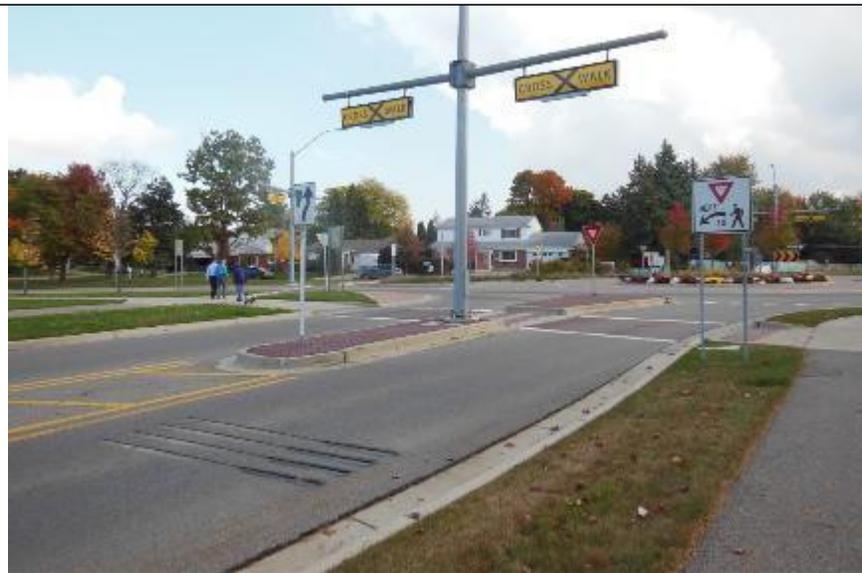
**Figure 12-164: Pedestrian view of crosswalk approach west leg**

- a) Landscape strip between sidewalk and street.
- b) Yield here to pedestrians sign before crosswalk.
- c) Overhead crosswalk signs.
- d) Rumble strips in roadway.
- e) Narrow splitter island.
- f) Crosswalk outlined with white lines, brick color/texture in crosswalk.

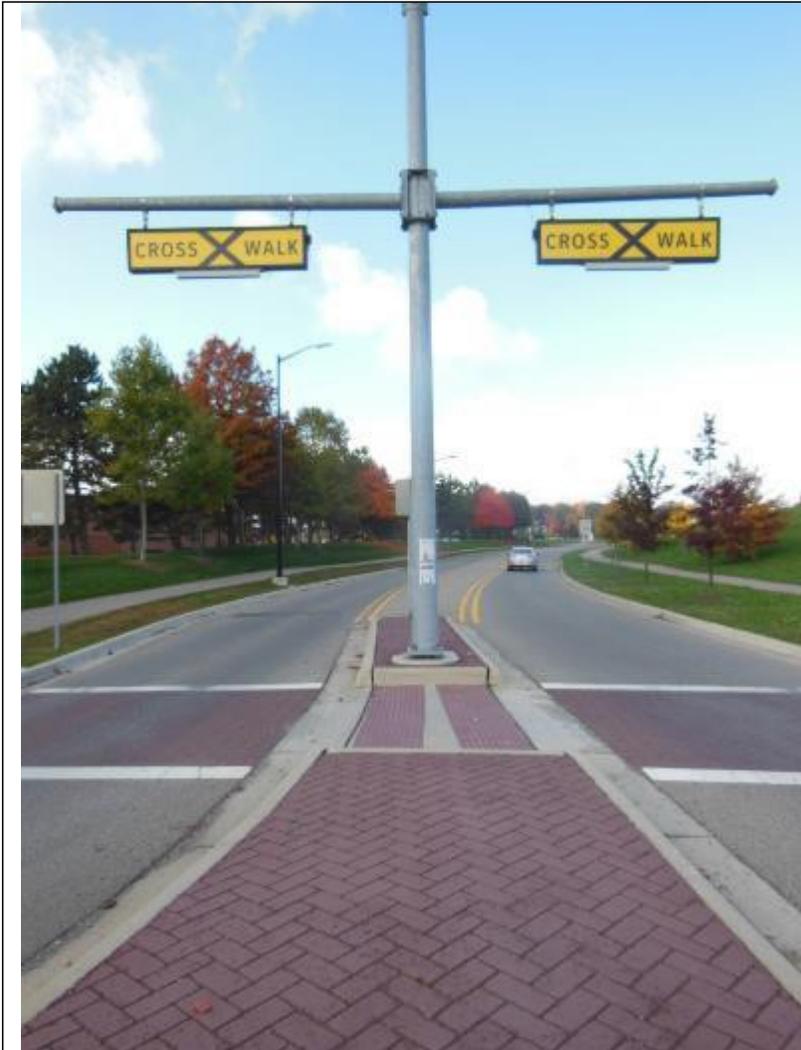
**Figure 12-165: Narrow splitter island**

- a) Cut-through.**
- b) Brick patterns on raised sections (same brick pattern in crosswalk).**
- c) Less than one foot separation in detectable warning surfaces.**
- d) Detectable warnings aligned with crosswalk direction.**
- e) Curb line and gutter slightly angled in relation to crosswalk direction.**
