## Guidelines for the Application of Crossing Solutions at Roundabouts and Channelized Turn Lanes for Pedestrians with Vision Disabilities

Bastian Schroeder, Lee Rodegerdts, Pete Jenior, Edward Myers, Christopher Cunningham, Katy Salamati, Sarah Searcy, Sarah O'Brien, Janet Barlow, and Billie Louise (Beezy) Bentzen; National Cooperative Highway Research Program; Transportation Research Board; National Academies of Sciences, Engineering, and Medicine

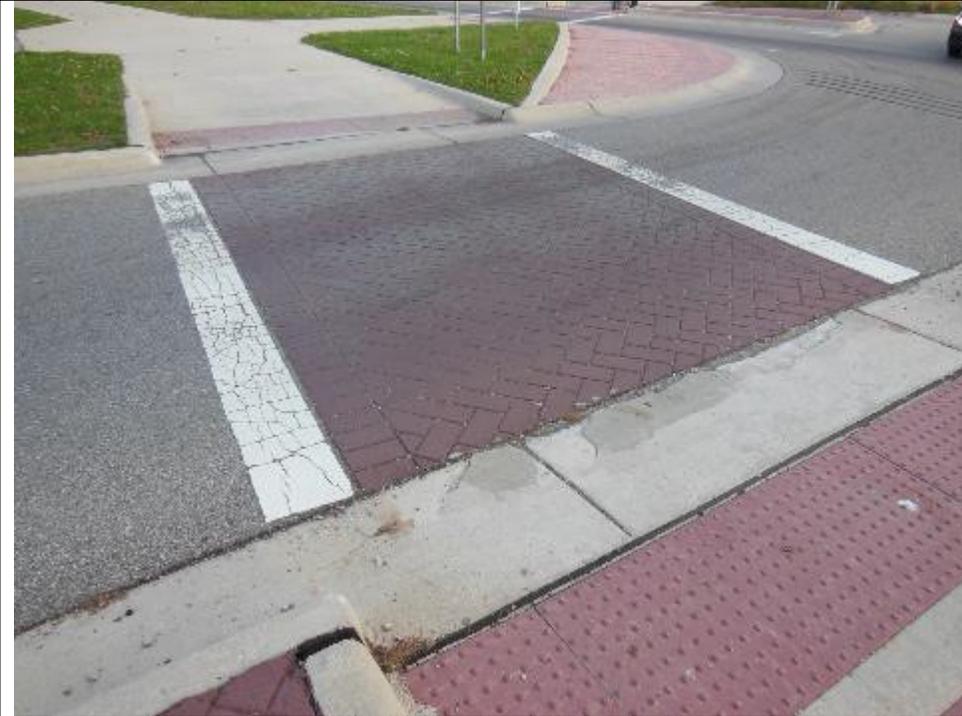
**Figure 12-166: Truck apron at entry**

**a) Slightly raised but very close to crosswalk.**

**b) Worn brick stamped pattern in crosswalk.**

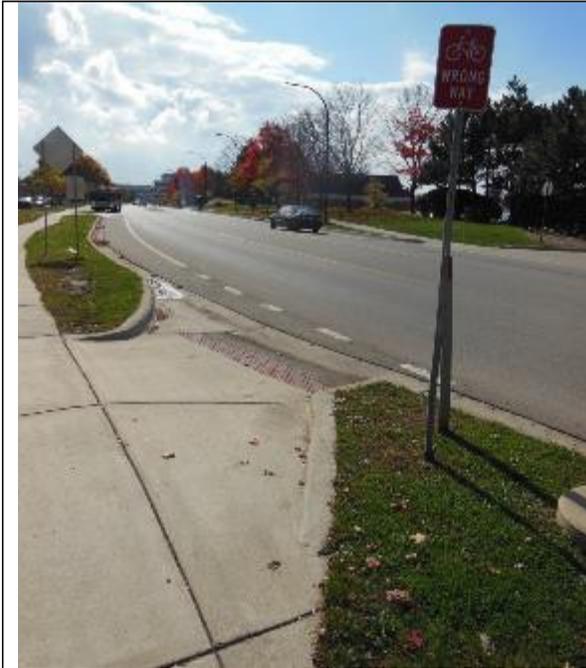
**Figure 12-171: Bike ramp on entry**

- a) Wrong way sign for bicyclists.
- b) Short ramp.
- c) Landscape strip continues past bike ramp.

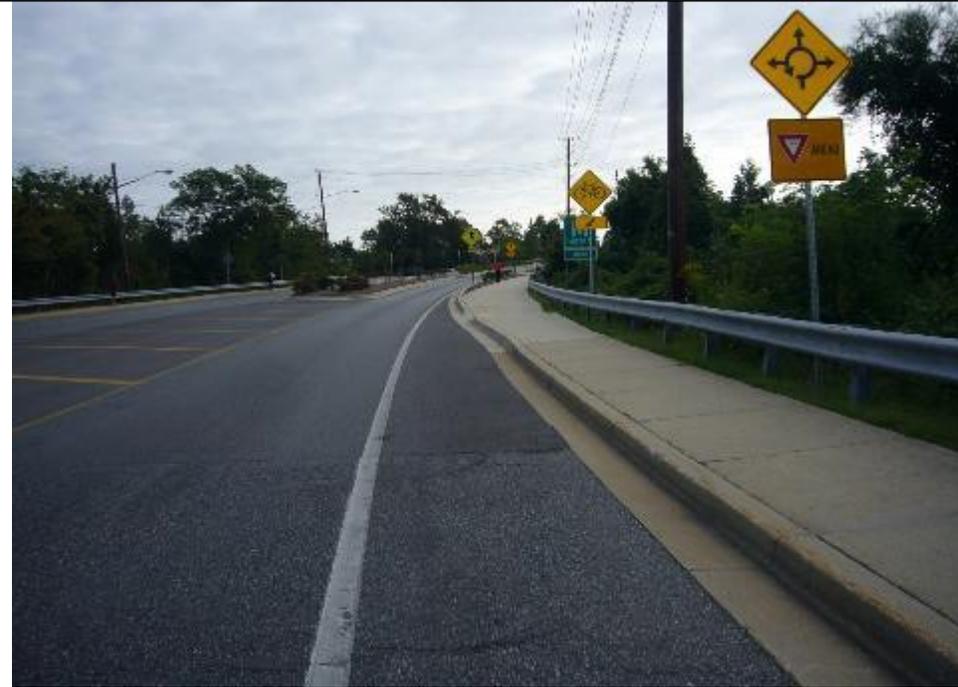
Figure 12-172: Driver's view on approach on west leg (Cherrywood)

- a) Roundabout sign and yield ahead sign.
- b) No directional signage on approach ( what street).
- c) Bike lane (see next photo and description)
- d) Pedestrian crossing ahead sign.
- e) Pedestrian crossing sign at crossing with 'hump' placard under it.
- f) Wide striped median area, then raised landscaped area.
- g) Directional sign for Metro station.

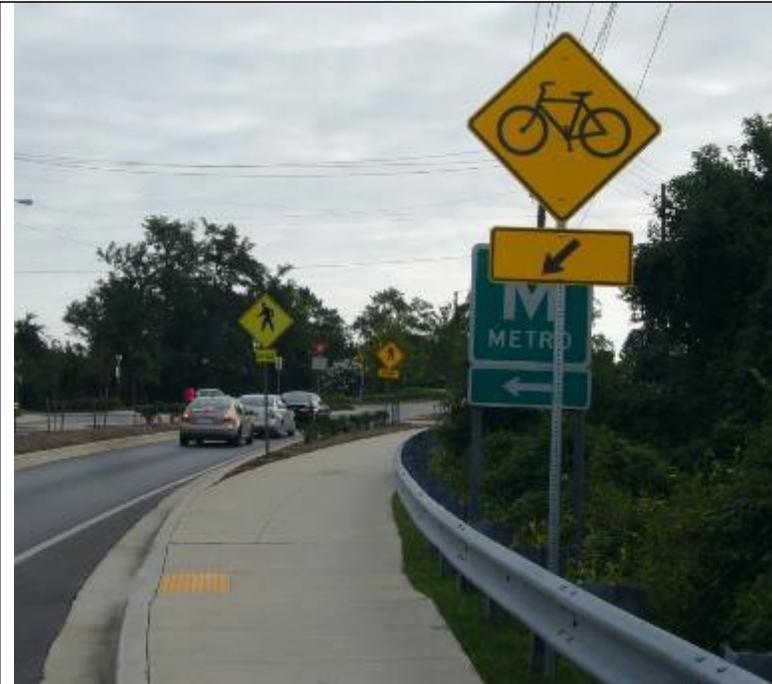
**Figure 12-173: Bike sign and ramp to sidewalk**

- a) **Bicycle sign.**
- b) **No bike lane ends sign, although there's no dotted line to signify bicyclists can take lane.**
- c) **Widened sidewalk and bike ramp to sidewalk with construction identical to curb ramp construction.**
- d) **If bicyclists want to go left toward Metro station, they have to take a lane unless they cross at pedestrian crossing, but then sidewalk is very narrow on north side of roundabout.**
- e) **Observed some erratic and dangerous bicyclist movements (riding on left, wrong way in circle, etc.).**

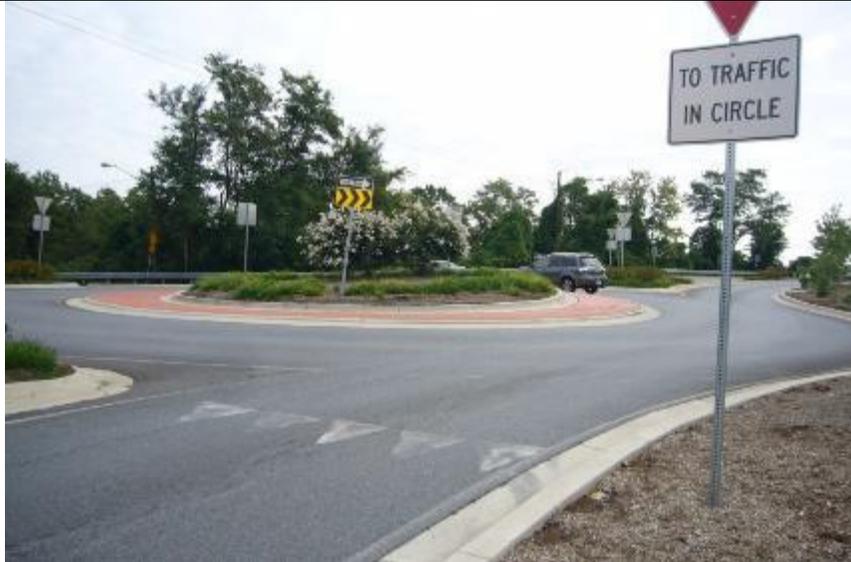
**Figure 12-174: Markings and signs at entry**

- a) Faded sharks tooth yield line.
- b) Yield sign.
- c) TO TRAFFIC IN CIRCLE placard below yield sign
- d) Chevron sign and one-way sign on central island

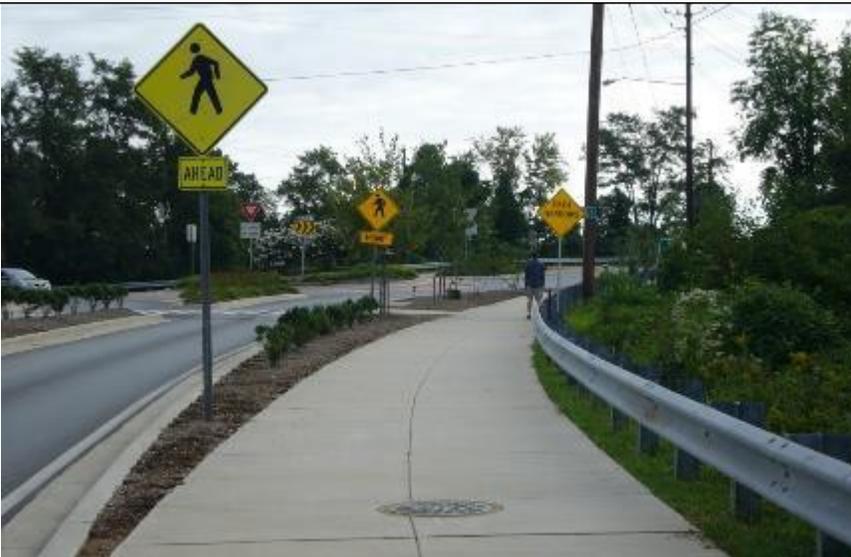
**Figure 12-175: Pedestrian view on approach**

- a) Wide sidewalk.
- b) Landscaping between sidewalk and curb.
- c) No indication of crosswalk location on sidewalk (blind pedestrians have to be looking for it).
- d) Path narrows sign (for bicyclists?).

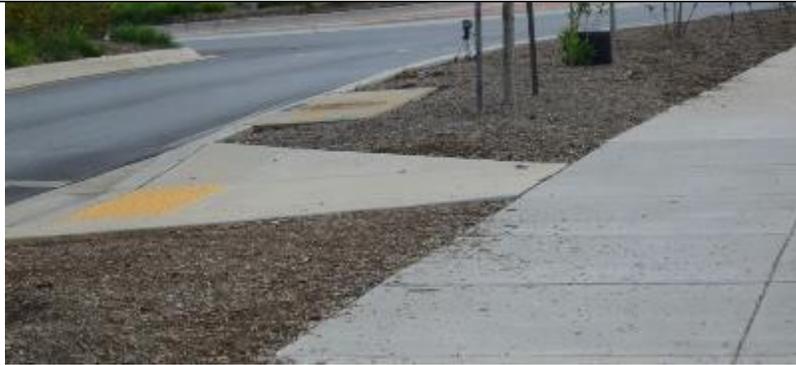
**Figure 12-176: Narrow entry to curb ramp and crosswalk**

- a) Narrow, four-foot entry to ramp/crosswalk area, missed by some blind participants.
- b) Wide flares on ramp (flares unnecessary with landscaping on both sides).
- c) Would be better to have entry as wide as crosswalk with returned curbs on each side.
- d) Detectable warnings at base of ramp.

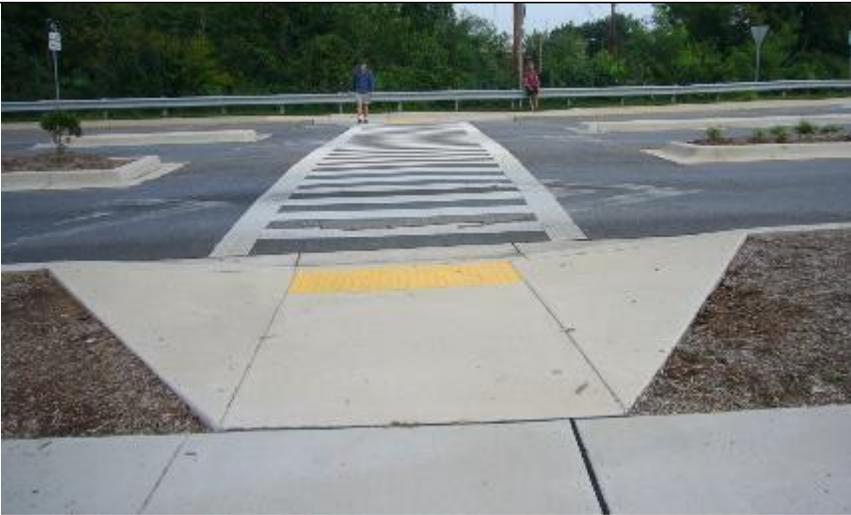
**Figure 12-177: View of pedestrian crosswalk – west crosswalk across Cherrywood looking north**

- a) Six-foot wide crosswalk.
- b) Perpendicular curb ramp with detectable warnings.
- c) Crosswalk raised as speed hump for vehicles, although slope is not really detectable underfoot to pedestrian.
- d) No pedestrian refuge area between entry and exit lanes, although there are raised planted medians between each lane.
- e) Ladder markings for crosswalk.
- f) Speed hump markings very faded.

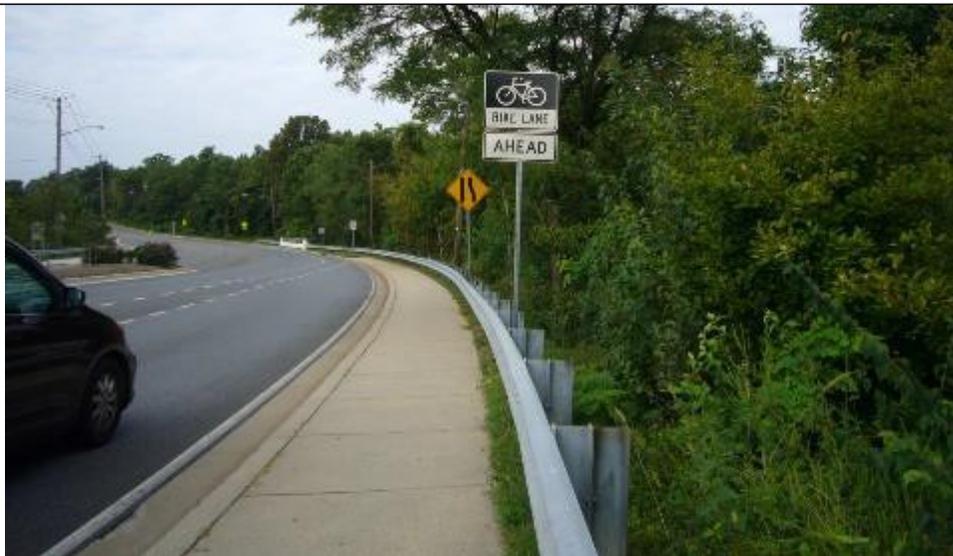
**Figure 12-179: View of west leg, (leaving roundabout), looking west from crosswalk on north side of Cherrywood Lane**

- a) Lane ends symbol sign (W4-2)
- b) BIKE LANE AHEAD sign
- c) Dotted bike lane markings between lanes
- d) 30 mph speed limit sign after roundabout on all legs, no sign reducing speed at roundabout.

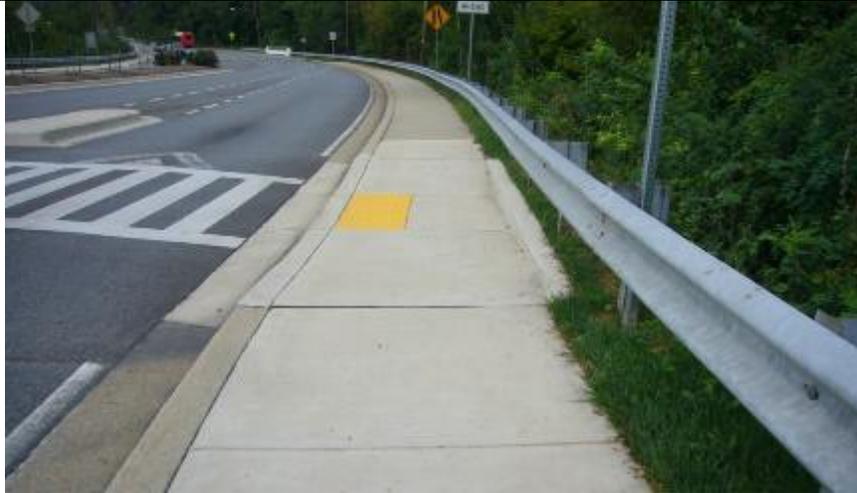
**Figure 12-180: Parallel curb ramp on north side (exit lanes) of west crosswalk**

- a) Parallel curb ramp in narrow sidewalk.**
- b) Cars felt very close to pedestrians on narrow sidewalk, particularly buses (and there were a lot of buses here).**
- c) Lots of cross slope on sidewalk coming around curve toward ramp.**
- d) Detectable warnings on curb ramp landing.**

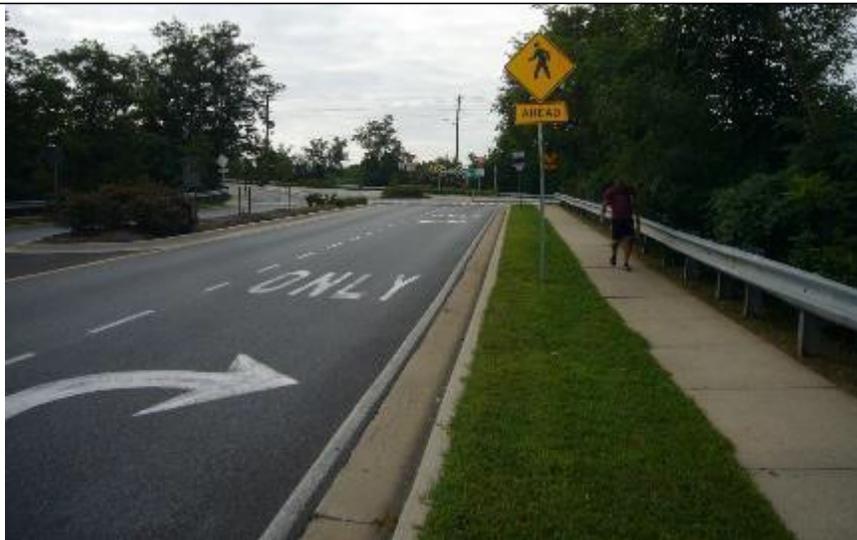
**Figure 12-181: Approach from north**

- a) Two lanes, right lane with pavement markings RIGHT ONLY**
- b) Guide sign is beyond roundabout center island [To south 95-495 and left arrow] somewhat hidden by bushes; no other guide signs found.**
- c) Pedestrian crossing ahead warning sign.**

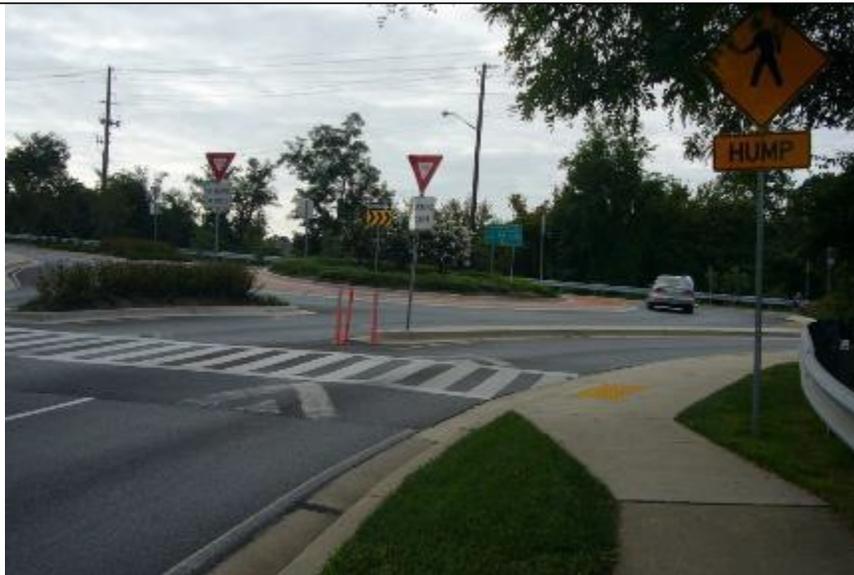
**Figure 12-183: Median between lanes**

- a) Concrete island installed between right only lane and through/right lane (similar treatment present on east approach).
- b) Yield signs on median island and splitter islands.
- c) Placard **TO TRAFFIC IN CIRCLE** under yield sign.
- d) Orange delineators in front of median nose.
- e) Crosswalk close to yield point.
- f) Pedestrian crossing sign, with **HUMP** placard installed beneath it (partially visible on right edge of photo).

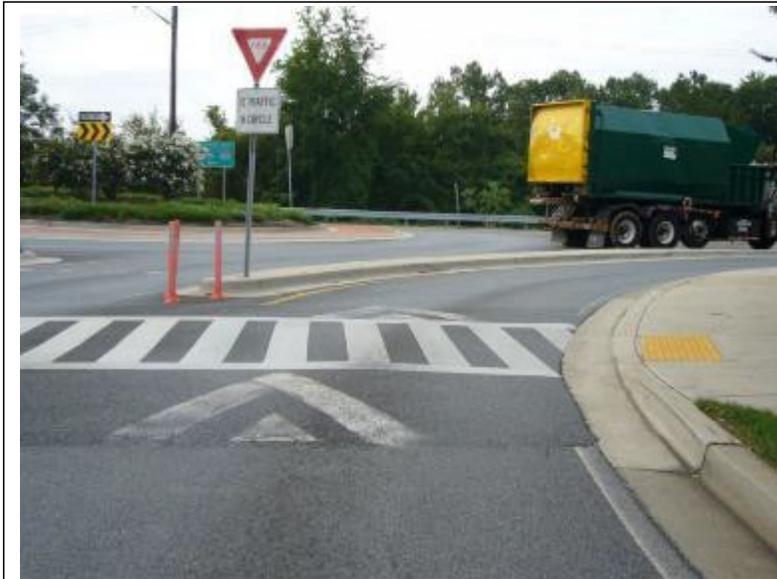
**Figure 12-184: Another view of median and crosswalk (north crossing)**

- a) Raised crosswalk.
- b) Speed hump markings and construction visible.
- c) Yield sign for left lane.

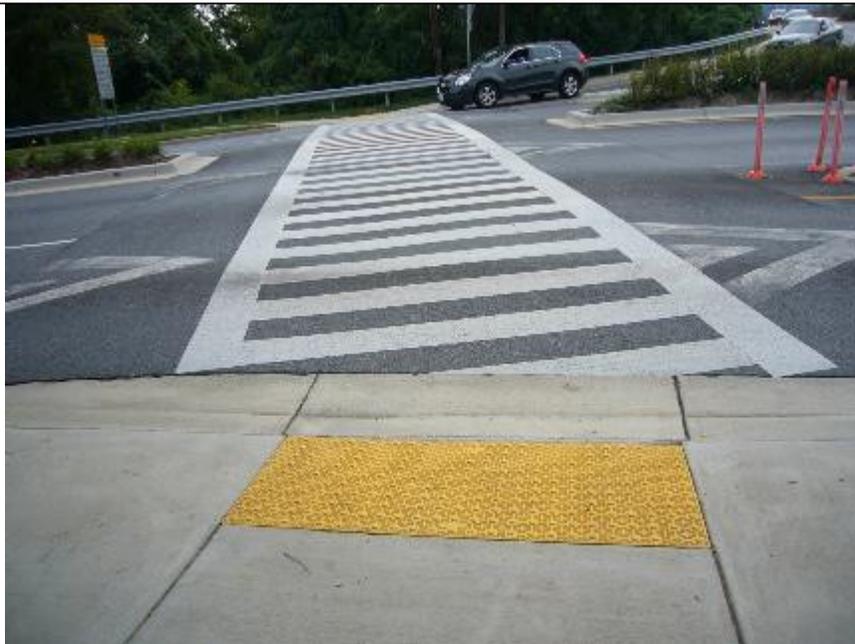
**Figure 12-185: View of crosswalk north crossing**

- a) Ladder crosswalk markings.
- b) Combo curb ramp.
- c) Raised crosswalk.
- d) Crosswalk not aligned perpendicular to gutter.
- e) No pedestrian refuge even though there's a splitter island and there could be adequate room for a refuge.

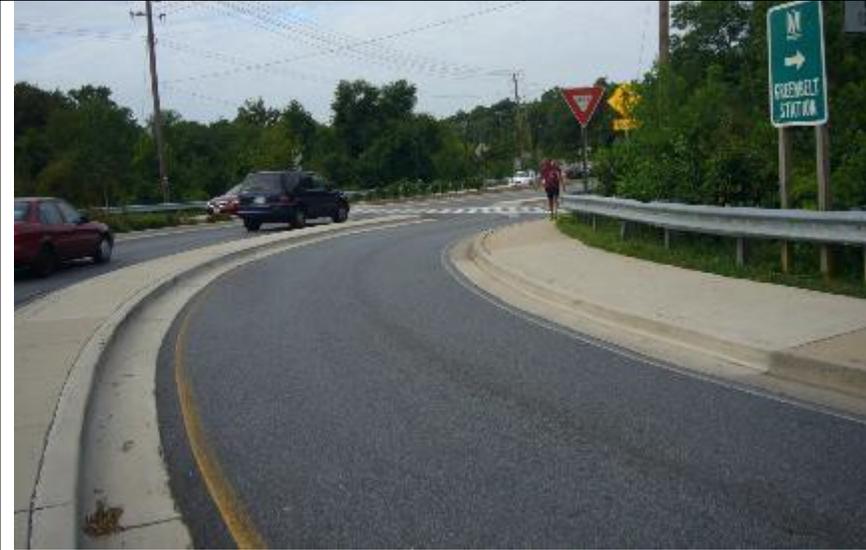
**Figure 12-186** View of exit lane crosswalk on west leg from north leg (from median between right only lane and right/through lane)

- a) Note that from this point driver in right lane cannot see pedestrian standing in the ramp at the crosswalk.
- b) Yield sign – not sure who driver is yielding to at that point - pedestrians?
- c) Narrow sidewalk at back of curb.

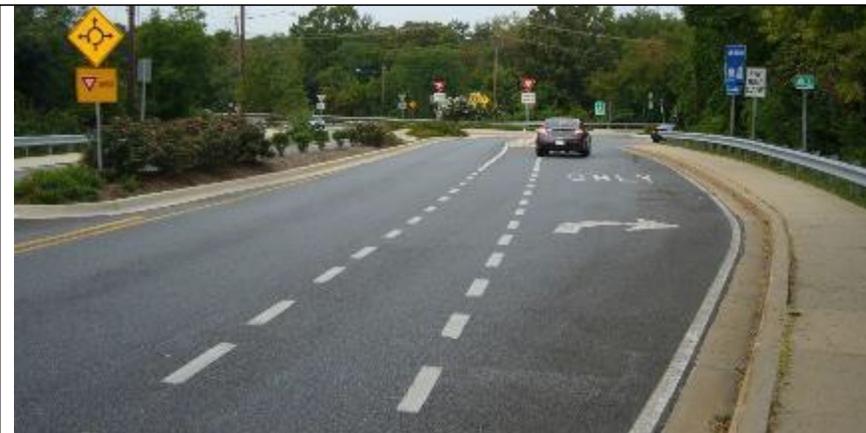
**Figure 12-187:** East approach

- a) Right only lane and right/through lane.
- b) No pedestrian crosswalk on this leg.
- c) Bike lane has dotted markings, then solid again ending in median nose? Should be striped out somehow?
- d) Roundabout sign, yield ahead placard.

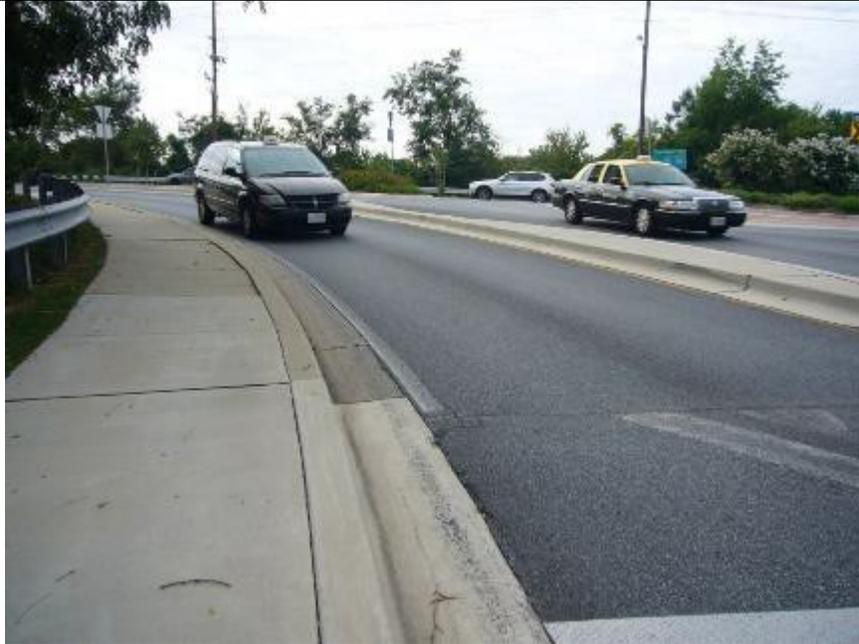
**Figure 12-188: View from crosswalk of vehicles approaching from east leg to north leg**

- a) Vehicle moving pretty quickly downhill.
- b) Closest lane vehicle not visible around curve until about 50 feet before crosswalk
- c) Speed hump and pedestrian sign with HUMP placard not visible more than 50 before crosswalk.

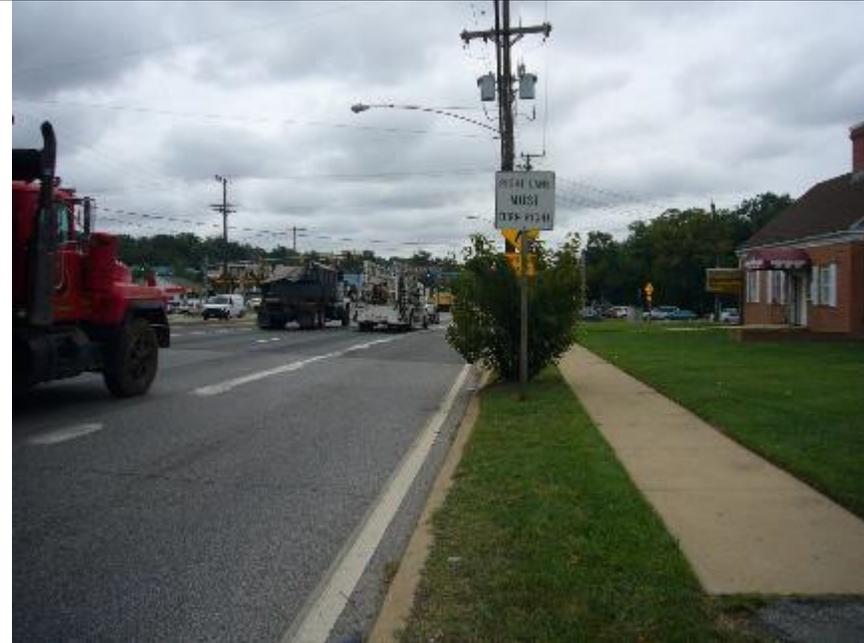
Figure 12-190: Approach to intersection

- a) RIGHT LANE MUST TURN RIGHT sign.
- b) Pedestrian crossing warning sign.
- c) Lots of truck traffic on Kenilworth Road.

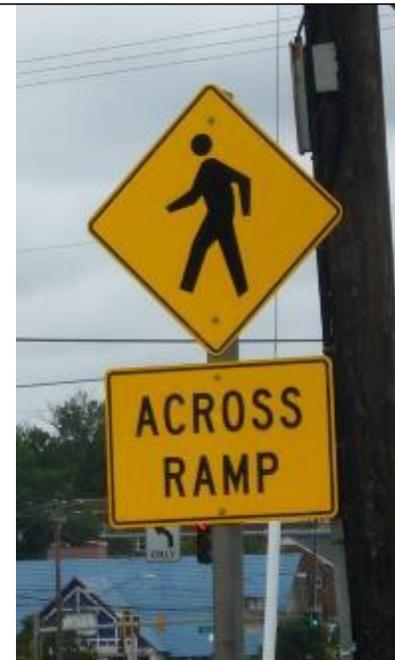
Figure 12-191: Unusual placard under pedestrian warning sign: ACROSS RAMP

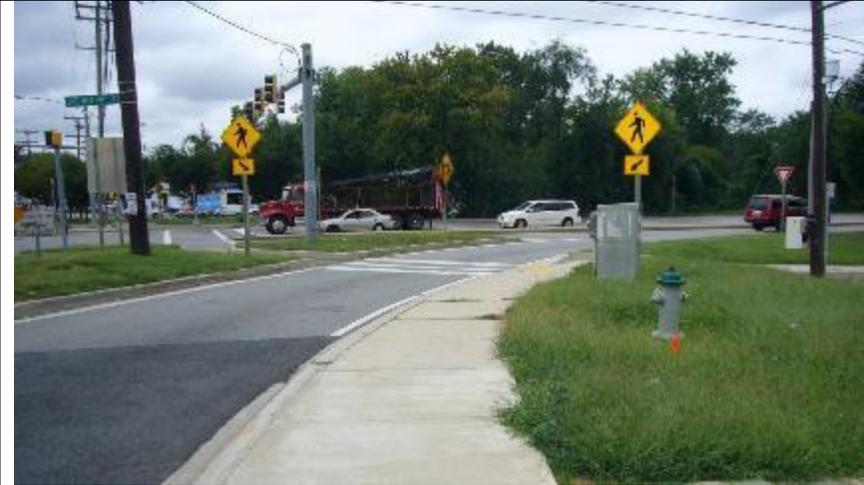
**Figure 12-192: View of crosswalk location**

- a) Channelized right turn with decel lane, sloping downhill toward East West Highway.
- b) Yield signs at merge point with EW Highway.
- c) Pedestrian warning signs.
- d) Marked crosswalk.
- e) Signal controller box may block driver's view of pedestrians (from slightly further back).

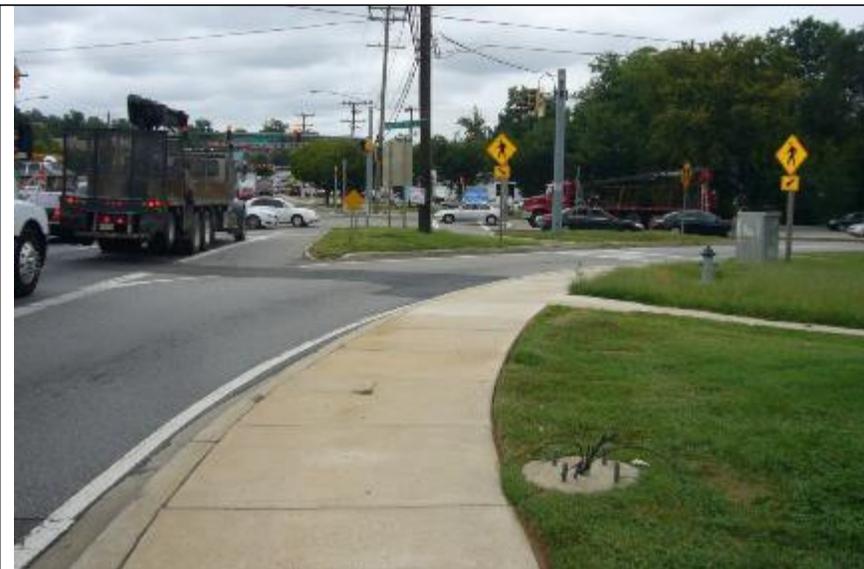
**Figure 12-193: Pedestrian's view on approach**

- a) Sidewalk at back of curb.
- b) Grass on side away from street.

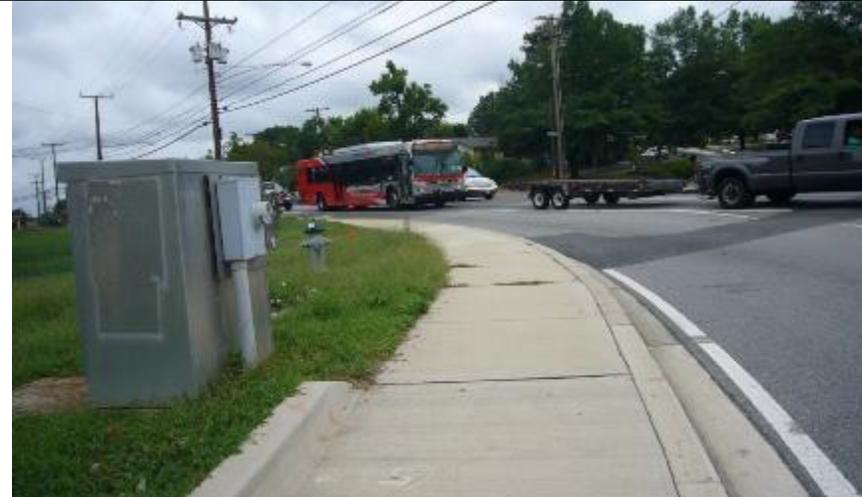
**Figure 12-194: Pedestrian's view of approaching traffic from crosswalk**

**a) Note that controller blocks view of cars approaching in the right turn lane.**

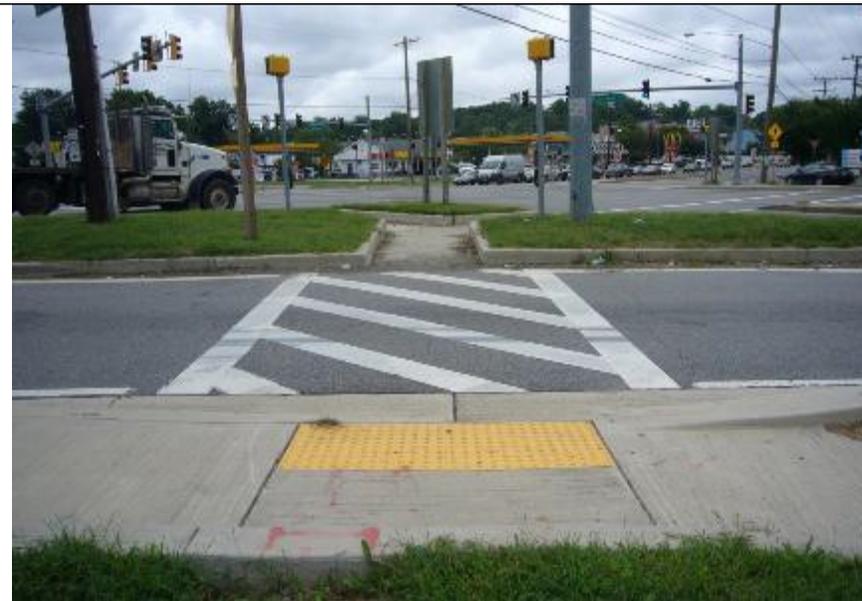
**Figure 12-195: View of crosswalk and island**

**a) Parallel ramp (entire sidewalk slopes down to level with the street).**

**e) Grass on island areas that are not cut-through.**

**f) APS with pushbutton locator tones on island for crossings of Kenilworth and East-West Highway.**

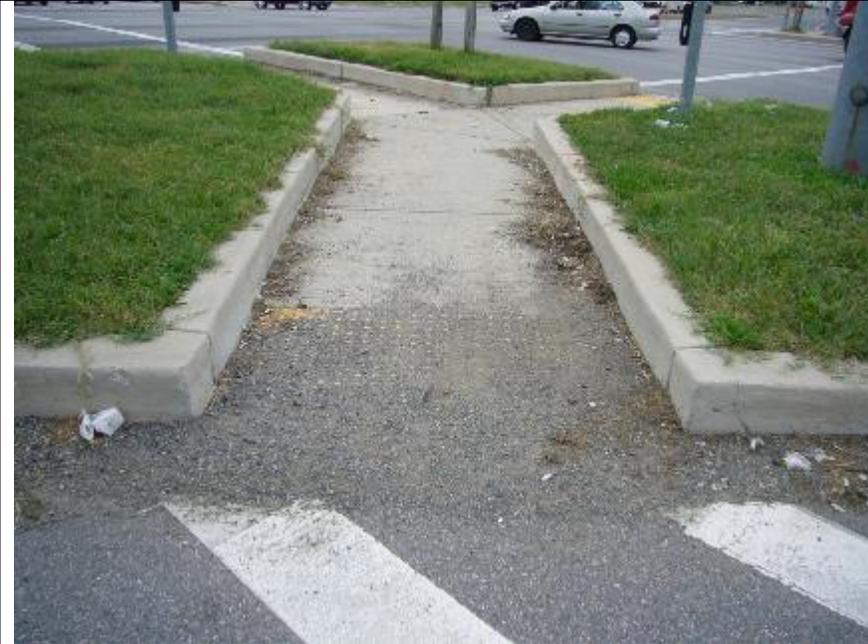
**Figure 12-196: Detectable warning on island at entry to cut-through area covered in dirt and debris**

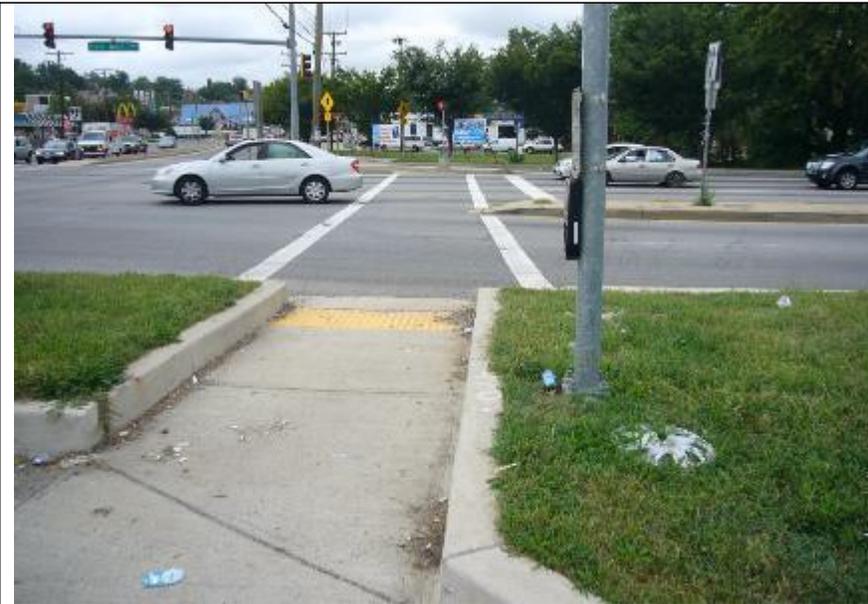
**Figure 12-197: Crossing East West Highway from island**

- a) Narrow cut-through bordered by grass.
- b) Curbs on cut-through basically aligned with direction of travel on the crosswalk.
- c) Detectable warning at edge of street.
- d) APS more than 10 feet from edge of street.

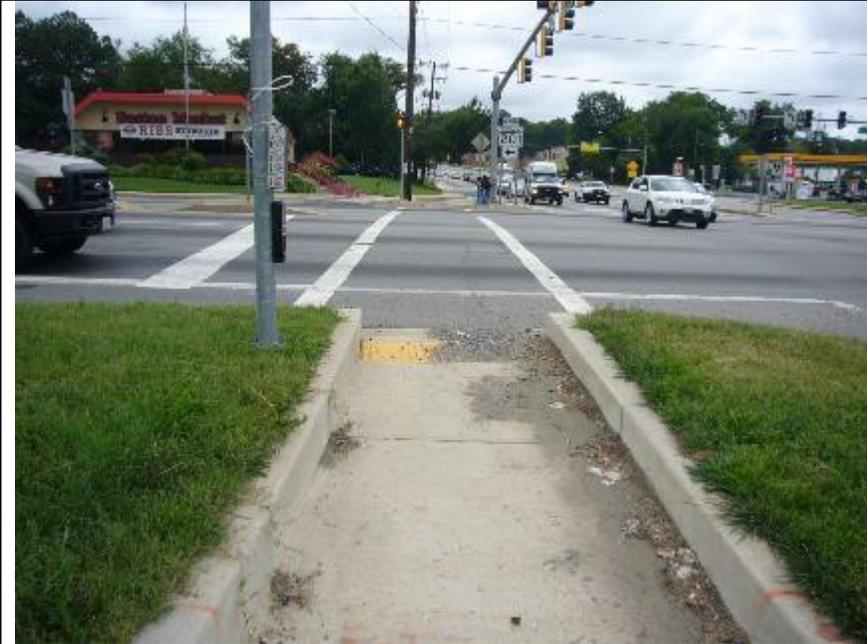
**Figure 12-198: Crossing Kenilworth Road from island**

- a) Narrow cut-through area bordered by grass.**
- b) Lots of debris in cut-through area.**
- c) APS about 5 feet back from road.**
- d) Cut-through, gutter and detectable warning aligned with direction of travel on the crosswalk.**

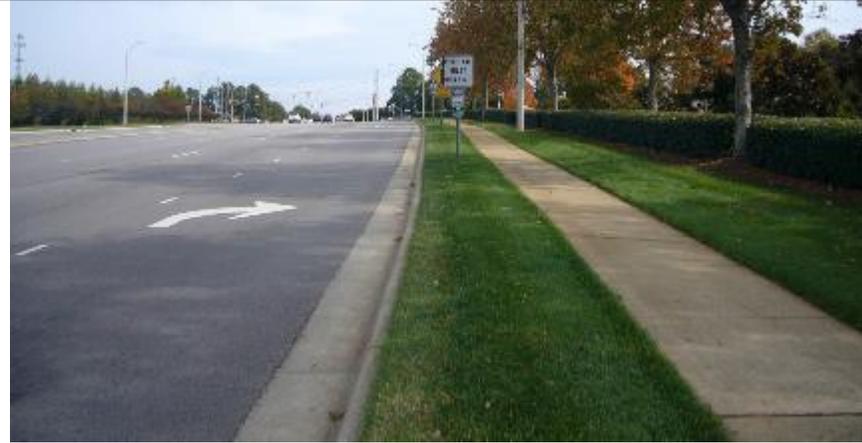
Figure 12-199: Driver's view on approach on Tryon Road

- a) RIGHT LANE MUST TURN RIGHT sign.
- b) Right turn arrow lane marking.
- c) Signal ahead warning sign (behind RT sign in this photo).
- d) Uphill approach.

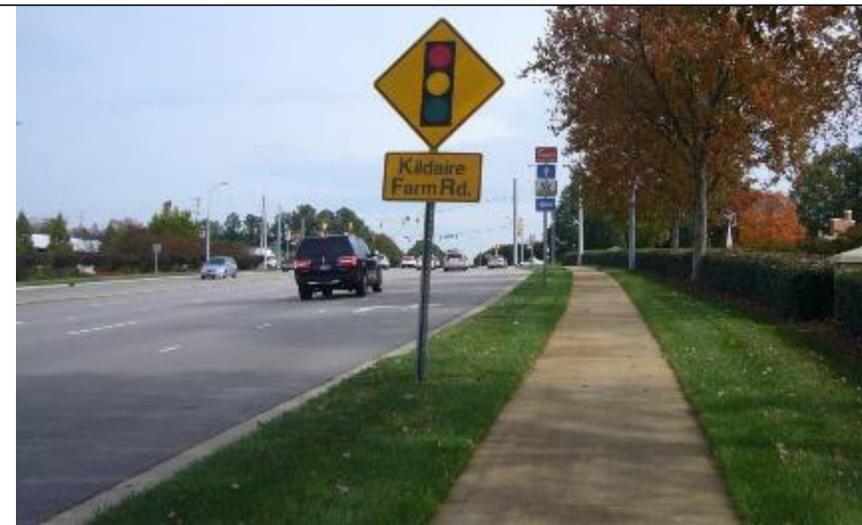
Figure 12-200: Signal ahead sign

- a) Signal ahead sign with road name.
- b) Other guide signs on approach.

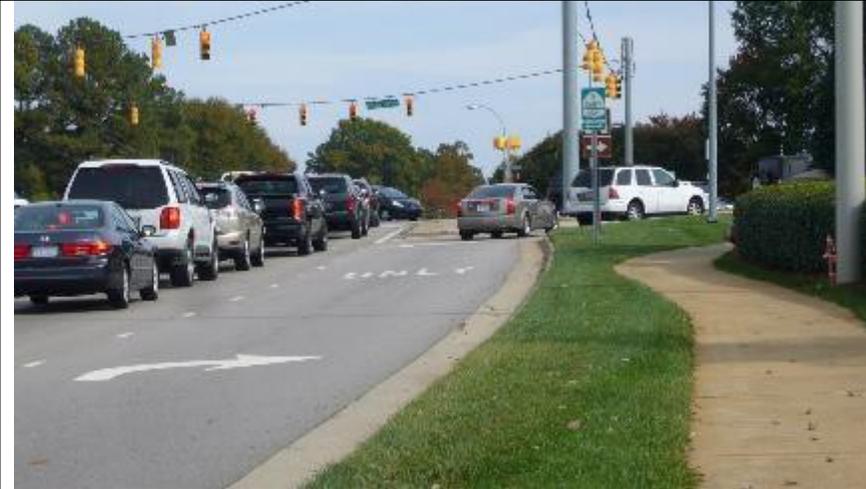
**Figure 12-201: Driver's view of CTL and pedestrian crossing**

- a) Right turn arrow and ONLY pavement marking.
- b) Informational signs (bike route and wildlife viewing area signs).
- c) No pedestrian crossing sign.
- d) Marked pedestrian crosswalk (pavement markings).

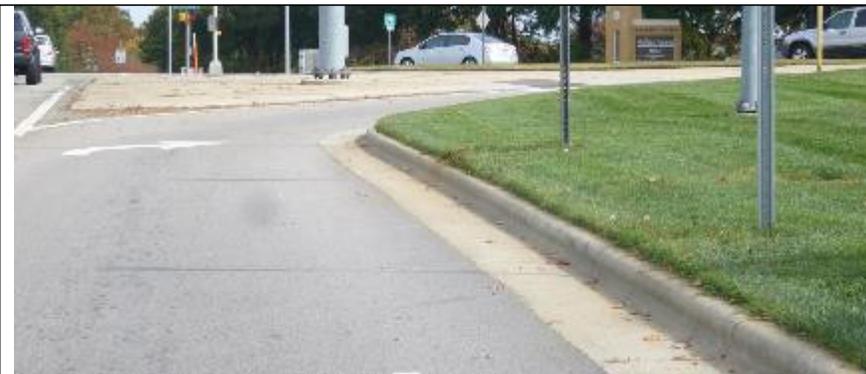
**Figure 12-202: Marked crosswalk is not very visible on approach**

**Although the crosswalk is marked with continental stripes, it is not very visible to approaching drivers. No warning sign to add more visibility.**

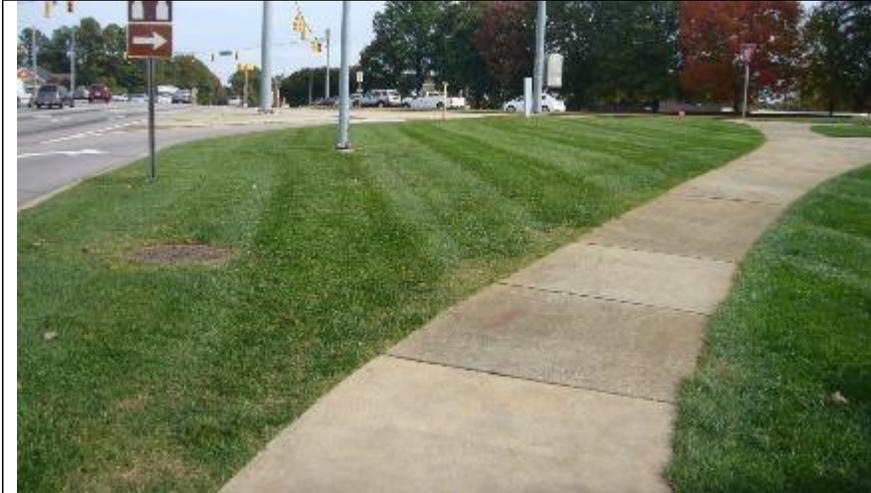
**Figure 12-203: Pedestrian approach**

- a) Sidewalk separated from roadway by wide landscape strip.
- b) Sidewalk curves away from road, around corner, then a spur angles back to crosswalk.
- c) Crosswalk is at location where pole and with signal controller is visible in this photo.

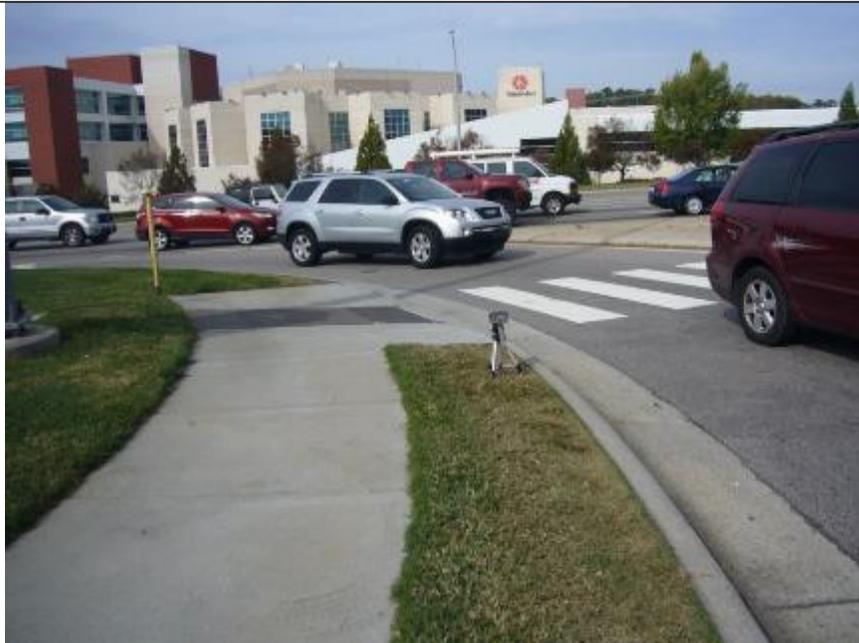
**Figure 12-204: Crosswalk approach sidewalk**

- a) Perpendicular ramp.
- b) Sidewalk all slopes toward crosswalk.
- c) Grass landscape strip between sidewalk and curb on approach to crosswalk.

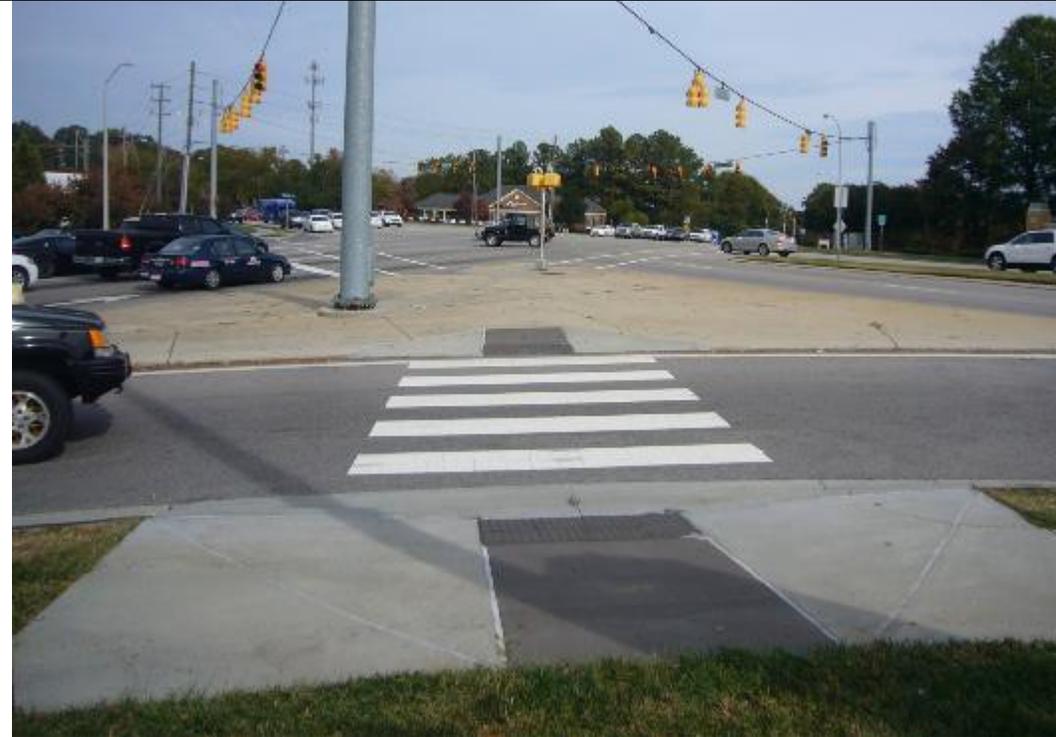
**Figure 12-205: Crosswalk across right turn lane and view of large island area**

- a) Large flares on ramp wider than crosswalk area.**
- b) Detectable warning at base of ramp.**
- c) Continental markings for crosswalk.**
- d) Large completely paved island.**
- e) Signal pole in middle of island where some blind participants looked for a pushbutton (could hear the pole).**
- f) Standard (non-audible) pushbuttons on pedestrian signal pole near crosswalks across Kildaire Farm and Tryon.**

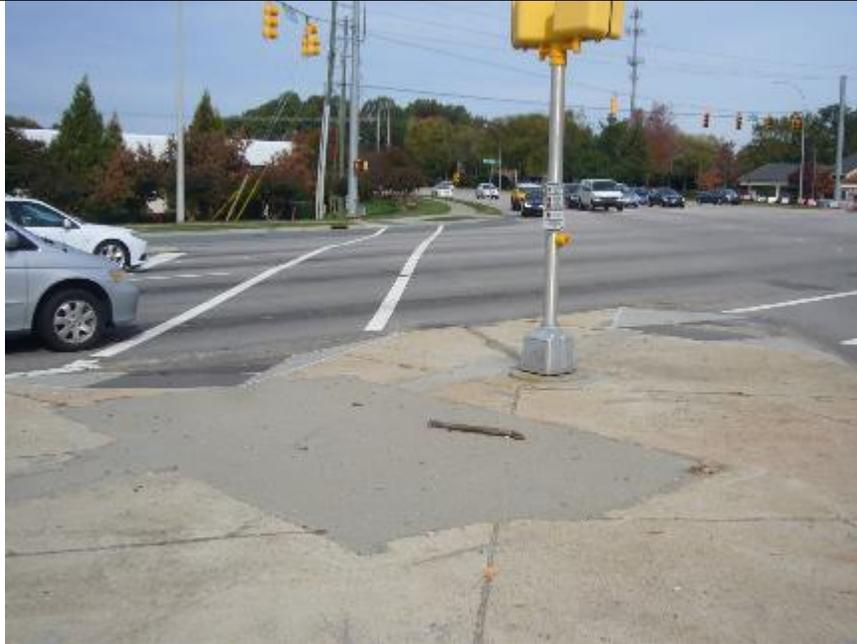
**Figure 12-206: Curb ramps and crosswalks for Tryon (front) and Kildaire Farm (to right)**

- a) Ramp slope and detectable warning aligned with crosswalk direction, gutter not aligned perpendicular to crosswalk.
- b) Pushbuttons back more than 10 feet from both crosswalks, two buttons on same pole.
- c) Darker pavement on ramp as well as detectable warnings.
- d) Lots of debris and sand on detectable warning at Kildaire Farm crossing. In addition, entire corner is basically flat, not just where detectable warning is installed.

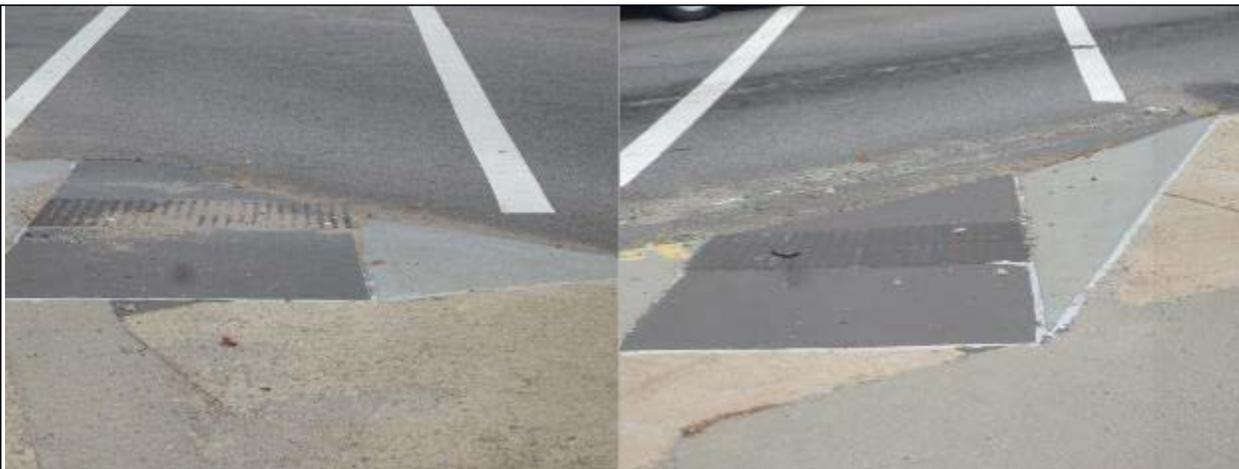
**Figure 12-207: Closer view of curb ramps**

- a) Ramp to Kildaire Farm Rd. crossing on left, Tryon Road crossing on right.
- b) Designs look like they were an attempt to align the ramps with the crosswalk, but road/ramp connection does not meet ADA requirements.

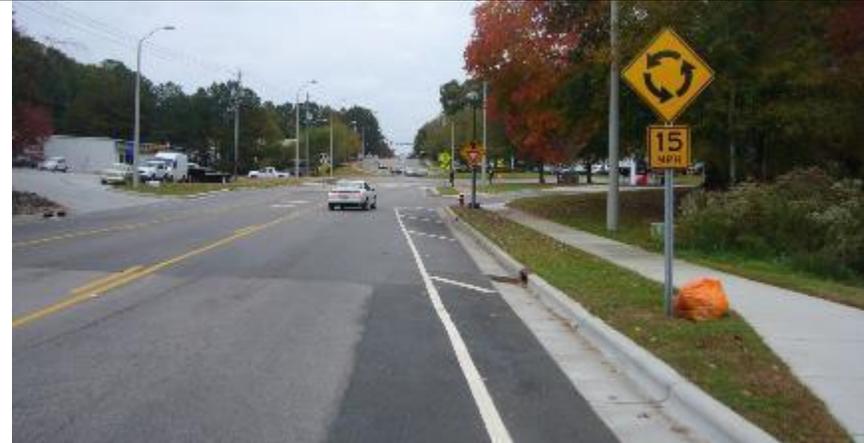
Figure 12-208: Driver's view of roundabout on approach from west on Old Apex Road

- a) Roundabout sign and advisory speed sign.
- b) Yield ahead sign.
- c) Center two way turn lane.
- d) Driveway into gas station on right just before crosswalk and roundabout entry.
- e) Pedestrian warning signs at crosswalk.

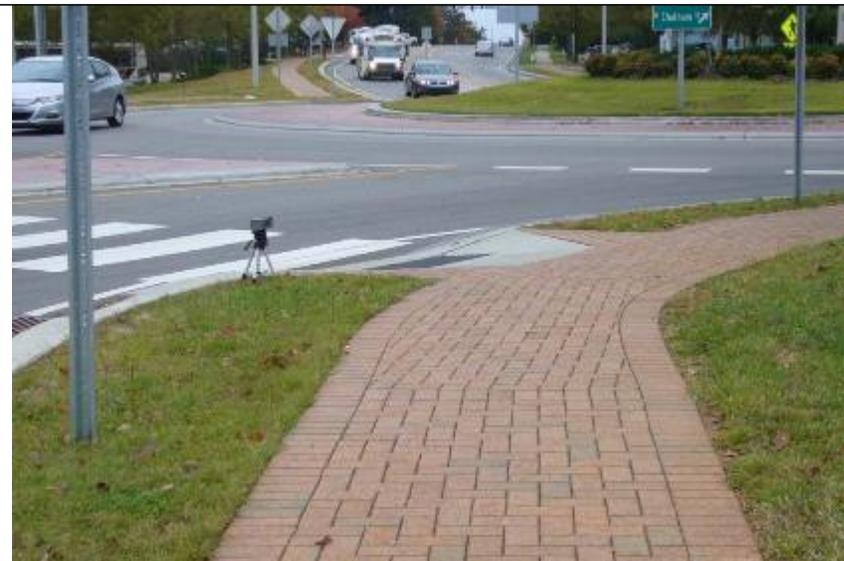
Figure 12-209: Pedestrian approach to west crosswalk, entry leg

- a) Brick sidewalk.
- b) Grass landscape strip between sidewalk and curb.
- c) Ramp slope outside of sidewalk area.

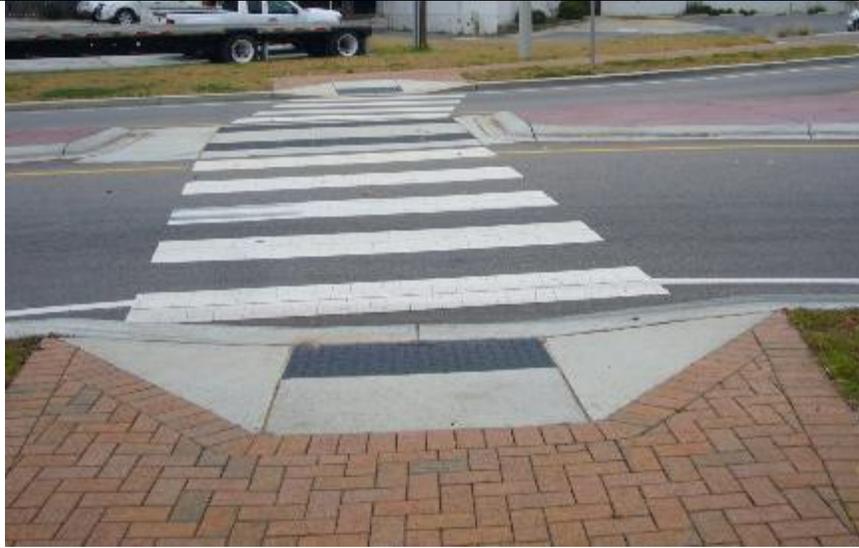
**Figure 12-210: West crosswalk, from south end**

- a) One lane entry.**
- b) Landscaping on both sides of ramp.**
- c) Brick sidewalks near roundabout.**
- d) Perpendicular curb ramp.**
- e) Detectable warning at base of ramp.**
- f) Ramps slope, detectable warning and gutter lined up in crosswalk direction (generally within).**
- g) Narrow splitter island with wide cut-through area.**
- h) Detectable warning surface does not cover full width of cut-through opening in island.**

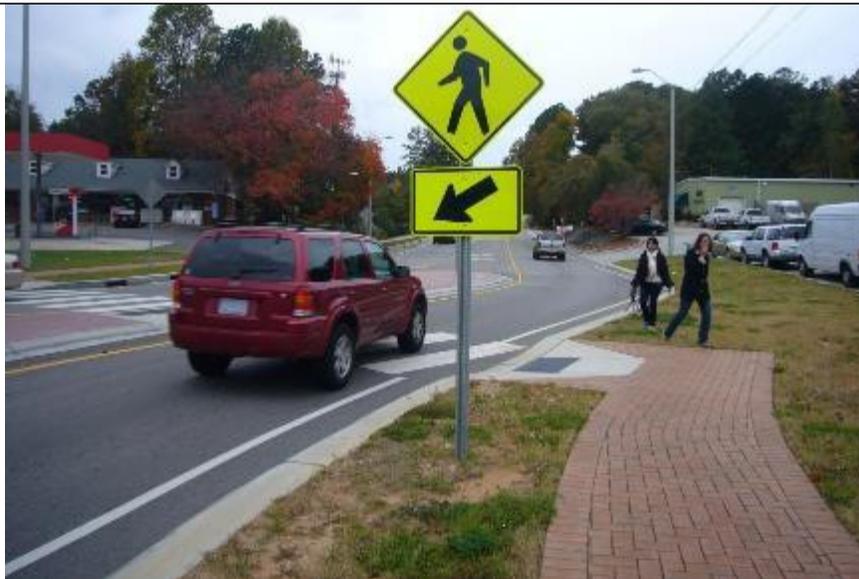
**Figure 12-212: Pedestrian approach to west crosswalk, exit lane**

- a) Grass landscape strip between sidewalk and curb.
- b) Brick sidewalk, concrete curb ramp.
- c) Pedestrian warning sign with downward arrow before crosswalk.

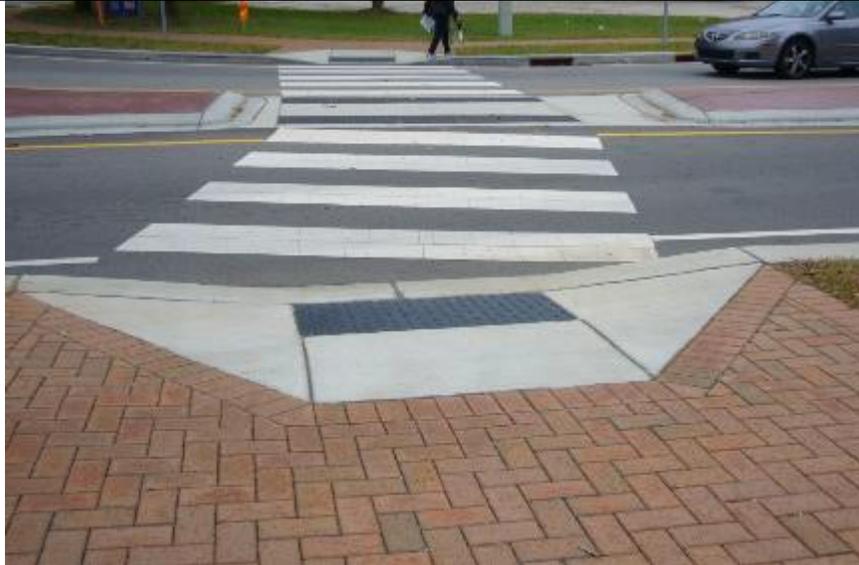
**Figure 12-213: West crosswalk, looking south, exit lane crossing**

- a) Perpendicular ramp.
- b) Brick sidewalk.
- c) Sidewalk does not continue past crosswalk.
- d) Ramp, DW and gutter aligned to left of crosswalk.
- e) Narrow island with wide cut-through.
