## Guidelines for the Application of Crossing Solutions at Roundabouts and Channelized Turn Lanes for Pedestrians with Vision Disabilities

Bastian Schroeder, Lee Rodegerdts, Pete Jenior, Edward Myers, Christopher Cunningham, Katy Salamati, Sarah Searcy, Sarah O'Brien, Janet Barlow, and Billie Louise (Beezy) Bentzen; National Cooperative Highway Research Program; Transportation Research Board; National Academies of Sciences, Engineering, and Medicine

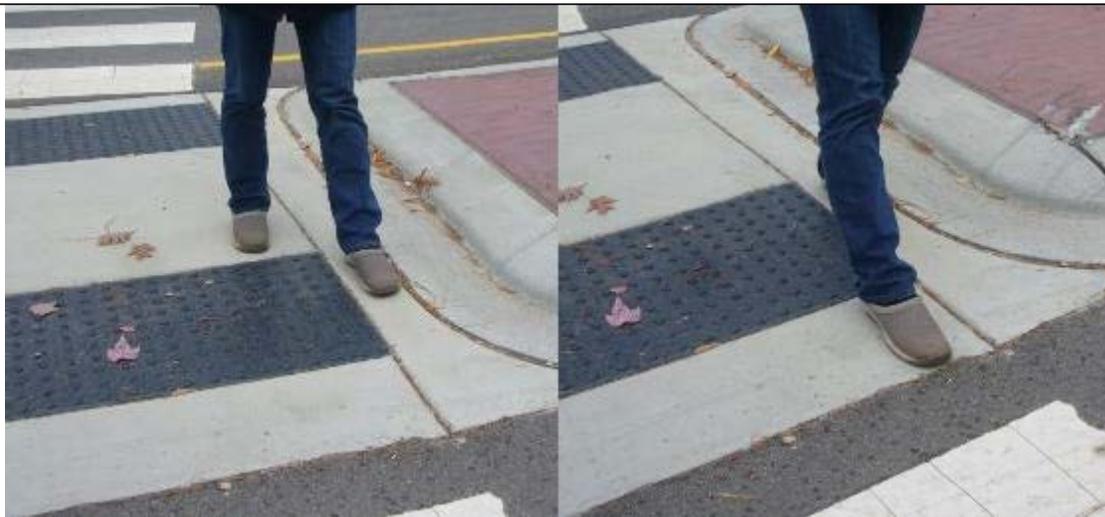
**Figure 12-214: Illustration of pedestrian stepping past detectable warning surface that doesn't extend the full width of the cut-through in island**

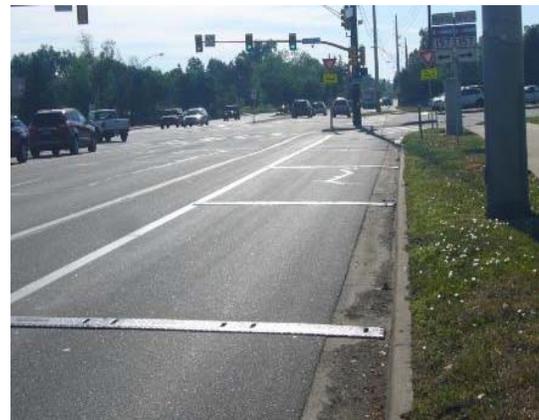
**Exhibit 2: Special Feature**

This site features two channelized turn lanes (CTLs). The first CTL is at the northeast quadrant of the intersection of Foothills Parkway and Baseline Road. It contains a deceleration lane, an acceleration lane and sound strip treatment. The second CTL is at the southwest quadrant of the intersection of Foothills Parkway and Baseline Road. It contains a deceleration lane, an acceleration lane and a raised crosswalk. These sites were two of three of the six Boulder CTL locations that were outside the city limits along an urban arterial corridor.

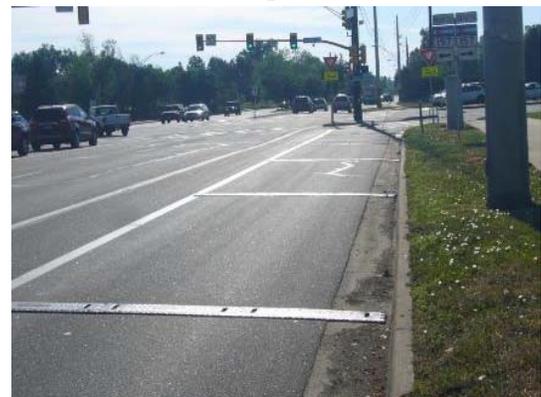
**Exhibit 2: Special Feature**

This site features two channelized turn lanes (CTLs). The first CTL is at the northeast quadrant of the intersection of Foothills Parkway and Baseline Road. It contains a deceleration lane, an acceleration lane and sound strip treatment. The second CTL is at the southwest quadrant of the intersection of Foothills Parkway and Baseline Road. It contains a deceleration lane, an acceleration lane and a raised crosswalk. These sites were two of three of the six Boulder CTL locations that were outside the city limits along an urban arterial corridor.

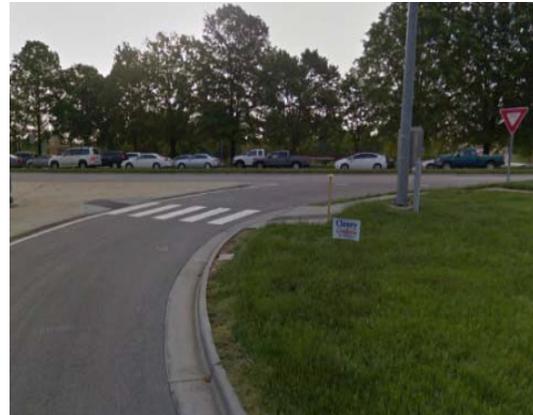
**Exhibit 2: Special Feature**

This channelized turn lane is at the southwest quadrant of the intersection of Kildaire Farm Road and Tyron Road in Cary, North Carolina. It features a deceleration lane, but no acceleration lane, and no pedestrian signage at the crosswalk. Kildaire Farm Road features an uphill grade in advance of the CTL.

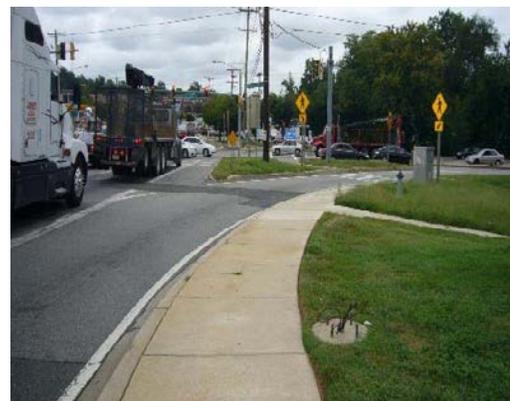
**Exhibit 2: Special Feature**

This channelized turn lane (CTL) is at northwest quadrant of the intersection of Kenilworth Avenue and West Highway Street in Greenbelt, Maryland. The site features a deceleration lane and an acceleration lane. No further treatment is installed beyond standard pedestrian signage at crosswalk.

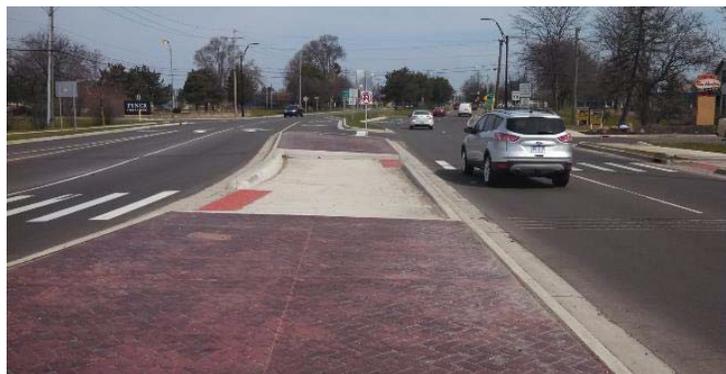
### Exhibit 2: Special Feature

The roundabout is outfitted with grooved rumble strips in advance of the crosswalk at a distance of approximately 20-30' before the crosswalk markings. Presumably, these rumble strips are intended to alert drivers of the upcoming crosswalk.

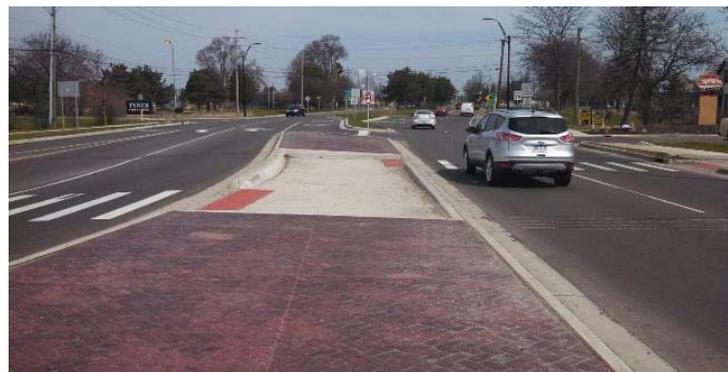
### Exhibit 2: Special Feature

The roundabout is outfitted with grooved rumble strips in advance of the crosswalk at a distance of approximately 20-30' before the crosswalk markings. Presumably, these rumble strips are intended to alert drivers of the upcoming crosswalk.

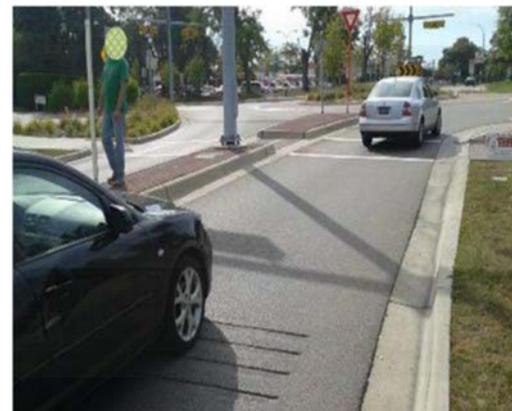
**Exhibit 2: Special Feature**

This single-lane site is at Huron Parkway and Nixon Road. It has single-lane approaches on all four legs and standard crosswalks approximately 20' from the circulatory roadway. A set of four rumble strips is milled approximately 50' prior to each crosswalk to alert drivers and provide an auditory queue for pedestrians.

- The single-lane roundabout featured very slow vehicular speed and generally high yielding compliance from drivers.
- Frequent pedestrian activity was observed at the site, raising driver expectations of pedestrians.
- The rumble strips were difficult to hear outside of the vehicle at the slow travel speeds, and further were placed very close to the crosswalk, which gave little reaction time for pedestrians.
- No interventions were recorded at either the entry or the exit legs.

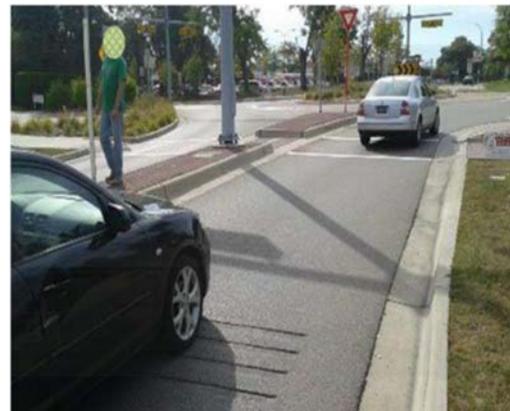
**Exhibit 2: Special Feature**

This single-lane site is at Huron Parkway and Nixon Road. It has single-lane approaches on all four legs and standard crosswalks approximately 20' from the circulatory roadway. A set of four rumble strips is milled approximately 50' prior to each crosswalk to alert drivers and provide an auditory queue for pedestrians.

- The single-lane roundabout featured very slow vehicular speed and generally high yielding compliance from drivers.
- Frequent pedestrian activity was observed at the site, raising driver expectations of pedestrians.
- The rumble strips were difficult to hear outside of the vehicle at the slow travel speeds, and further were placed very close to the crosswalk, which gave little reaction time for pedestrians.
- No interventions were recorded at either the entry or the exit legs.

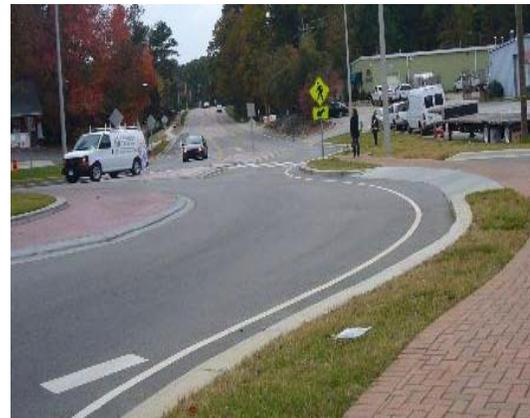
Exhibit 2: Special Feature

This single-lane roundabout is at the intersection of Old Apex Road and West Chatham Street in Cary, North Carolina. This three-legged roundabouts has no additional treatments installed.

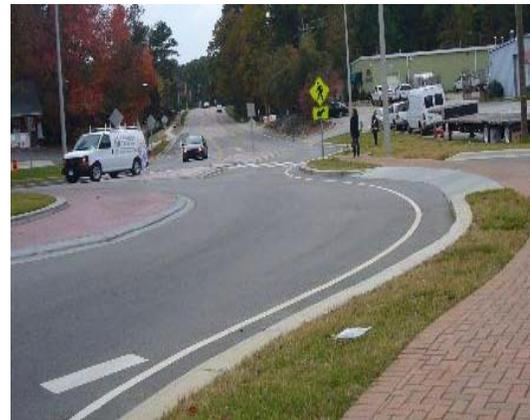
**Exhibit 2: Special Feature**

This single-lane roundabout is at the intersection of Old Apex Road and West Chatham Street in Cary, North Carolina. This three-legged roundabouts has no additional treatments installed.

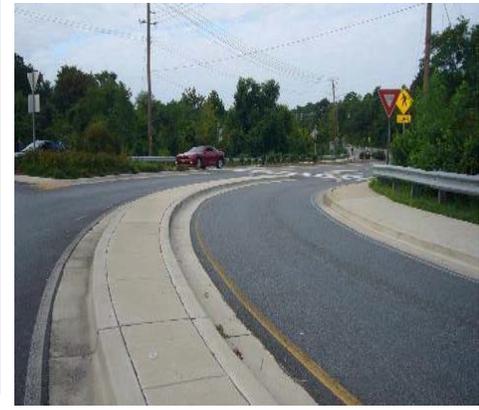
Exhibit 1: Traffic Volume Exhibit 2: Special Feature

This roundabout is at the intersection of Cherrywood Lane and Greenbelt Metro Drive in Greenbelt, Maryland. It contains slip lanes and raised crosswalks. The west approach entry and exit legs of this site were studied.

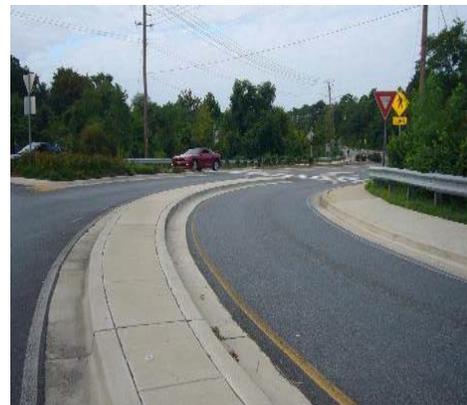
Exhibit 1: Traffic Volume Exhibit 2: Special Feature

This roundabout is at the intersection of Cherrywood Lane and Greenbelt Metro Drive in Greenbelt, Maryland. It contains slip lanes and raised crosswalks. The west approach entry and exit legs of this site were studied.

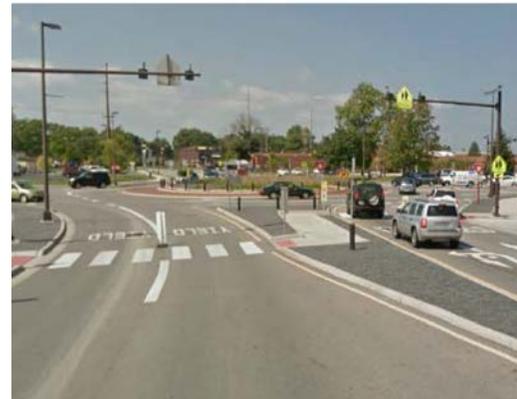
**Exhibit 2: Special Feature**

This roundabout has two-lane entries and exits at all approaches and is outfitted with in-road yield-to-pedestrian warning signs. The east approach features an offset exit leg, while the west approach has more standard crosswalk geometry. The east approach further has overhead flashing beacons for a school crossing, but these devices were not active during the study.

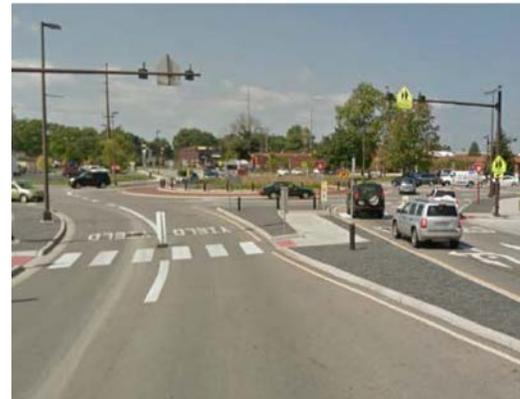
Exhibit 2: Special Feature

This roundabout has two-lane entries and exits at all approaches and is outfitted with in-road yield-to-pedestrian warning signs. The east approach features an offset exit leg, while the west approach has more standard crosswalk geometry. The east approach further has overhead flashing beacons for a school crossing, but these devices were not active during the study.

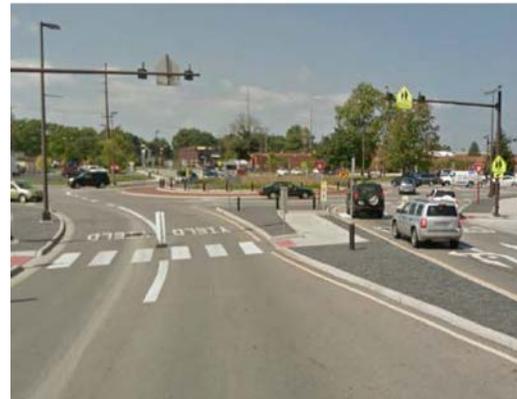
Exhibit 2: Special Feature

This roundabout has two-lane entries and exits at all approaches and is outfitted with in-road yield-to-pedestrian warning signs. The east approach features an offset exit leg, while the west approach has more standard crosswalk geometry. The east approach further has overhead flashing beacons for a school crossing, but these devices were not active during the study.

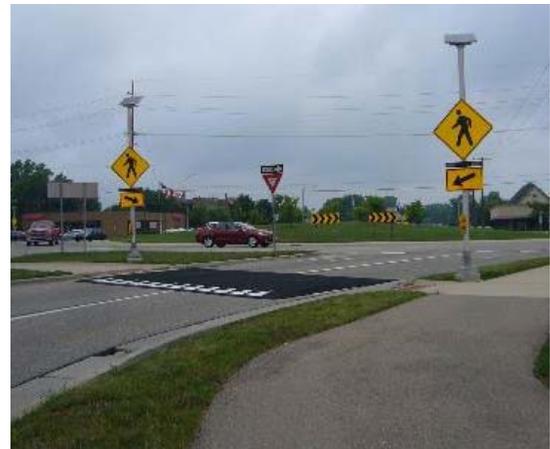
Exhibit 2: Special Feature

This multi-lane roundabout is at Maple Road and Farmington Road. The roundabout was previously evaluated in a separate research project in (a) a “before” condition without treatment, and (b) in an “after” condition with Rectangular Rapid-Flashing Beacons (RRFBs) installed. For this study, the roundabout was outfitted also with raised crosswalk at four test legs: 3-lane entry from east, three-lane exit to east, two-lane entry from south, and two-lane exit to north.

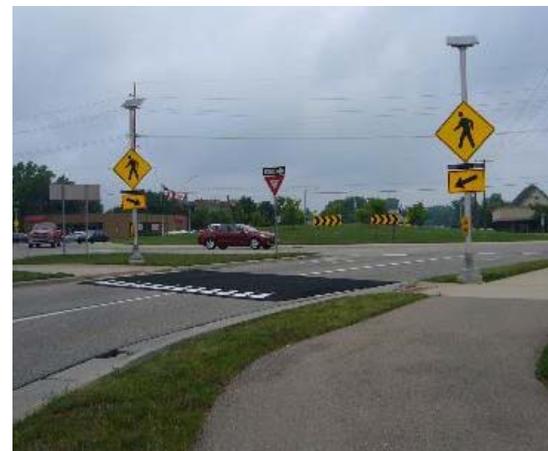
Exhibit 2: Special Feature

This multi-lane roundabout is at Maple Road and Farmington Road. The roundabout was previously evaluated in a separate research project in (a) a “before” condition without treatment, and (b) in an “after” condition with Rectangular Rapid-Flashing Beacons (RRFBs) installed. For this study, the roundabout was outfitted also with raised crosswalk at four test legs: 3-lane entry from east, three-lane exit to east, two-lane entry from south, and two-lane exit to north.

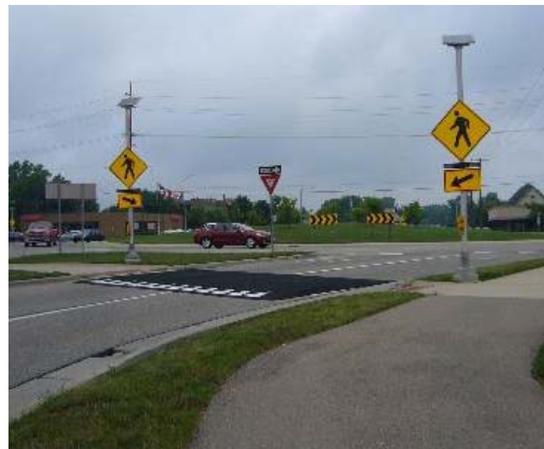
Exhibit 2: Special Feature

This multi-lane roundabout is at Maple Road and Farmington Road. The roundabout was previously evaluated in a separate research project in (a) a “before” condition without treatment, and (b) in an “after” condition with Rectangular Rapid-Flashing Beacons (RRFBs) installed. For this study, the roundabout was outfitted also with raised crosswalk at four test legs: 3-lane entry from east, three-lane exit to east, two-lane entry from south, and two-lane exit to north.

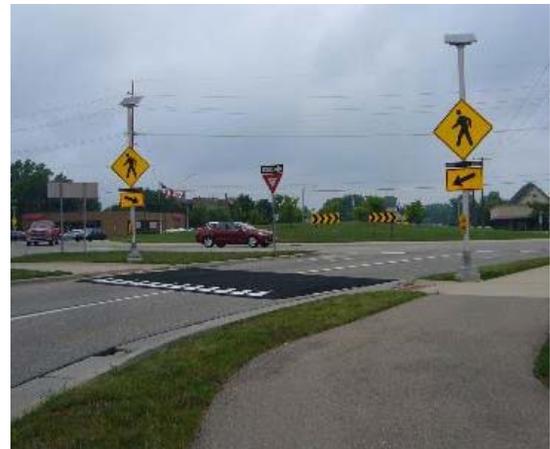
**Exhibit 2: Special Feature**

This multi-lane roundabout is at Maple Road and Farmington Road. The roundabout was previously evaluated in a separate research project in (a) a “before” condition without treatment, and (b) in an “after” condition with Rectangular Rapid-Flashing Beacons (RRFBs) installed. For this study, the roundabout was outfitted also with raised crosswalk at four test legs: 3-lane entry from east, three-lane exit to east, two-lane entry from south, and two-lane exit to north.
